Zeitschrift: IABSE reports = Rapports AIPC = IVBH Berichte
Band: 56 (1987)

Artikel: Control and detecting system related to the construction of the underground railway line in Rome
Autor: Cangiano, Mario / Croci, Giorgio
DOI: <https://doi.org/10.5169/seals-43574>

Control and Detecting System related to the construction of the underground railway line in Rome

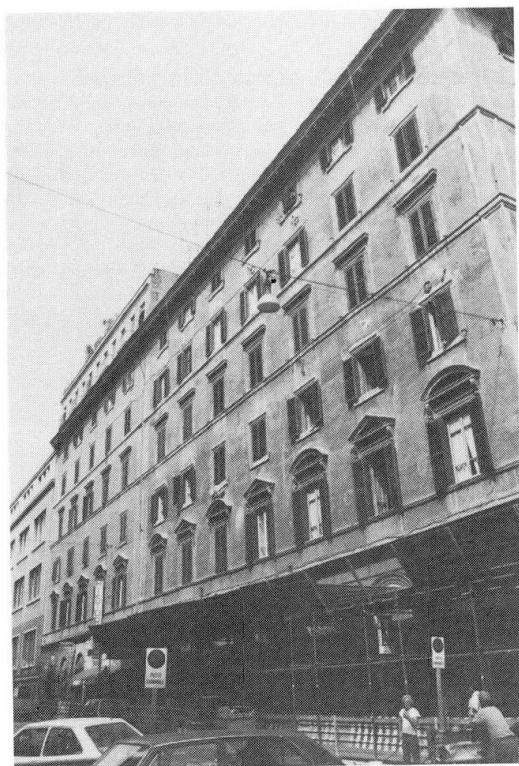
Fig. 1 Facade looking on
Via Palestro

The present article examines some old masonry buildings in Rome in the area between Via Palestro, Via Vicenza and Via Villafranca (Figures 1-3), which have been affected by works to extend Underground Line B. Two tunnels, first one, then the other, for this extension were bored under these buildings at a depth of 20-25 metres below the road surface.

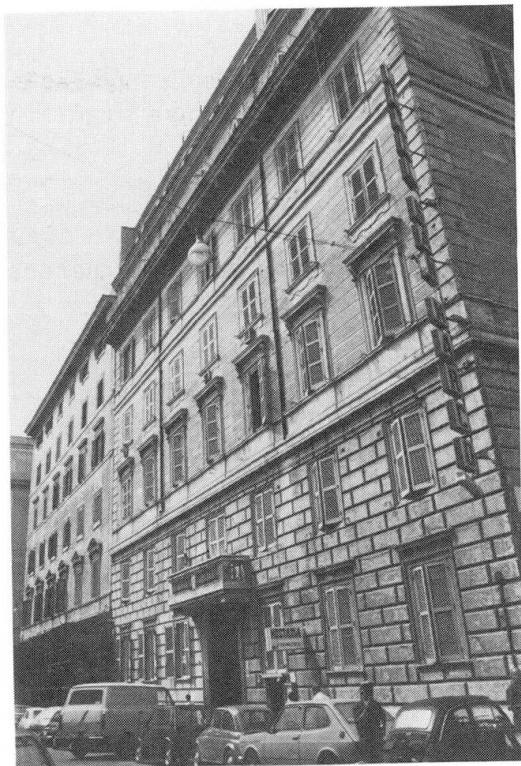
Fig. 2 Facade looking on
Via Vicenza

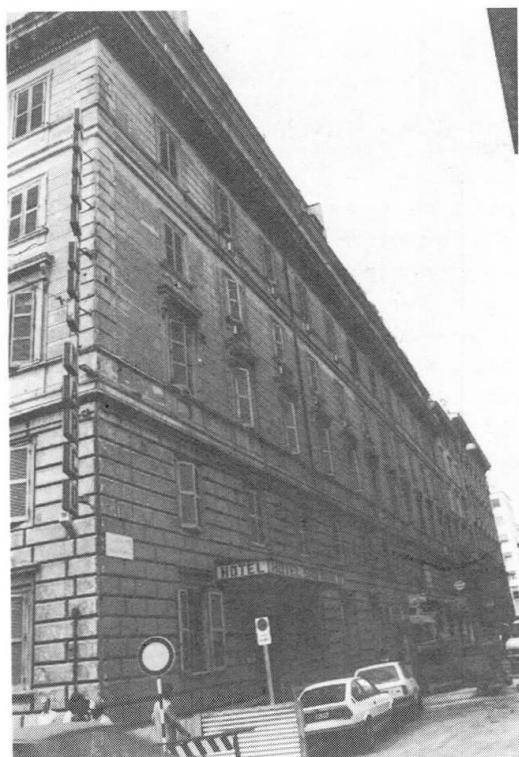
Fig. 3 Facade looking on Via Villafranca

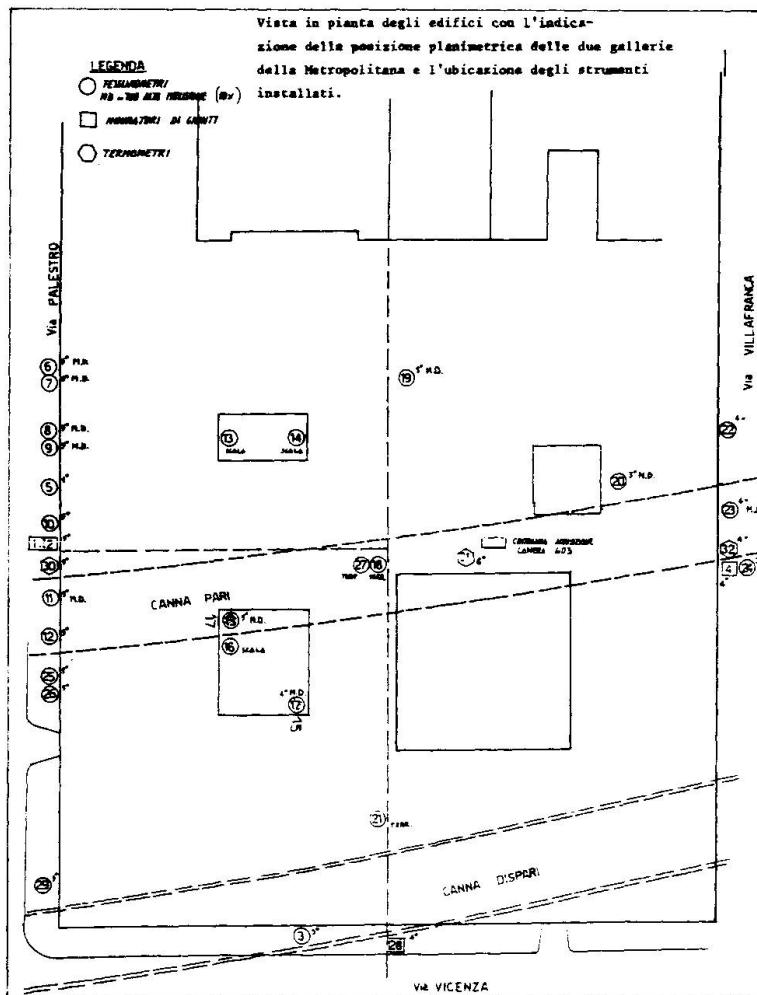
Fig. 4 Plan view of the buildings with the indication of the two underground tunnels position and of the instrument location.

The three buildings recorded are situated one against the other and separated by joints in the construction (see Figures 4-7). The characteristics of the three buildings are very similar and can be summarised as follows.

Figures 4-7 show the positioning of the instruments on the structures and some details are visible in Figures 12-15.

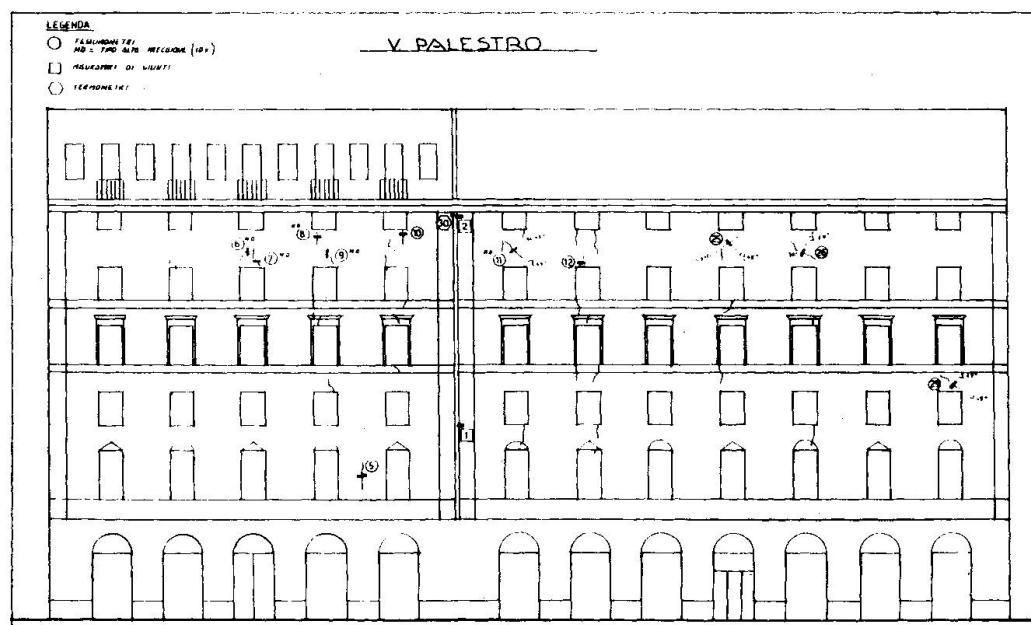
Fig. 5 Facade looking on Via Palestro
The crack pattern and the installed instruments are visible.

Some structures in the buildings in question have been modified at various times. Both the outsides and the internal structural elements show pronounced cracking. The lesions present on the outsides are shown in Figures 5-7, while Figures 8-11 show the most significant lesions encountered inside the buildings.

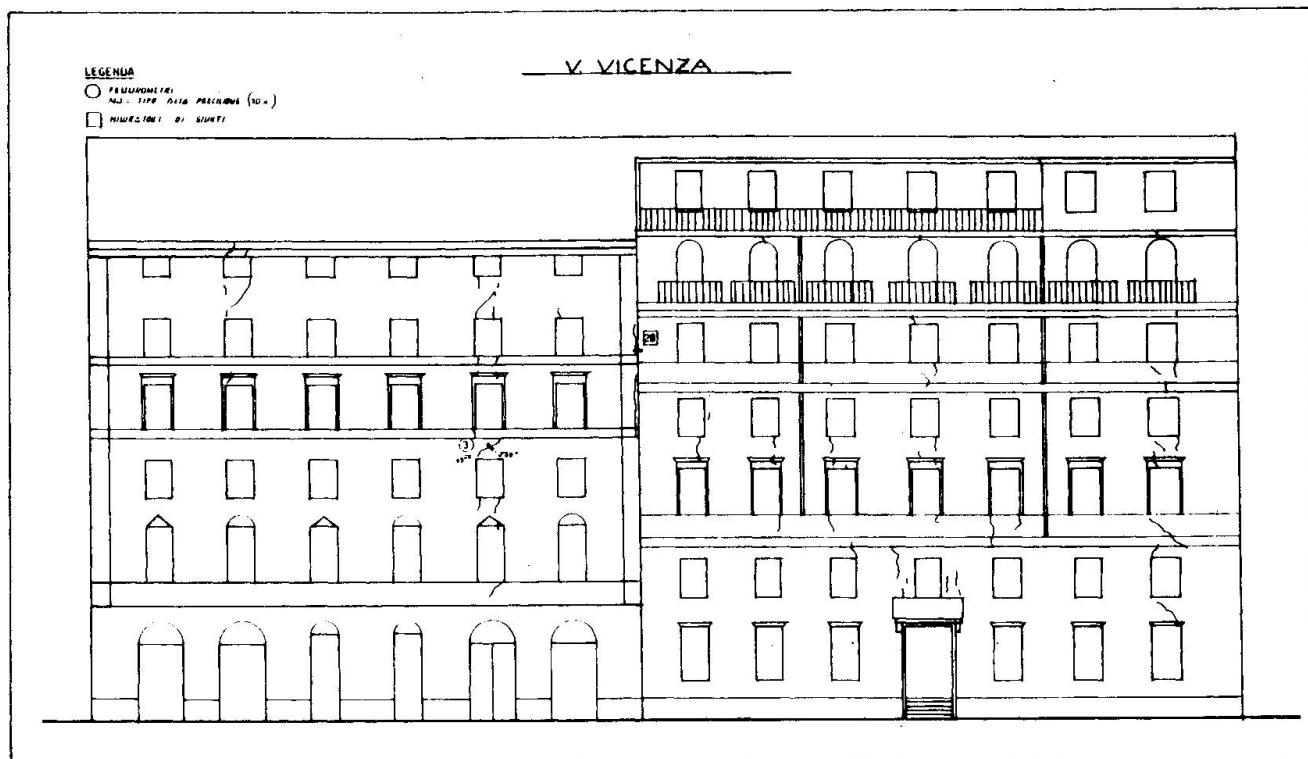
Fig. 6 Facade looking on Via Vicenza.
The crack pattern and the installed instruments are visible

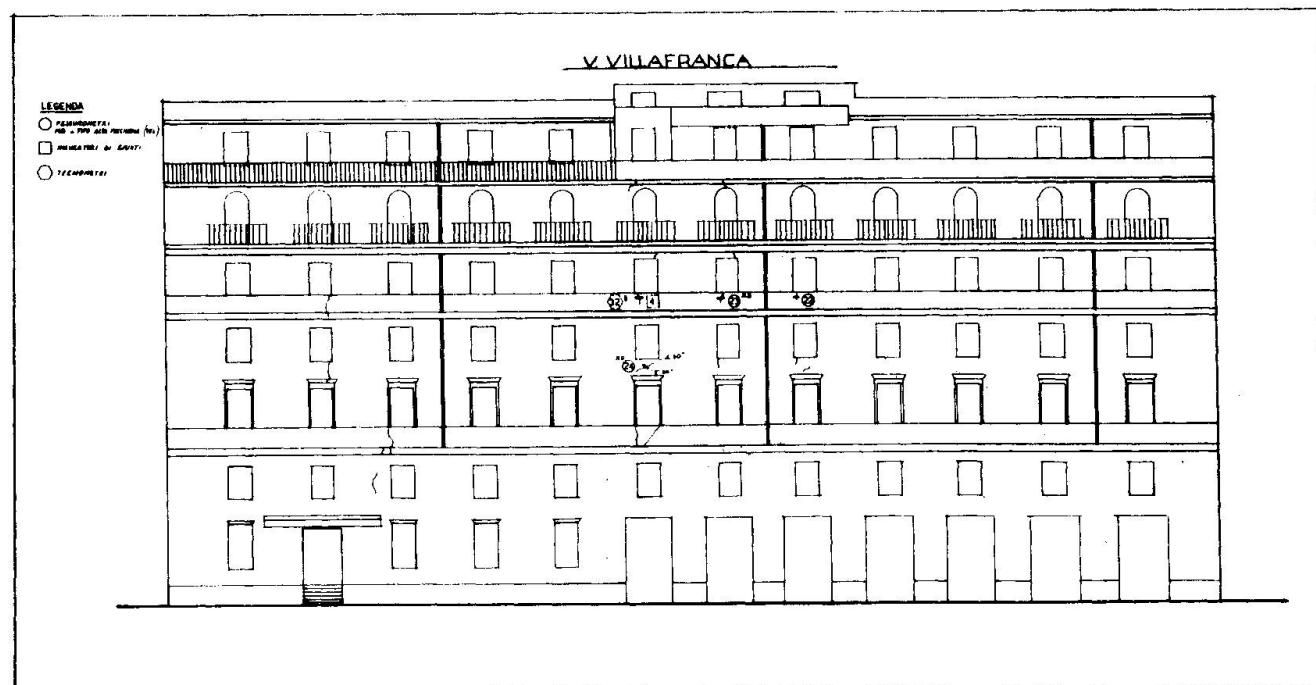
Fig. 7 Facade looking on Via Villafranca
The crack pattern and the installed instruments are visible

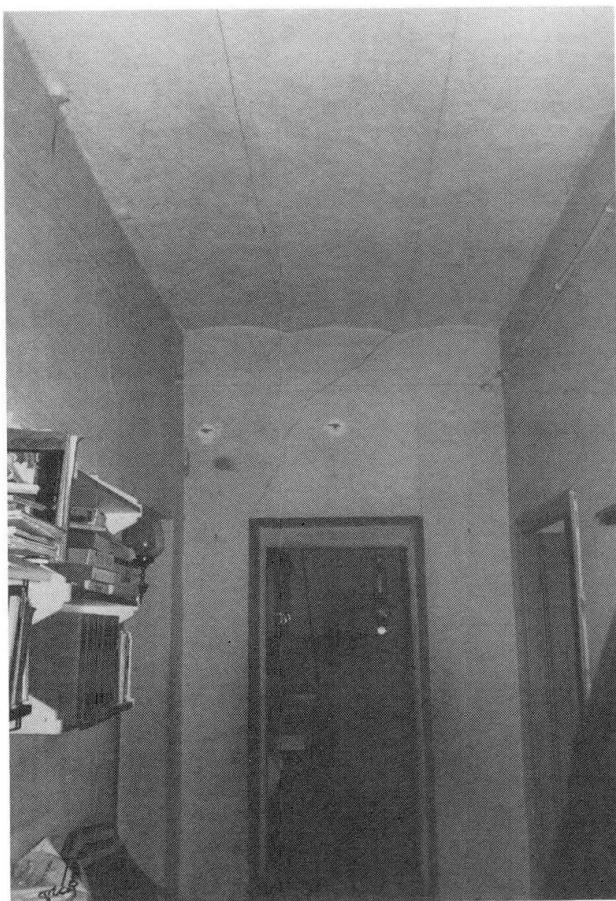
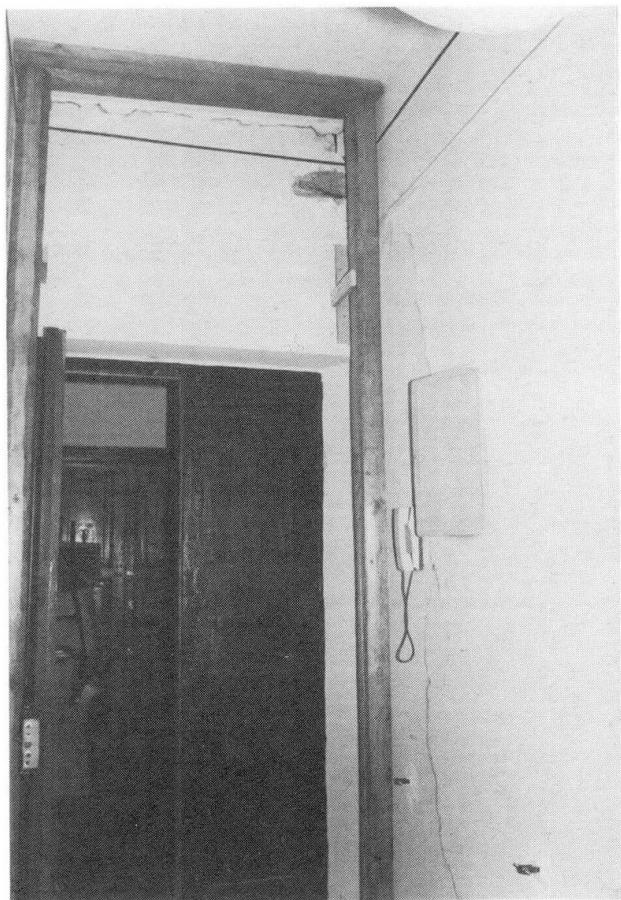
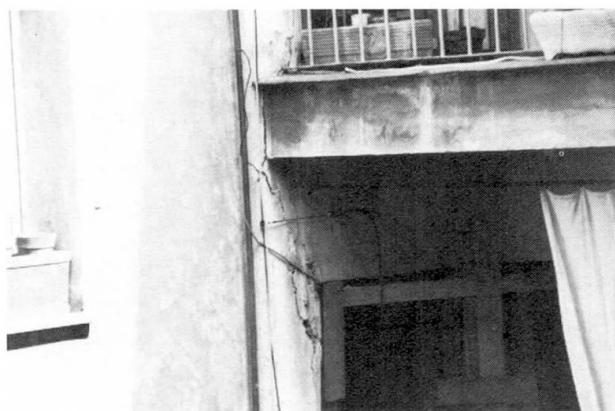
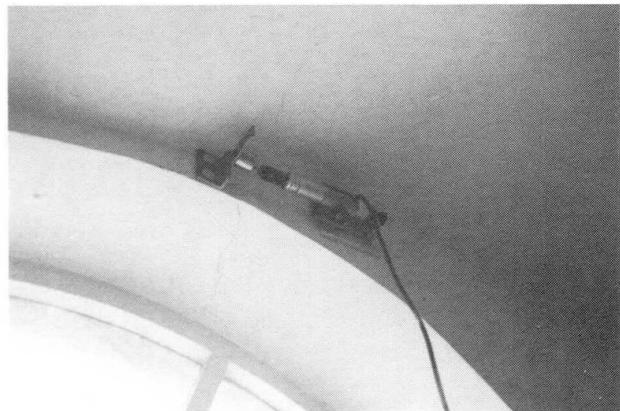
Fig. 8-11 Some of the most significative cracks on the masonry structures

This pattern of cracking, which existed prior to construction of the second tunnel for the Underground and to the installation of the measurement system described in this article, is attributable to a series of causes and phenomena occurring during the time since the buildings were constructed. Two of these seem to be largely responsible for the present static condition of the buildings.

The first is settling of the foundations due to rises and falls in the groundwater level. This is a characteristic of the whole zone and has, over time, produced a well-defined pattern of cracks in all the buildings examined. Such effects have been aggravated by a deterioration (sometimes directly observable) in the construction materials used, not all of which were of the best quality.

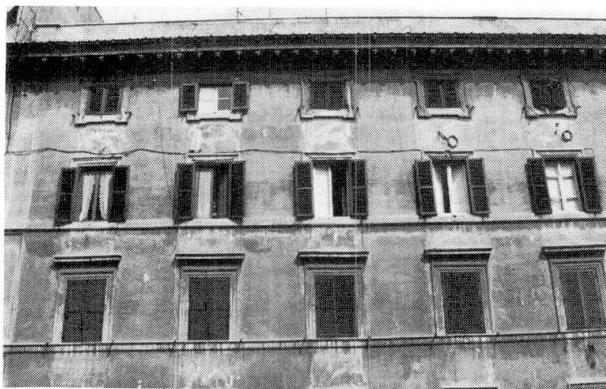
Fig. 12 Facade on Via Palestro with some of the installed instruments

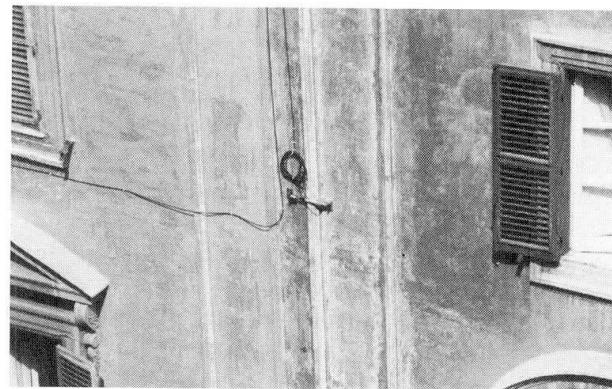
Fig. 13 The instrument n° 1

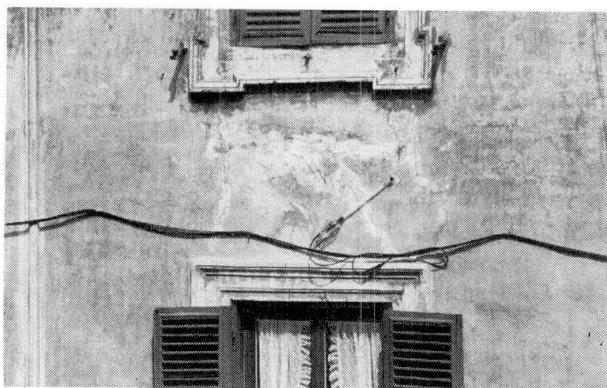
Fig. 14 The instrument n° 11

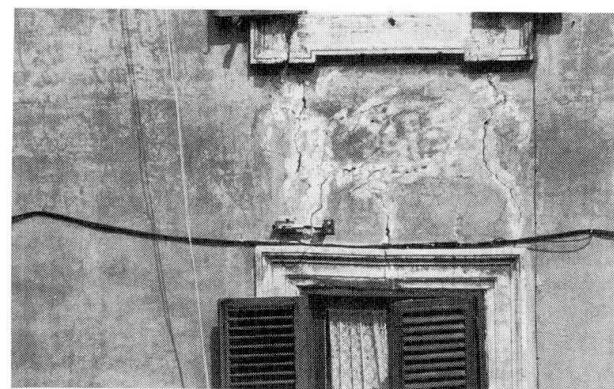
Fig. 15 The instrument n° 12

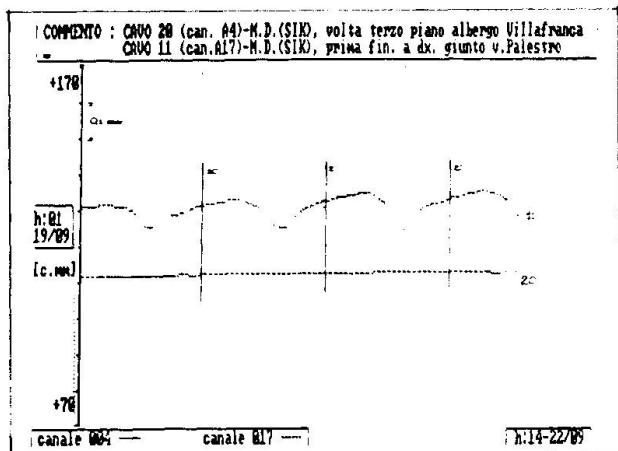
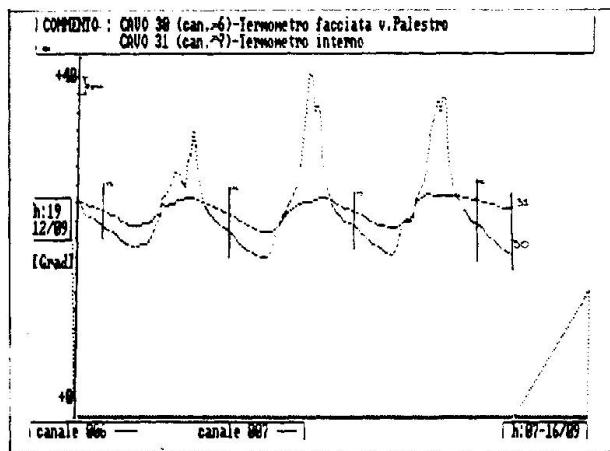
Figures 16 and 17 Two examples of the graphs produced

The data were processed by converting the measurement units to technical units and plotting these against time. The resulting graphs could be displayed immediately on the screen of a personal computer and subsequently printed on a portable printer connected to the same computer. Figures 16 and 17 are examples of the graphs produced. The processed data were recorded on diskettes.

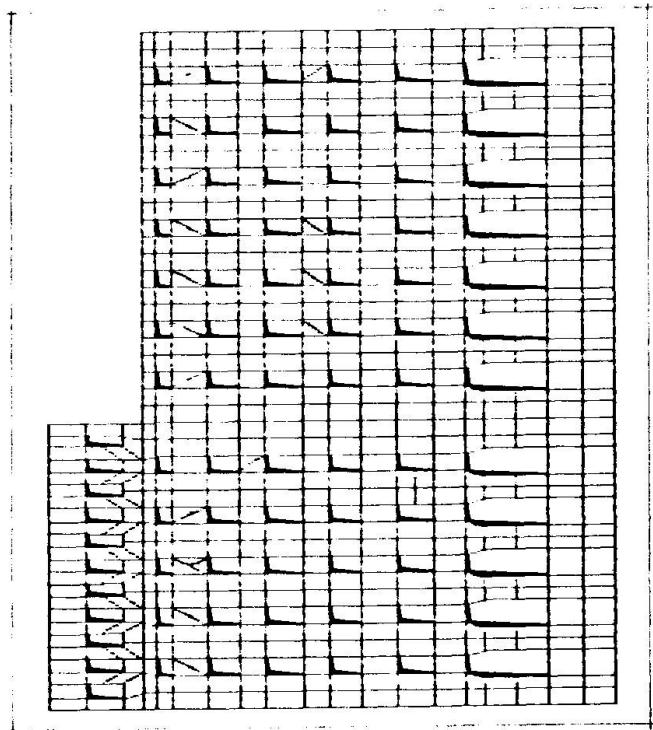
Fig. 18 Plot of mesh for one of the finite element models

The structural models analysed extend below the road surface level, at which point finite elements were inserted whose rigidities simulate the behaviour of the foundation wells and of the surrounding ground. Figure 18 shows the mesh design for one of the models.

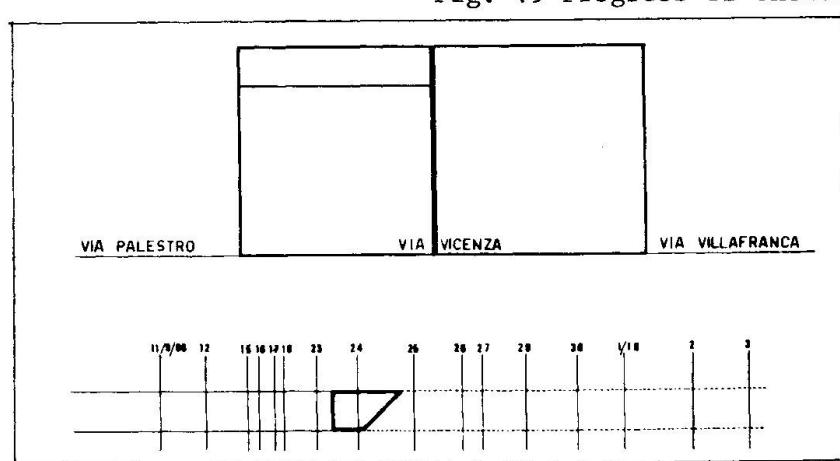
Fig. 19 Progress of excavations

Figures 20 and 21 show the subsidence diagrams measured at the base of the buildings on the Via Palestro and Via Villafranca faces respectively. These diagrams were drawn during the course of the excavations, the progress of which is shown in Figure 19.

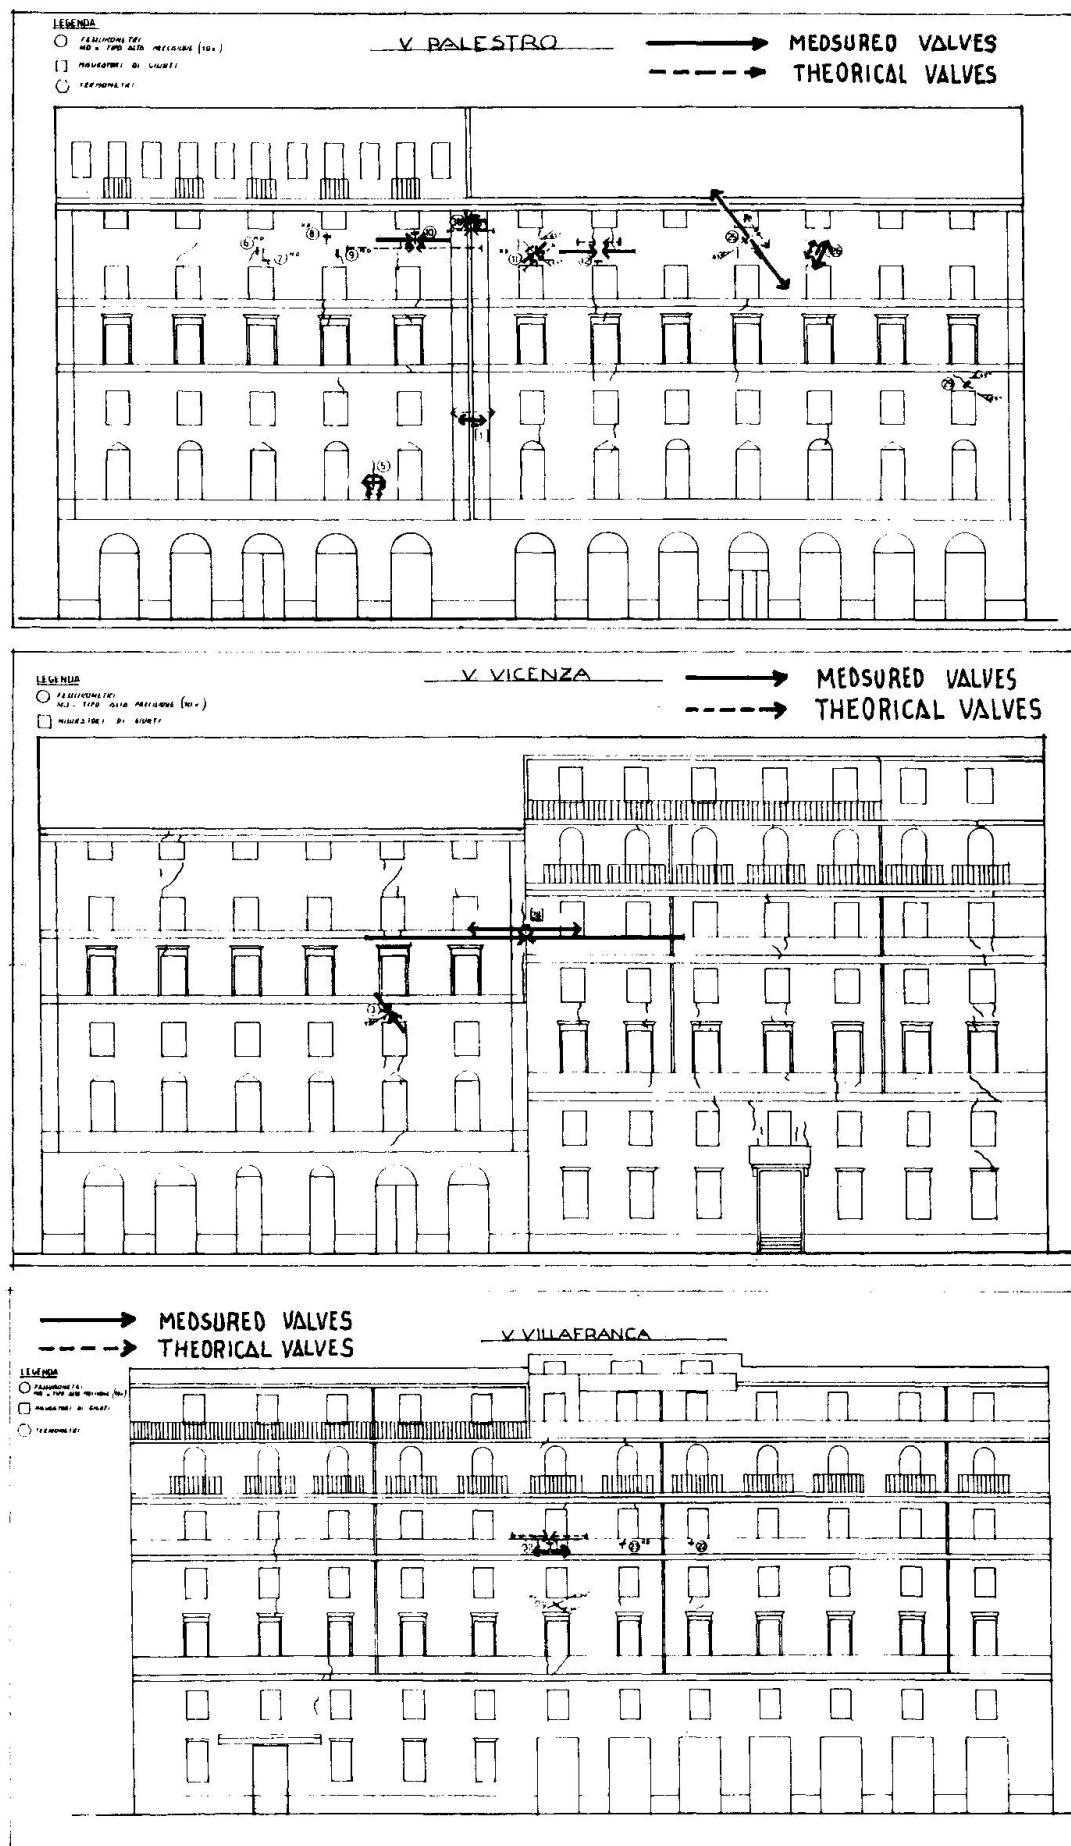
Fig. 22, 23
and 24
Corrisponden-
ce between
theoretical
analysis and
data measured

In general the results of the analyses carried out on the theoretical models show good agreement with the measured data (see Figures 22-24). The comparison was made at different times during the course of excavation and showed that it was possible to obtain a clear correlation between the real behaviour of the structure and theoretical predictions.

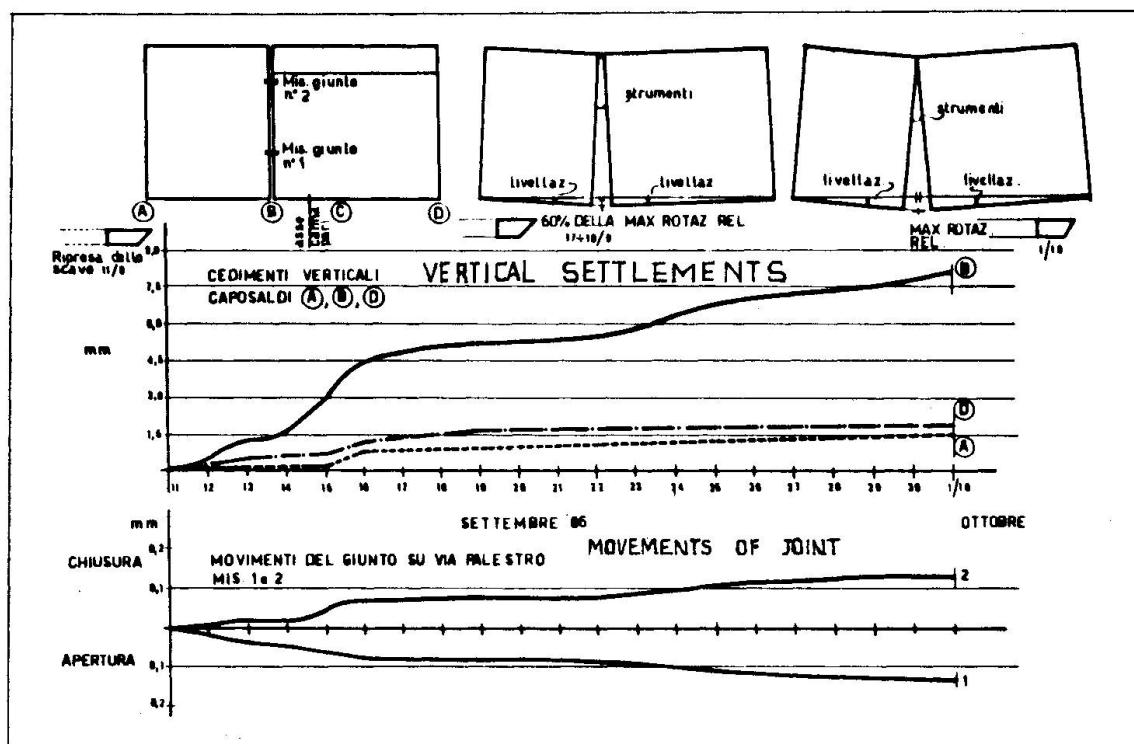
Fig. 25 Comparison between the measured settlements at the base of the building on Via Palestro and the movement of the joint.

Figures 25-29 show the extent and variation over time of the subsidence together with the measurement at the base of the buildings, movements of the lesions and of the joints. Figures 25 and 26 are for the Via Palestro face and show changes in subsidence over time with the corresponding changes in the opening of the joint between the two buildings examined and of the lesion measured with crack meter No. 12 (see Fig. 22).

The same Figures 25 and 26 show that most (about 60%) of the rotation about the joint occurred in the period between 12th and 17th September 1986, the day on which the shield reached the left hand building for about a quarter of its length. The remaining 40% of the rotation took place in the period from 18th September to 1st October at an almost constant rate, if one excepts a slight temporary increase on the 25th and 26th.

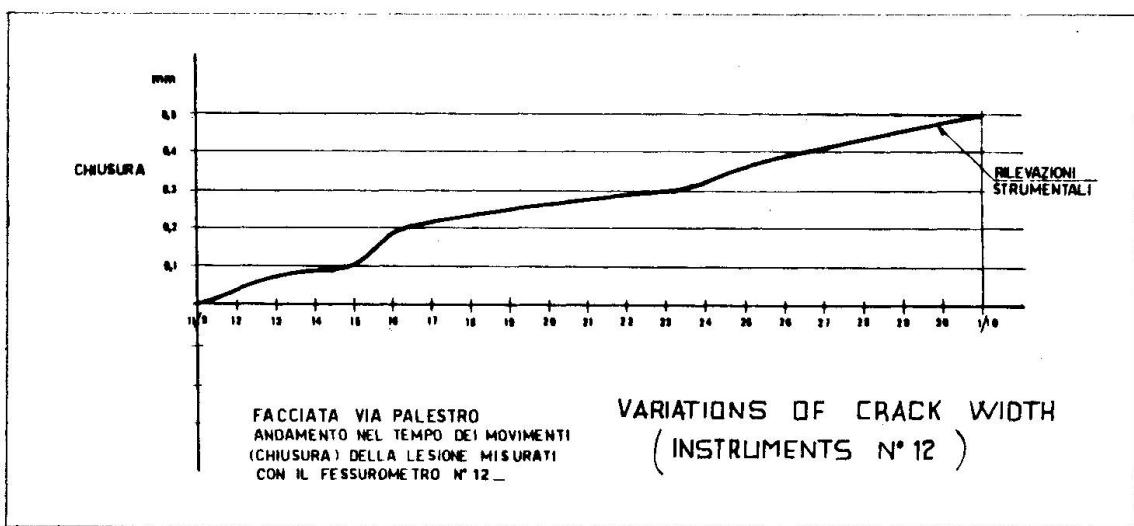
Fig. 26 Facade looking on Via Palestro
The variation over the time of the movements of the lesion on
which was installed the fissurometer n° 12

The behaviour of the joint over time seems to be in good agreement with the changes in subsidence over time and also with the behaviour of the lesion measured with crack meter No. 12.

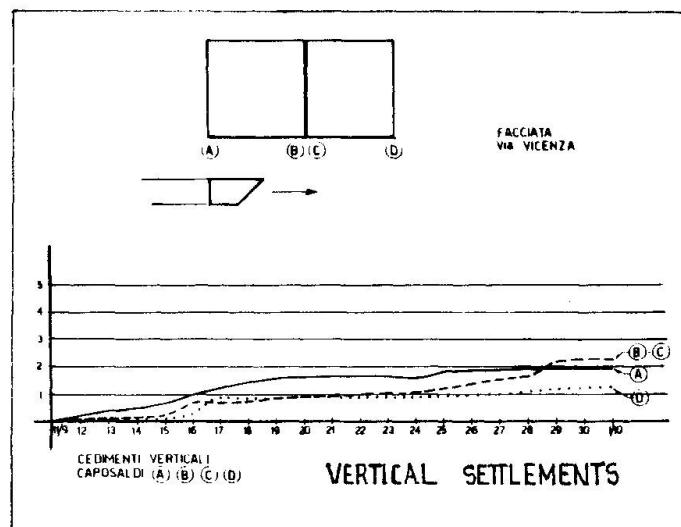
Fig. 27 Measured settlements on the base of the building on Via Vicenza

Figures 27 and 28 show the relationships between the changes over time in the subsidence measured at the data points on the Via Vicenza face and the behaviour of the joint between the two buildings on the same face. The following points deserve specific mention. First, the slightness of the subsidence and joint movements recorded up to 17th September (when the shield was entering below the building to the left of the joint) and, second, the

From Figure 27 one can obtain a final value for the relative subsidence between datum points A and B (corner with Via Palestro, joint) of about 0.4 mm, with a corresponding figure of about 0.1 mm between points C and D (joint, Via Villafranca corner).

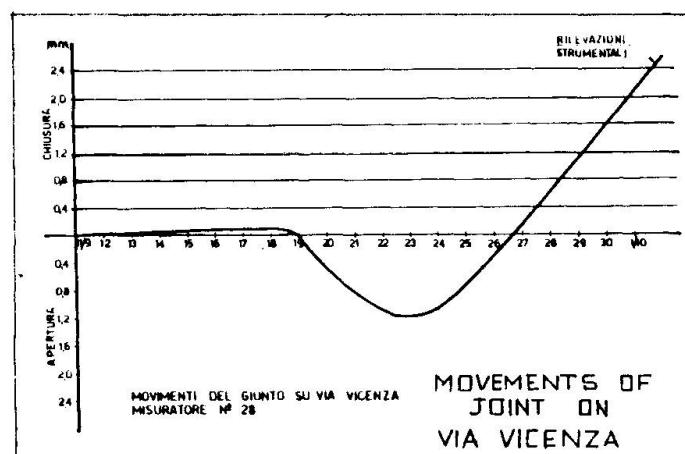
Fig. 28 Movements of the joint between the buildings on Via Vicenza

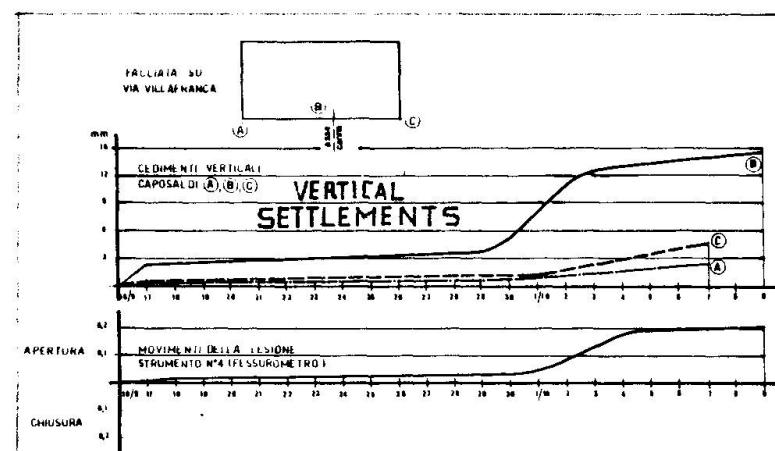
Fig. 29 Facade looking on Via Villafranca
Comparison between measured settlements and movements of the joint

Finally, Figure 29 shows the correlation between the subsidence of the datum points on the Via Villafranca face and the behaviour of the lesion instrumented with crack meter No. 4.
