**Zeitschrift:** IABSE reports = Rapports AIPC = IVBH Berichte

**Band:** 56 (1987)

**Artikel:** Control and detecting system related to the construction of the underground railway line in Rome

## Control and Detecting System related to the construction of the underground railway line in Rome

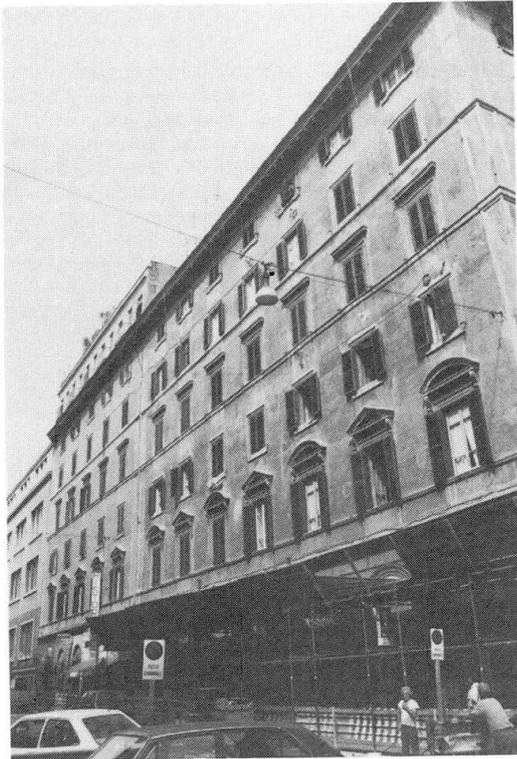
Fig. 1 Facade looking on  
Via Palestro

The present article examines some old masonry buildings in Rome in the area between Via Palestro, Via Vicenza and Via Villafranca (Figures 1-3), which have been affected by works to extend Underground Line B. Two tunnels, first one, then the other, for this extension were bored under these buildings at a depth of 20-25 metres below the road surface

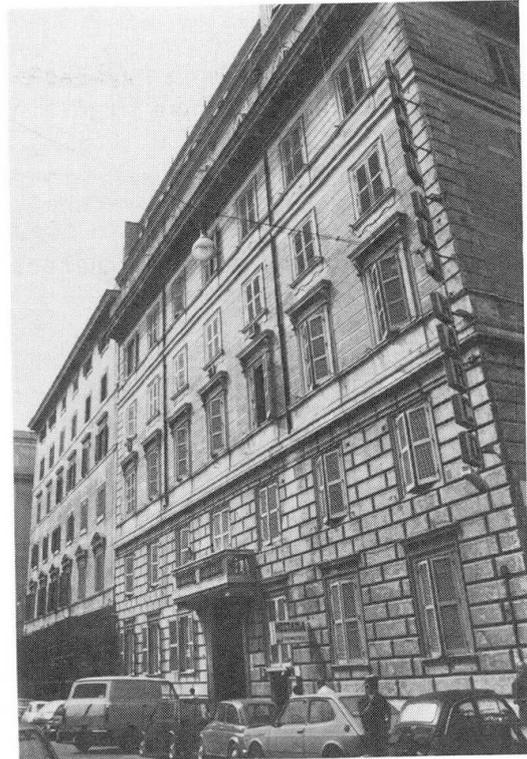
Fig. 2 Facade looking on  
Via Vicenza

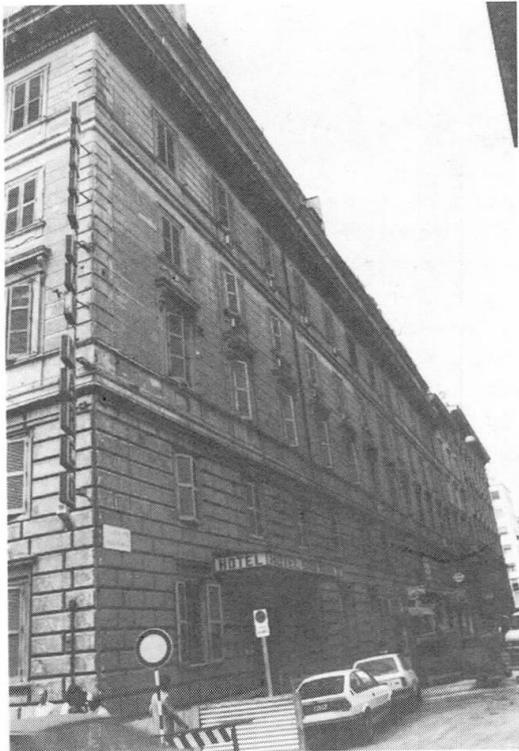
Fig. 3 Facade looking on Via Villafranca

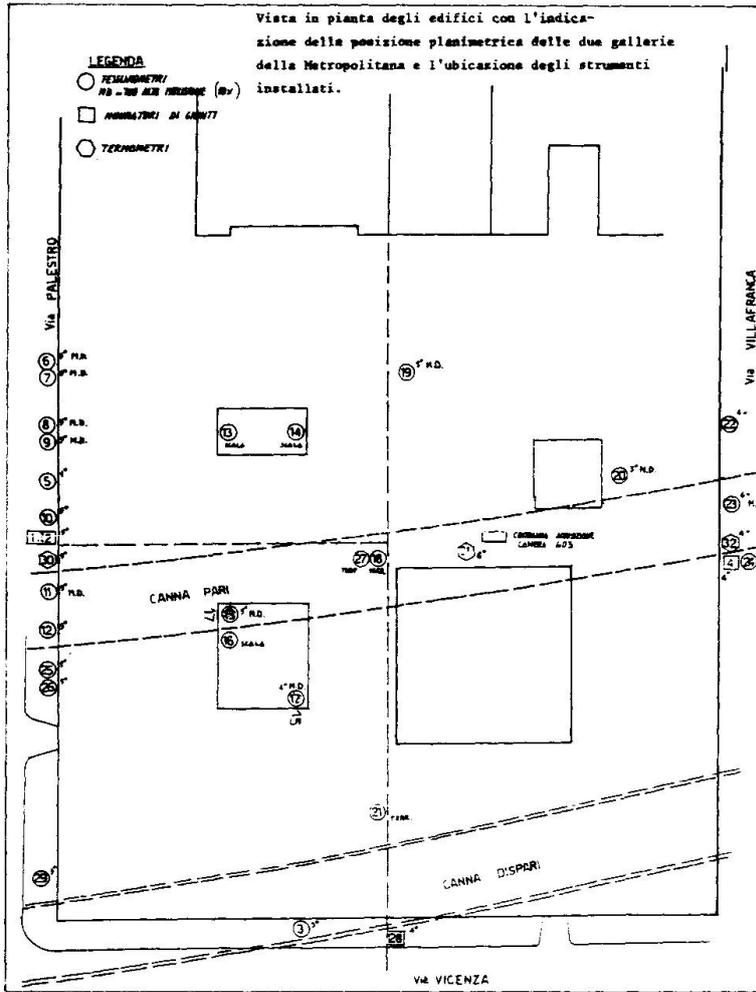
Fig. 4 Plan view of the buildings with the indication of the two underground tunnels position and of the instrument location.

The three buildings recorded are situated one against the other and separated by joints in the construction (see Figures 4-7). The characteristics of the three buildings are very similar and can be summarised as follows.

Figures 4-7 show the positioning of the instruments on the structures and some details are visible in Figures 12-15.

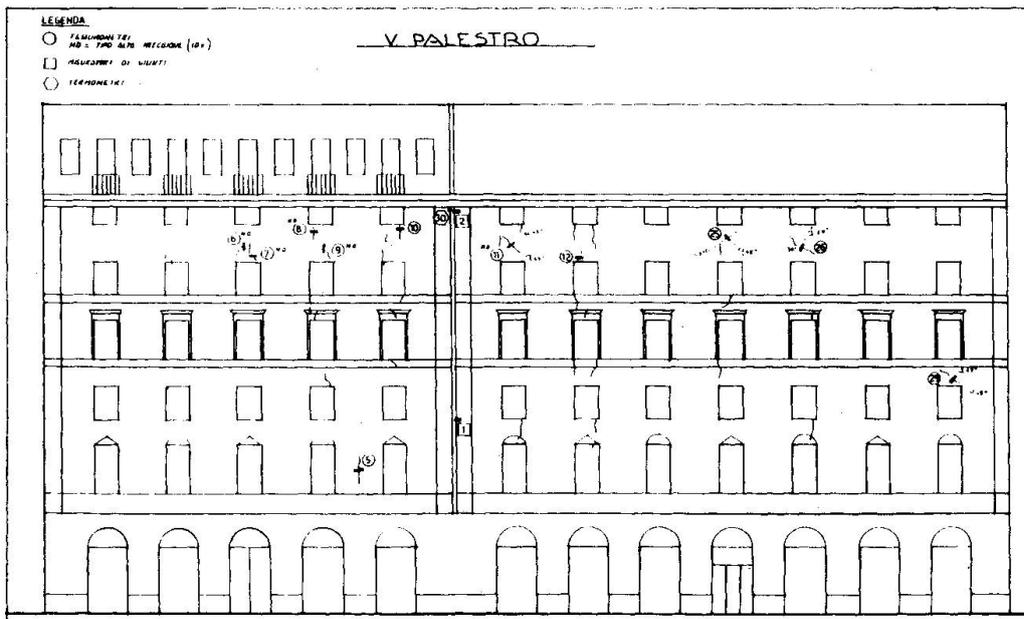
Fig. 5 Facade looking on Via Palestro  
The crack pattern and the installed instruments are visible.

Some structures in the buildings in question have been modified at various times. Both the outsides and the internal structural elements show pronounced cracking. The lesions present on the outsides are shown in Figures 5-7, while Figures 8-11 show the most significant lesions encountered inside the buildings.

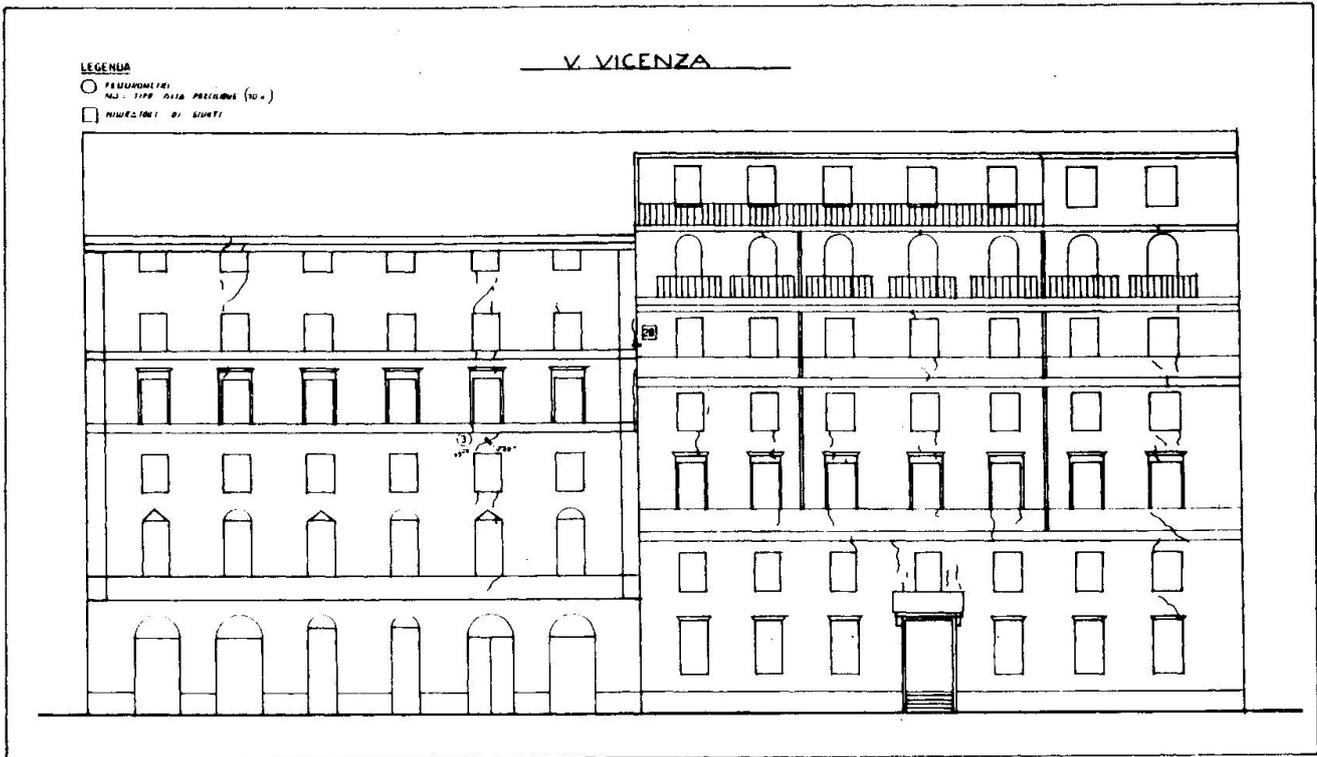
Fig. 6 Facade looking on Via Vicenza.  
The crack pattern and the installed instruments are visible

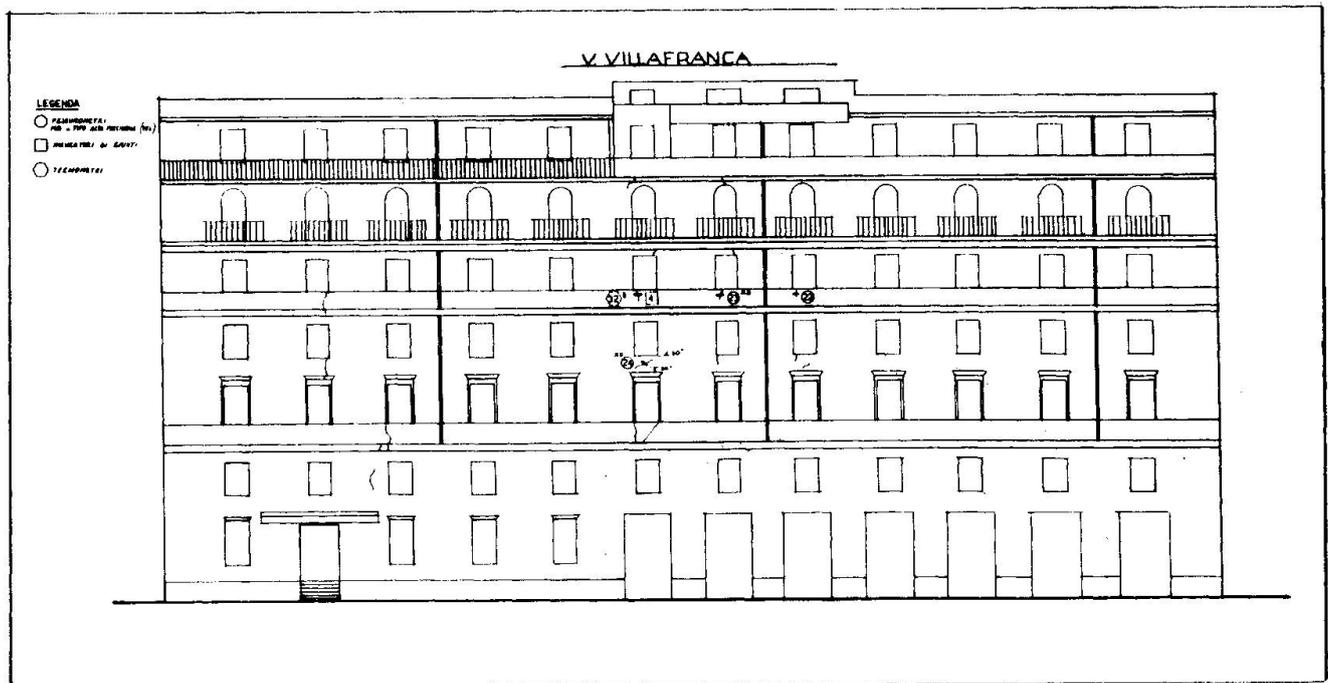
Fig. 7 Facade looking on Via Villafranca  
The crack pattern and the installed instruments are visible

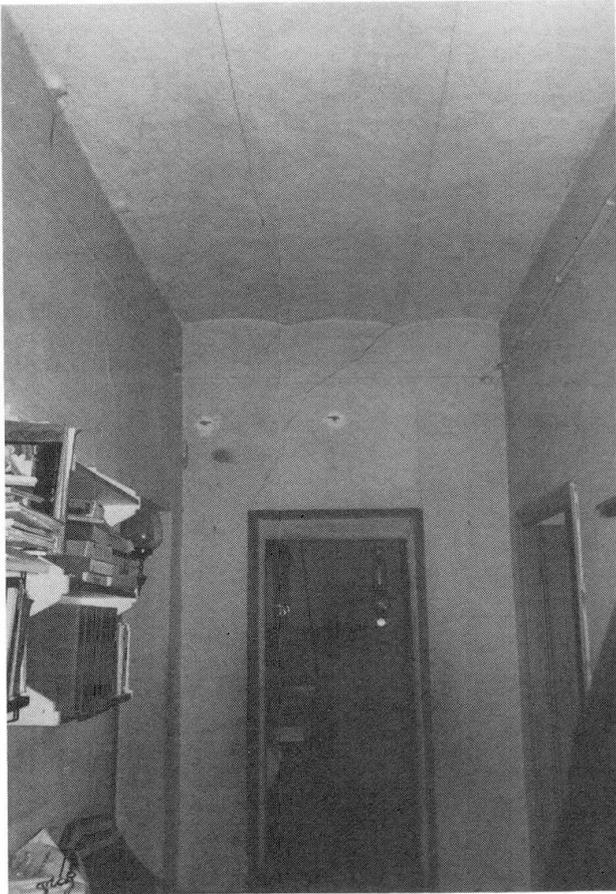
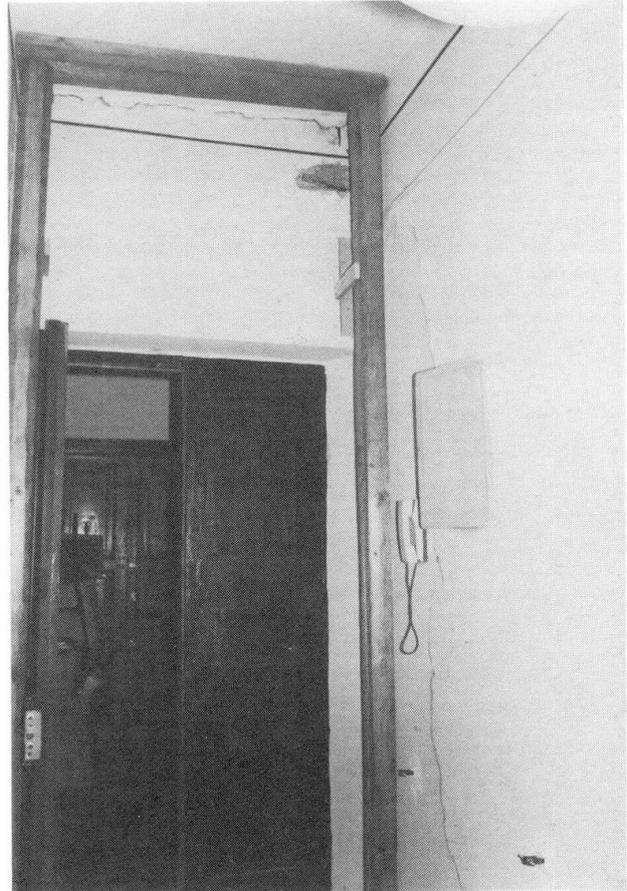
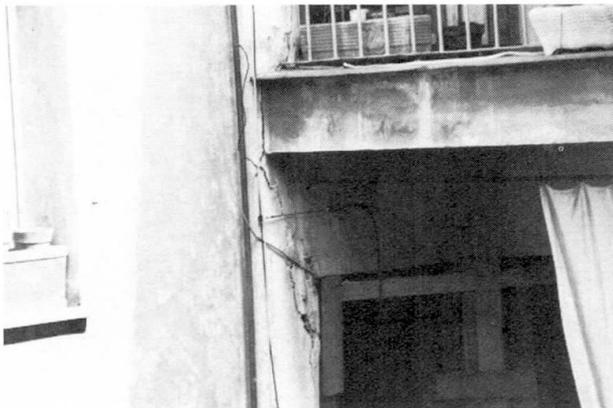
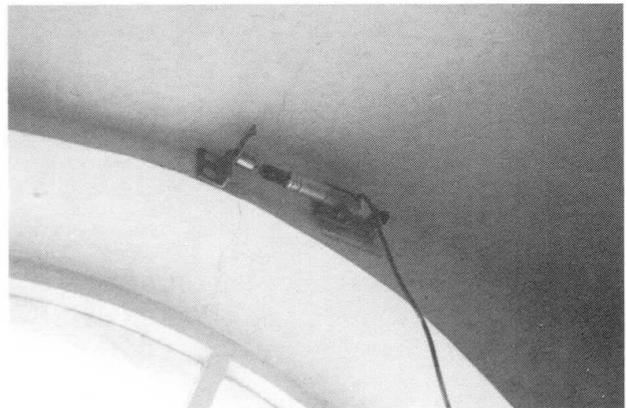
Fig. 8-11 Some of the most significant cracks on the masonry structures

This pattern of cracking, which existed prior to construction of the second tunnel for the Underground and to the installation of the measurement system described in this article, is attributable to a series of causes and phenomena occurring during the time since the buildings were constructed. Two of these seem to be largely responsible for the present static condition of the buildings.

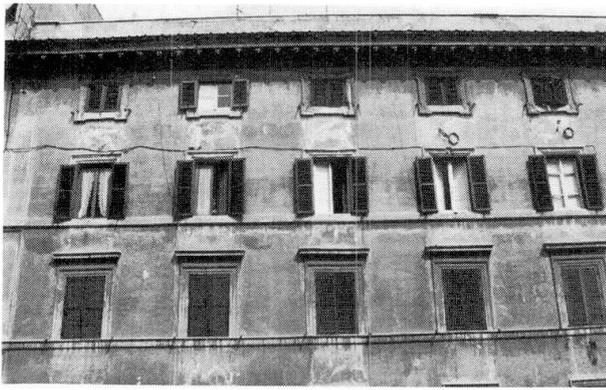
Fig. 12 Facade on Via Palestro with some of the installed instruments

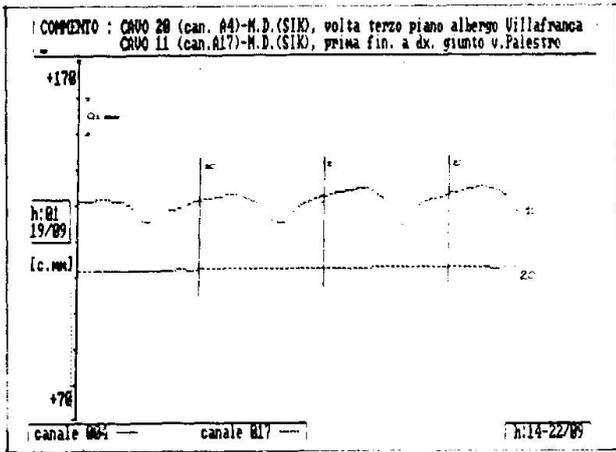
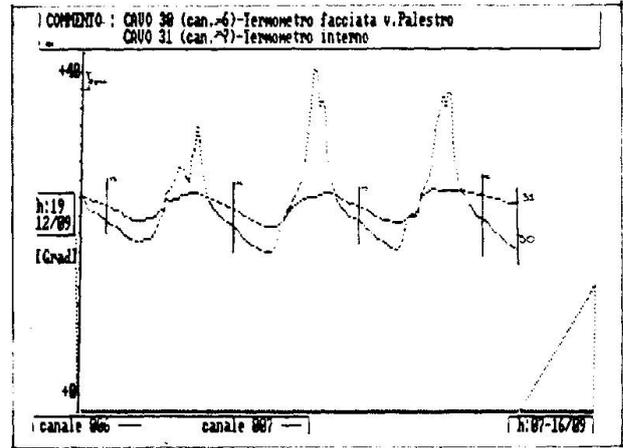
Figures 16 and 17 Two examples of the graphs produced

The data were processed by converting the measurement units to technical units and plotting these against time. The resulting graphs could be displayed immediately on the screen of a personal computer and subsequently printed on a portable printer connected to the same computer. Figures 16 and 17 are examples of the graphs produced. The processed data were recorded on diskettes.

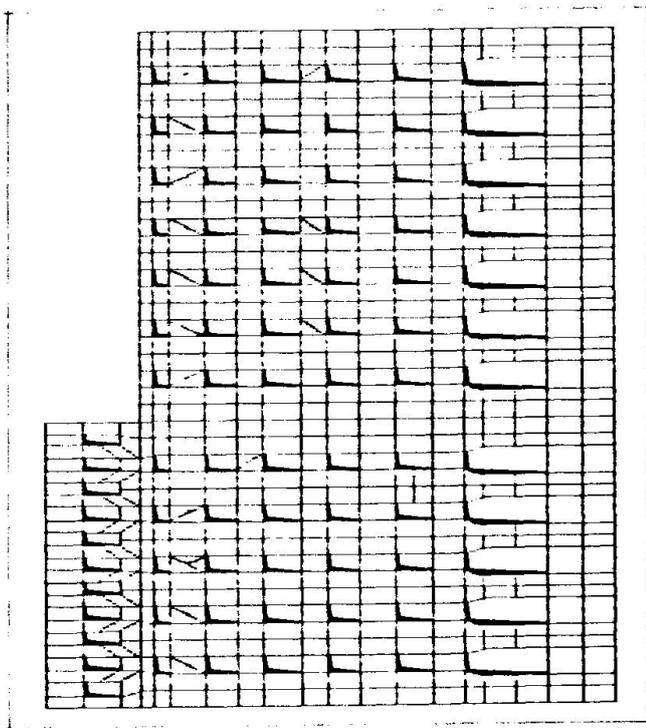
Fig. 18 Plot of mesh for one of the finite element models

The structural models analysed extend below the road surface level, at which point finite elements were inserted whose rigidities simulate the behaviour of the foundation wells and of the surrounding ground. Figure 18 shows the mesh design for one of the models.

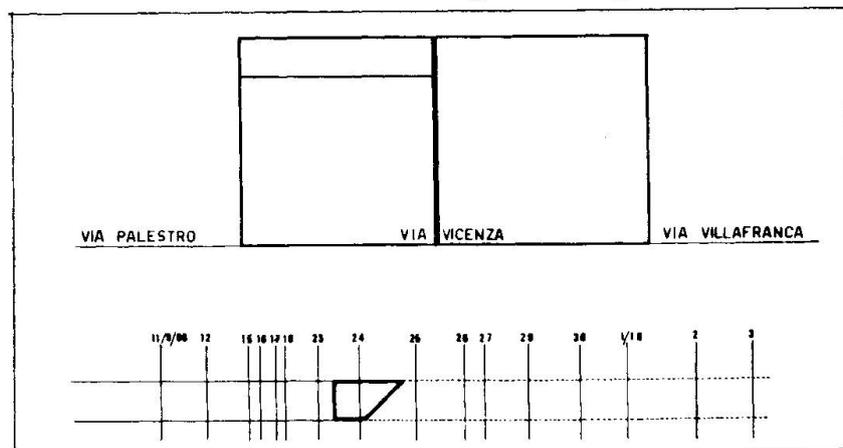
Fig. 19 Progress of excavations

Figures 20 and 21 show the subsidence diagrams measured at the base of the buildings on the Via Palestro and Via Villafranca faces respectively. These diagrams were drawn during the course of the excavations, the progress of which is shown in Figure 19.

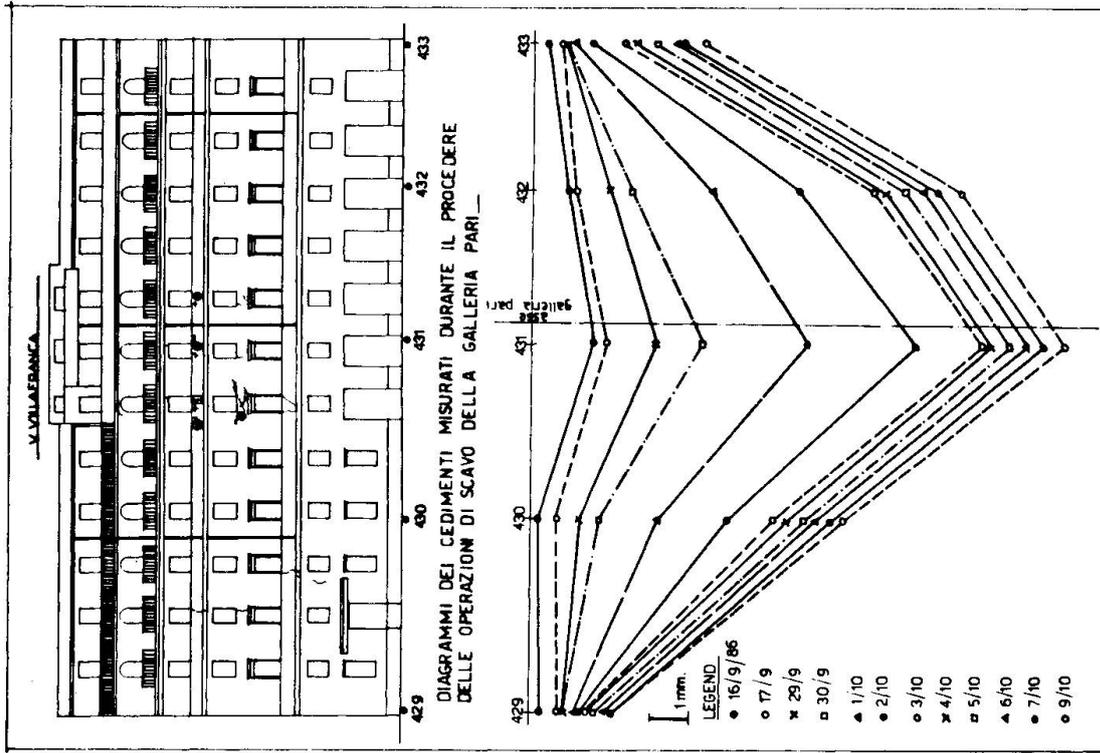
Fig. 20 Settlements diagram measured at the base of the building on Via Palestro

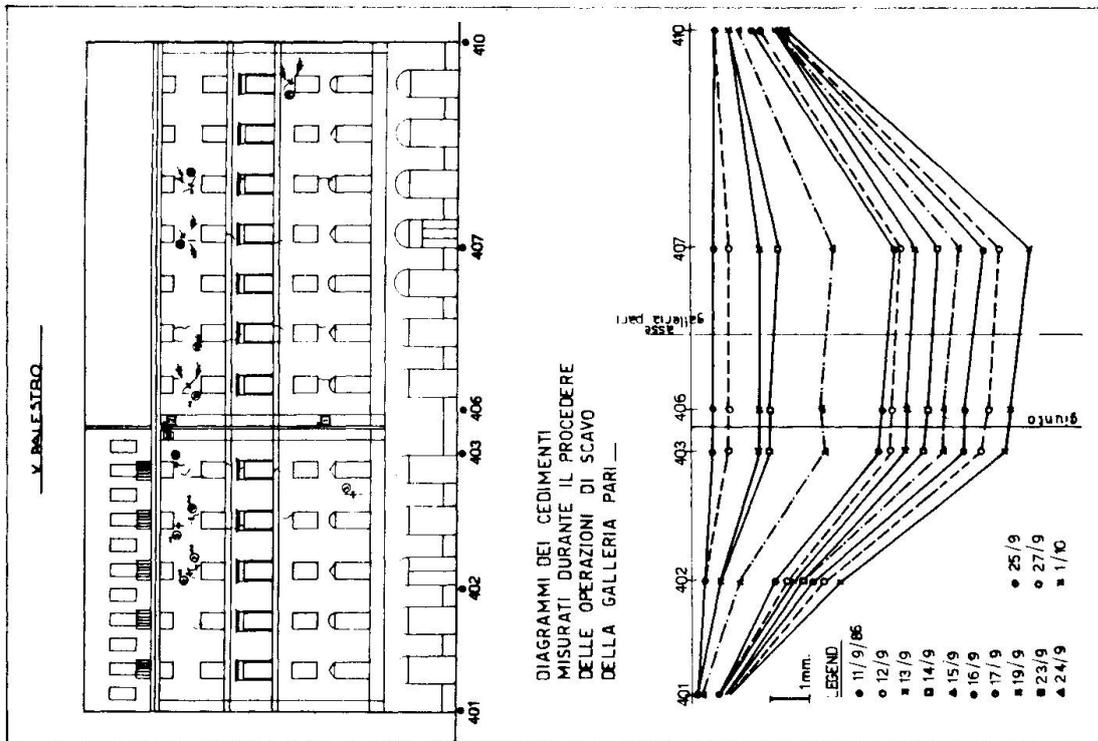
Fig. 21 Settlements diagram measured at the base of the building on Via Villafranca

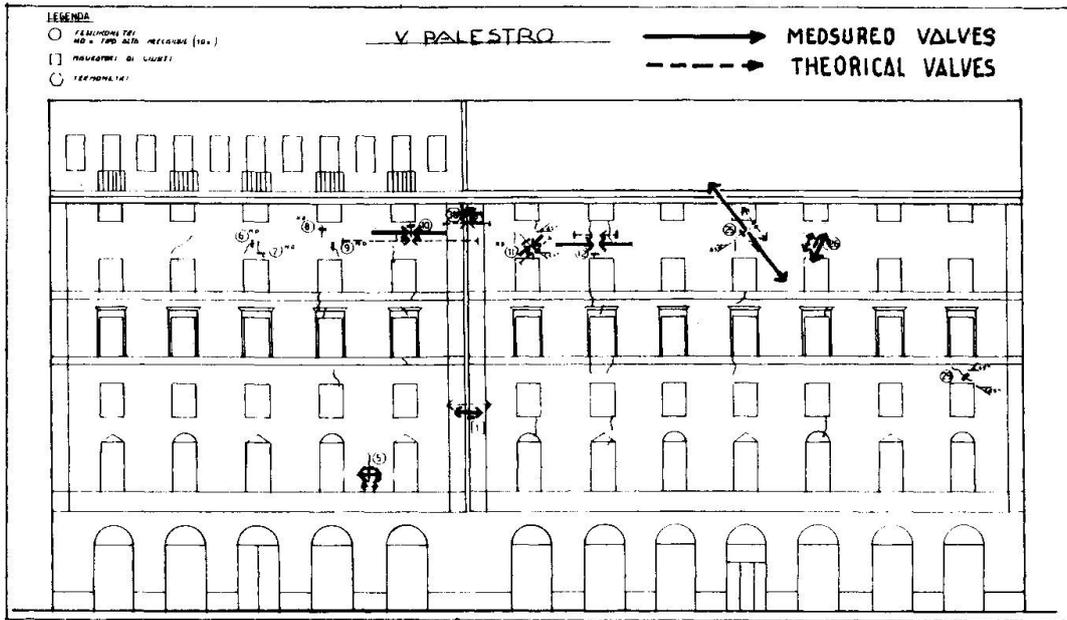
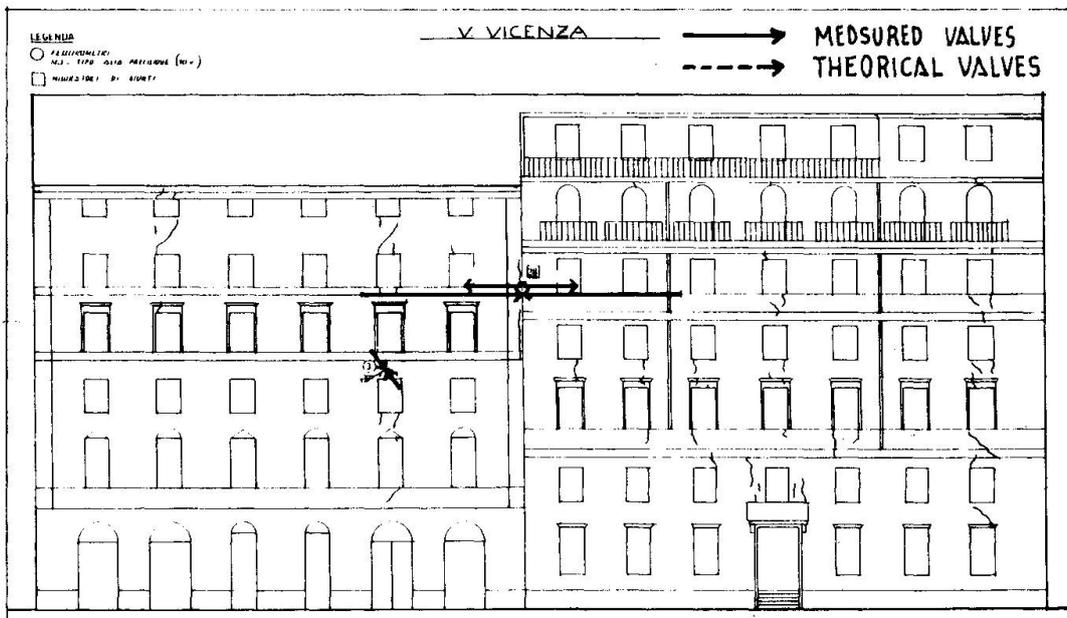
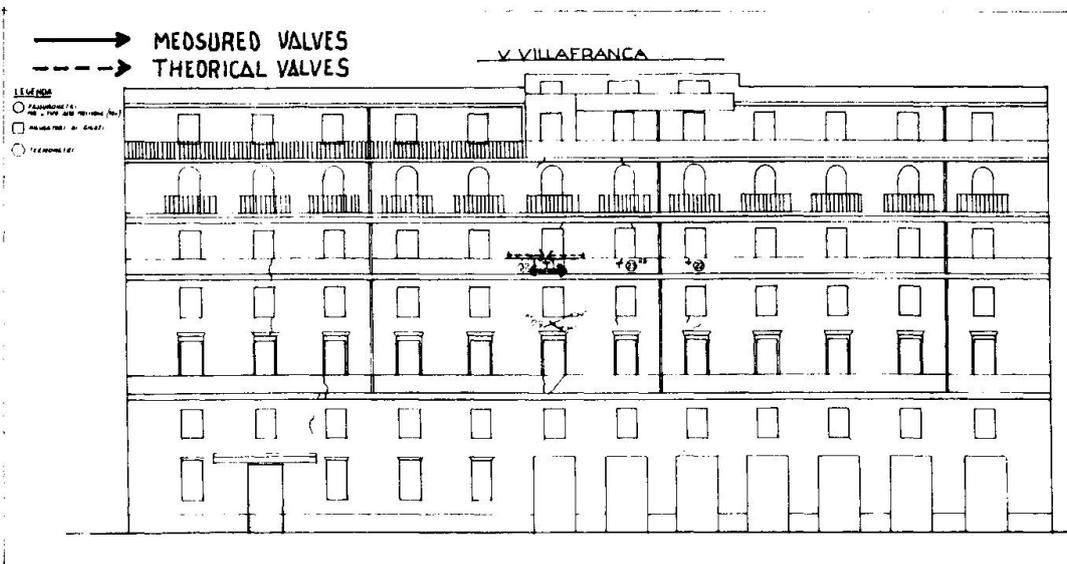
Fig. 22, 23 and 24  
Corrisponden-  
ce between  
theoretical  
analysis and  
data measured

In general the results of the analyses carried out on the theoretical models show good agreement with the measured data (see Figures 22-24). The comparison was made at different times during the course of excavation and showed that it was possible to obtain a clear correlation between the real behaviour of the structure and theoretical predictions.

Figures 25-29 show the extent and variation over time of the subsidence together with the measurement at the base of the buildings, movements of the lesions and of the joints. Figures 25 and 26 are for the Via Palestro face and show changes in subsidence over time with the corresponding changes in the opening of the joint between the two buildings examined and of the lesion measured with crack meter No. 12 (see Fig. 22).

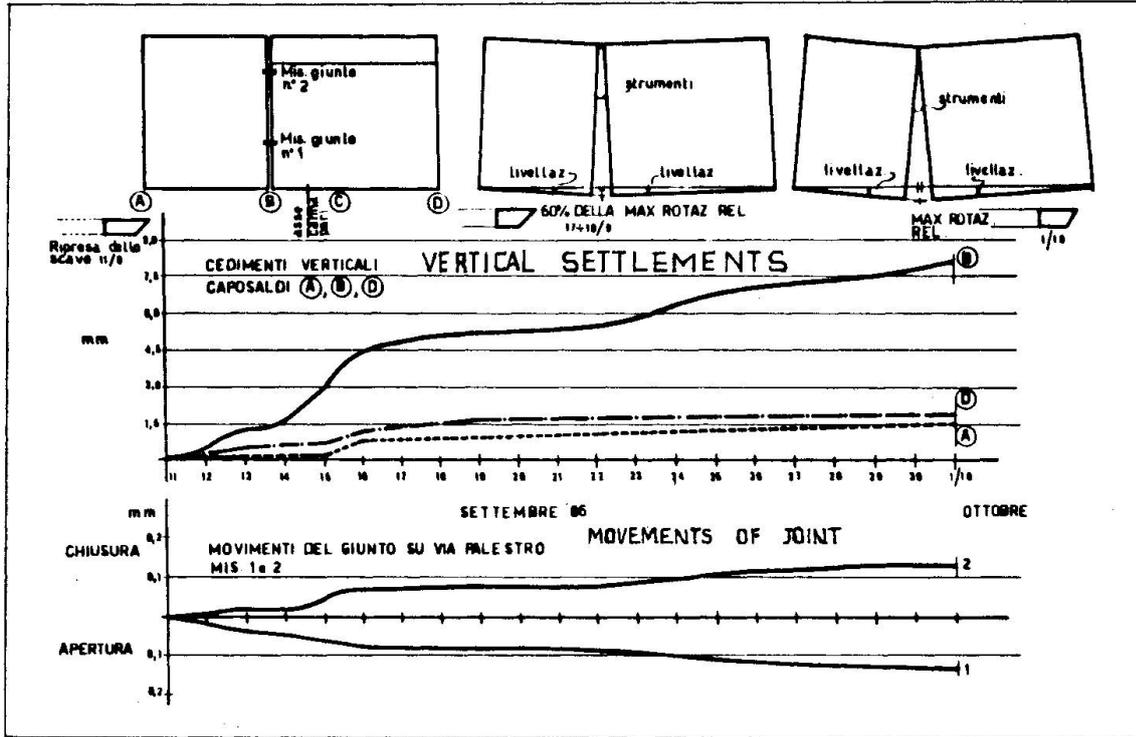
Fig. 25 Comparison between the measured settlements at the base of the building on Via Palestro and the movement of the joint.

The same Figures 25 and 26 show that most (about 60%) of the rotation about the joint occurred in the period between 12th and 17th September 1986, the day on which the shield reached the left hand building for about a quarter of its length. The remaining 40% of the rotation took place in the period from 18th September to 1st October at an almost constant rate, if one excepts a slight temporary increase on the 25th and 26th.

The behaviour of the joint over time seems to be in good agreement with the changes in subsidence over time and also with the behaviour of the lesion measured with crack meter No. 12.

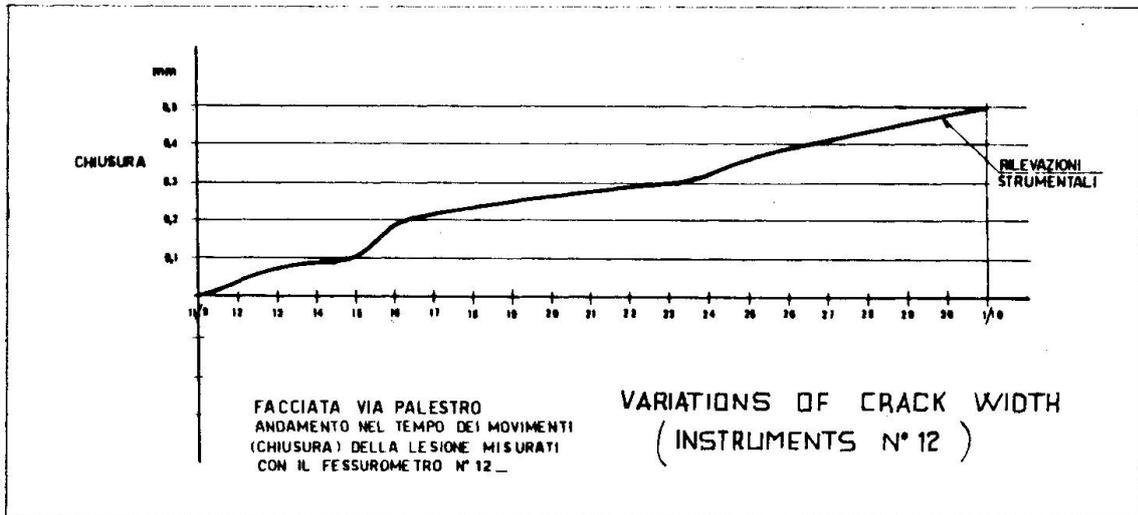
Fig. 26 Facade looking on Via Palestro. The variation over the time of the movements of the lesion on which was installed the fissurometer n° 12.

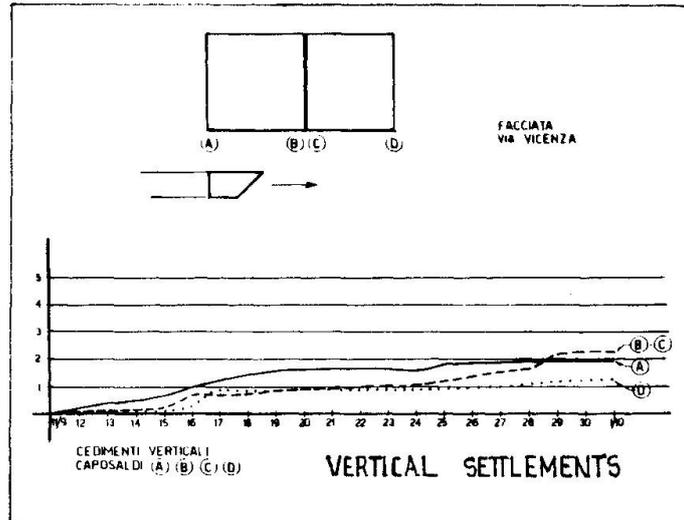
Fig. 27 Measured settlements on the base of the building on Via Vicenza

Figures 27 and 28 show the relationships between the changes over time in the subsidence measured at the data points on the Via Vicenza face and the behaviour of the joint between the two buildings on the same face. The following points deserve specific mention. First, the slightness of the subsidence and joint movements recorded up to 17th September (when the shield was entering below the building to the left of the joint) and, second, the

From Figure 27 one can obtain a final value for the relative subsidence between datum points A and B (corner with Via Palestro, joint) of about 0.4 mm, with a corresponding figure of about 0.1 mm between points C and D (joint, Via Villafranca corner).

The relative rotation of the joint (the sum of the rotations of the two buildings, 24 and 26 m long respectively, is:

$$\varphi_{0 \text{ tot.}} = \frac{0.0004}{24} + \frac{0.001}{26} = 5.513 \times 10^{-5}$$

To this rotation there corresponds a closing of the upper end of the joint, where the sensor is fixed, of

$$5.513 \times 10^{-5} \times 16.5 = 0.9 \text{ mm}$$

relative to the bottom end, the height being about 16.5 m. The value actually recorded by the instrument was 1.33 mm. The difference between these two correspond to the deformation of the structures.

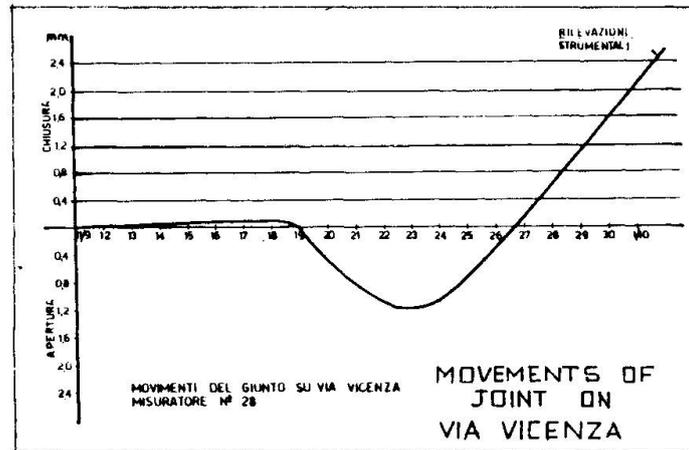
Fig. 28 Movements of the joint between the buildings on Via Vicenza

inversion of rotation about the joint on inversion of relative subsidence between the joint area and the opposite extremity of the building towards Via Villafranca. This inversion took place about 29th September when the shield was approaching Via Villafranca.

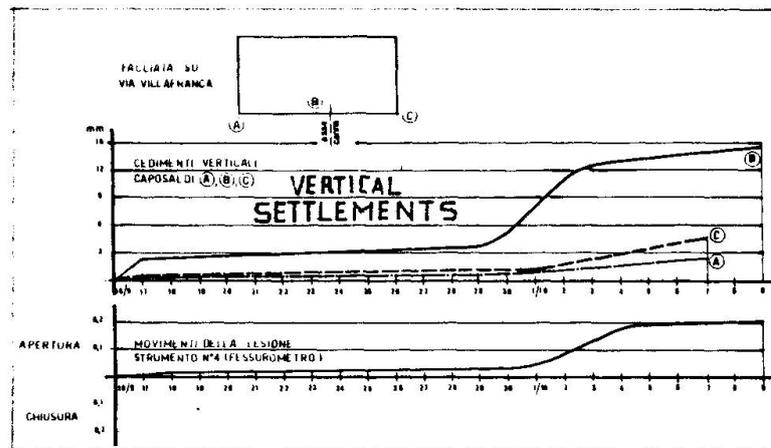
Fig. 29 Facade looking on Via Villafranca Comparison between measured settlements and movements of the joint

Finally, Figure 29 shows the correlation between the subsidence of the datum points on the Via Villafranca face and the behaviour of the lesion instrumented with crack meter No. 4.
