Zeitschrift: IABSE reports = Rapports AIPC = IVBH Berichte
Band: 56 (1987)

Artikel: Control and detecting system related to the construction of the underground railway line in Rome
Autor: Cangiano, Mario / Croci, Giorgio
DOI: <https://doi.org/10.5169/seals-43574>

Control and Detecting System related to the construction of the underground railway line in Rome

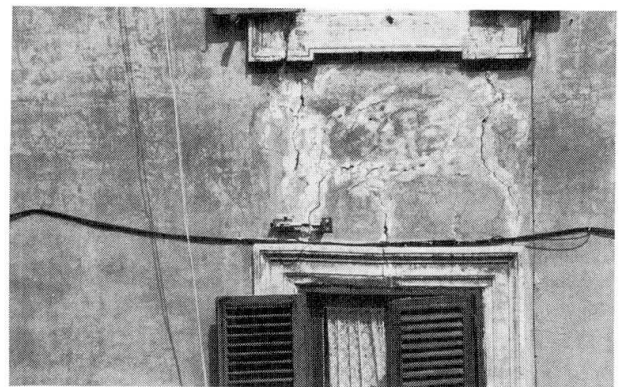
Fig. 15 The instrument n° 12
