**Artikel:** Control and detecting system related to the construction of the

underground railway line in Rome

Autor: Cangiano, Mario / Croci, Giorgio

# Control and Detecting System related to the construction of the underground railway line in Rome

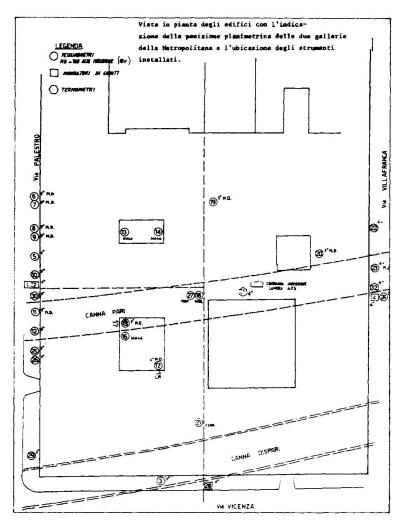
Fig. 4 Plan view of the buildings with the indication of the two underground tunnels position and of the instrument location.

Figures 4-7 show the positioning of the instruments on the structures and some details are visible in Figures 12-15.

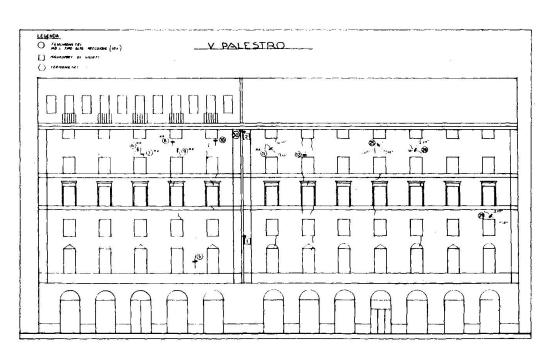
Fig. 5 Facade looking on Via Palestro
The crack pattern and the installed instruments are visible.

Some structures in the buildings in question have been modified at various times. Both the outsides and the internal structural elements show pronounced craking. The lesions present on the outsides are shown in Figures 5-7, while Figures 8-11 show the most significant lesions encountered inside the buildings.

This pattern of craking, which existed prior to construction of the second tunnel for the Underground and to the installation of the measurement system described in this article, is attributable to a series of causes and phenomena occurring during the time since the buildings were constructed. Two of these seem to be largely responsible for the present static condition of the buildings.

The first is settling of the foundations due to rises and falls in the groundwater level. This is a characteristic of the whole zone and has, over time, produced a well-defined pattern of cracks in all the buildings examined. Such effects have been aggravated by a deterioration (sometimes directly observable) in the construction materials used, not all of which were of the best quality.

The second factor is the series of minor earthquakes occurring during the century, which have contributed to and accentuated the process of deterioration.

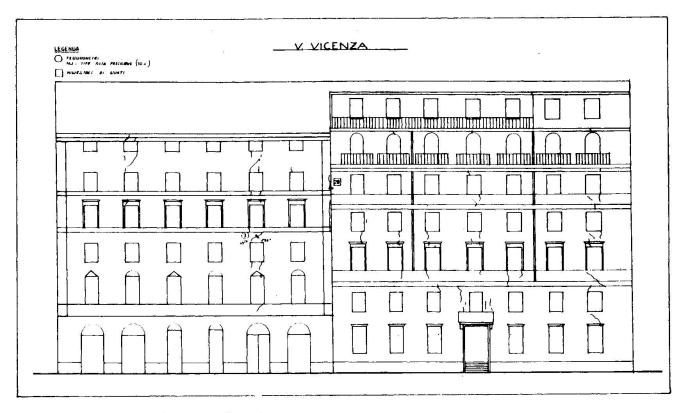
Fig. 6 Facade looking on Via Vicenza.

The crack pattern and the installed instruments are visible

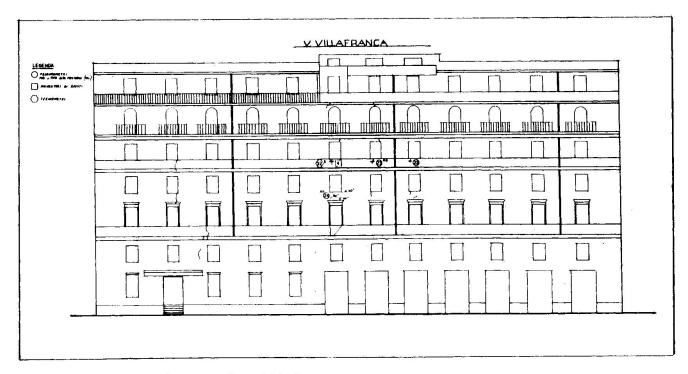
Fig. 7 Facade looking on Via Villafranca
The crack pattern and the installed instruments are visible

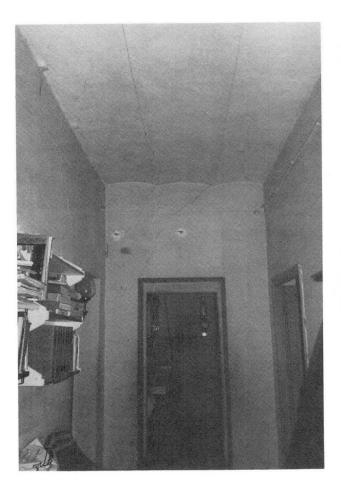
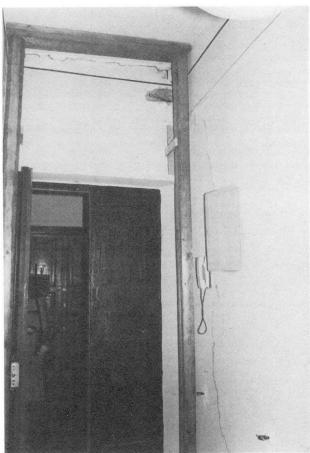
Fig. 8-11 Some of the most significative cracks on the masonry structures

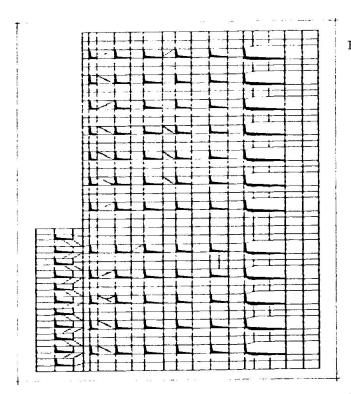
The structural models analysed extend below the road surface level, at which point finite elements were inserted whose rigidities simulate the behaviour of the foundation wells and of the surrounding ground. Figure 18 shows the mesh design for one of the models.

Fig. 18 Plot of mesh for one of the finite element models

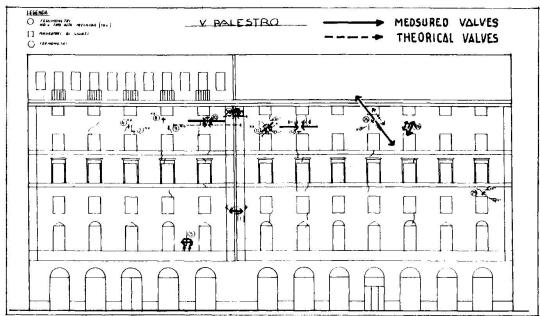
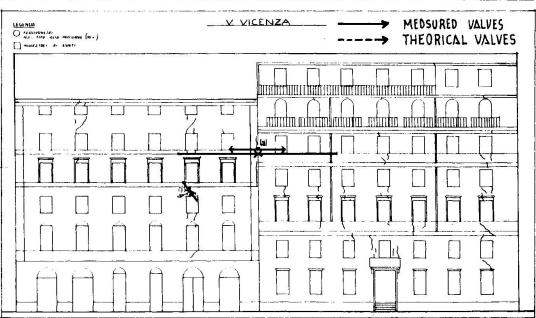
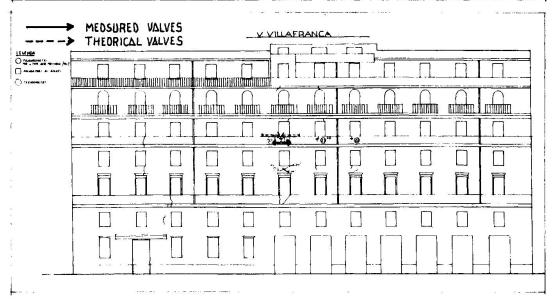
In general the results of the analyses carried out on the theoretical models show good agreement with the measured data (see Figures 22-24). The comparison was made at different times during the course of excavation and showed that it was possible to obtain a clear correlation between the real behaviour of the structure and theoretical predictions.

Fig. 22, 23 and 24 Corrispondence between theoretical analysis and data measured

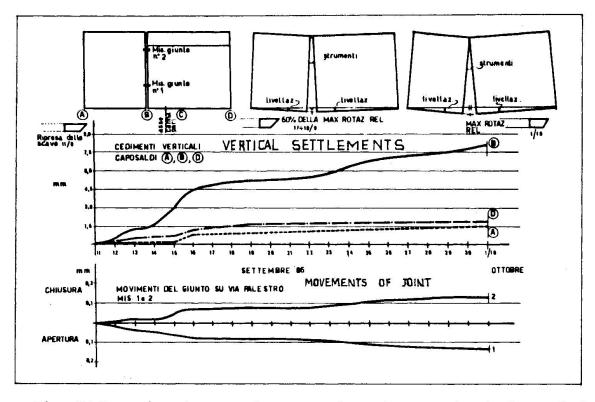
Figures 25-29 show the extent and variation over time of the subsidence together with the measurement at the base of the buildings, movements of the lesions and of the joints. Figures 25 and 26 are for the Via Palestro face and show changes in subsidence over time with the corresponding changes in the opening of the joint between the two buildings examined and of the lesion measured with crack meter No. 12 (see Fig. 22).

The same Figures 25 and 26 show that most (about 60%) of the rotation about the joint occurred in the period between 12th and 17th September 1986, the day on which the shield reached the left hand building for about a quarter of its length. The remaining 40% of the rotation took place in the period from 18th September ti 1st October at an almost constant rate, if one excepts a slight temporary increase on the 25th and 26th.

Fig. 25 Comparison between the measured settlements at the base of the building on Via Palestro and the movement of the joint.

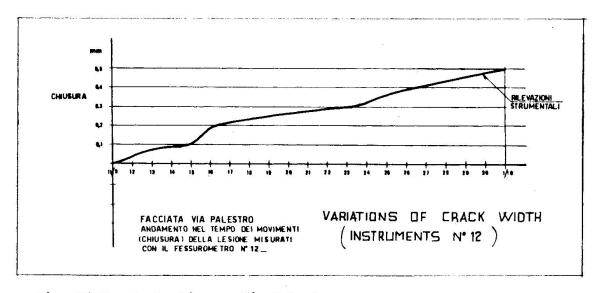
The behaviour of the joint over time seems to be in good agreement with the changes in subsidence over time and also with the behaviour of the lesion measured with crack meter No. 12.

Fig. 26 Facade looking on Via Palestro
The variation over the time of the movements of the lesion on which was installed the fissurometer n° 12

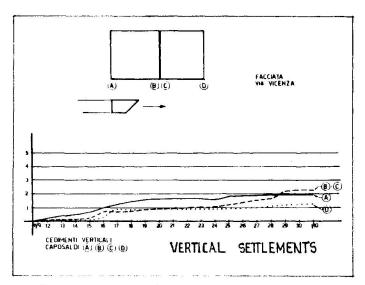
Fig. 27 Measured settlements on the base of the building on Via Vicenza

From Figure 27 one can obtain a final value for the relative subsidence between datum points A and B (corner with Via Palestro, joint) of about 0.4 mm, with a corresponding figure of about 0.1 mm between points C and D (joint, Via Villafranca corner).

The relative rotation of the joint (the sum of the rotations of the two buildings, 24 and 26 m long respectively, is:

relative to the bottom end, the height being about 16.5 m. The value actually recorded by the instrument was 1.33 mm. The difference between these two correspond to the deformation of the structures.

The higher value measured experimentally can be attributed to the greater deformability of the structures resulting from the crack pattern described previously.

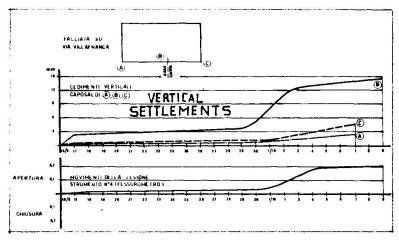
Fig. 29 Facade looking on Via Villafranca Comparison between measured settlements and movements of the joint

Finally, Figure 29 shows the correlation between the subsidence of the datum points on the Via Villafranca face and the behaviour of the lesion instrumented with crack meter No. 4.
