Zeitschrift: IABSE reports = Rapports AIPC = IVBH Berichte
Band: 57/1/57/2 (1989)
Rubrik: Poster Session 4

POSTERS

Strengthening of a Bridge with Epoxy Beam and Prestressed Steel
Renforcement d'un pont avec de l'époxi et des fils d'acier précontraints
Instandstellung einer Stahlbrücke mit Epoxyharz und Stahldrahtvorspannung

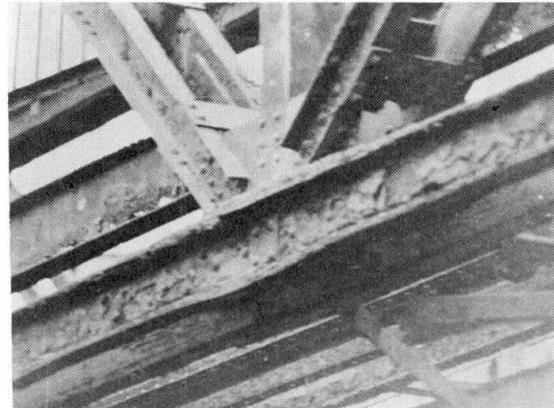
Fig. 3 Lower joints

2.1.2 The truss-frame lower joints were seriously damaged by the corrosion.

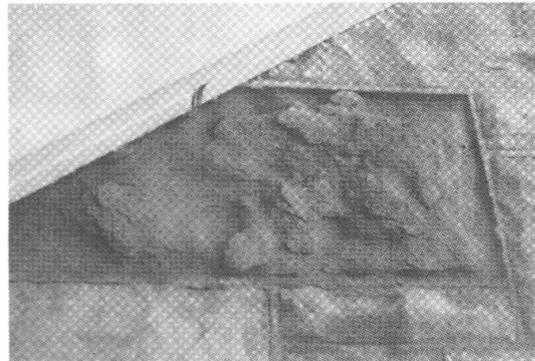
Fig. 1 Stone deterioration at repointed joint

Use of a modern, high strength "durable" material for repointing mortar joints often results in lessened durability for the building as a whole. In general, repointing should be done with a "soft" mortar, lower in strength than the adjacent masonry so that stresses from expansion, moisture migration or settlement can be accommodated within the joints rather than the stones. Use of a hard portland cement mortar can result in accelerated deterioration of the stone, while the mortar joints remain intact, as shown in Fig. 1.

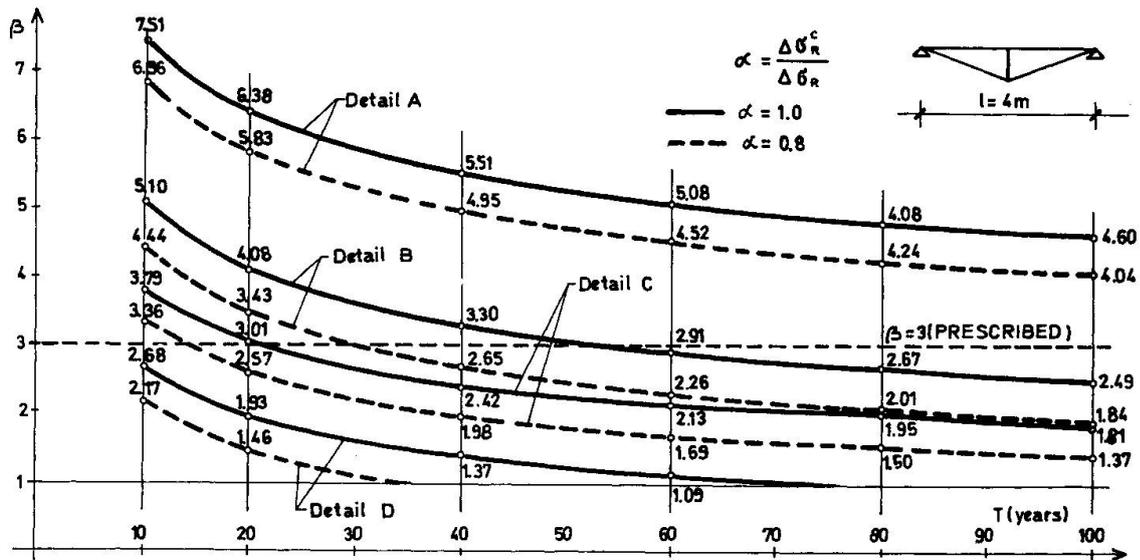
Fig. 5 Durability decrease at corrosion fatigue ($\alpha = 0.8$)

The following numerical analyses comprise the relationship of the reliability index and the life span of railway bridges from corrosion fatigue aspect. Fig. 5 shows this relationship for various detail categories, i.e. $\alpha = \frac{\Delta\sigma_r^c}{\Delta\sigma_r} = 1$ (uncorroded detail fatigue) and $\alpha = 0.8$ (corrosion fatigue strength if decreased by 20%).

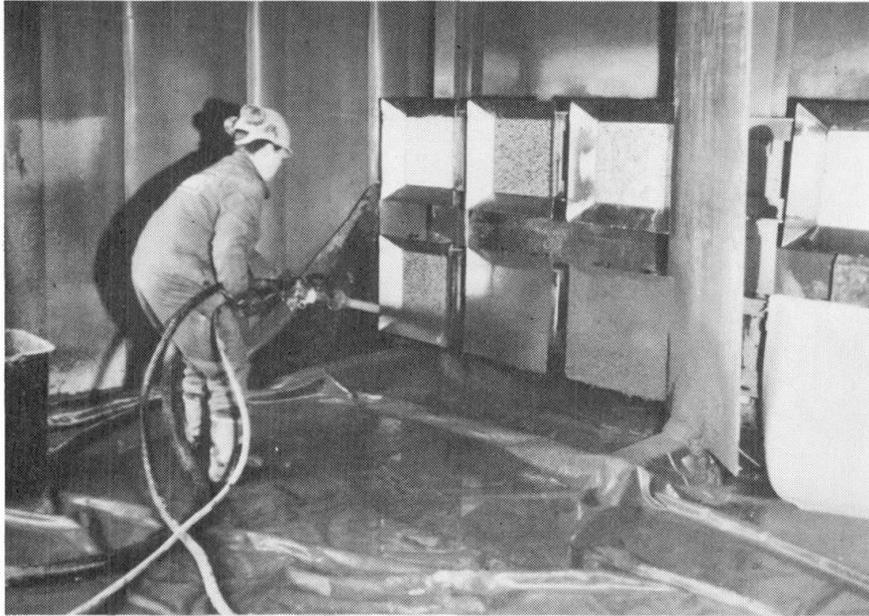
Fig. 1 Shotcrete gunned towards formwork, with bottoms of sawn concrete surfaces.

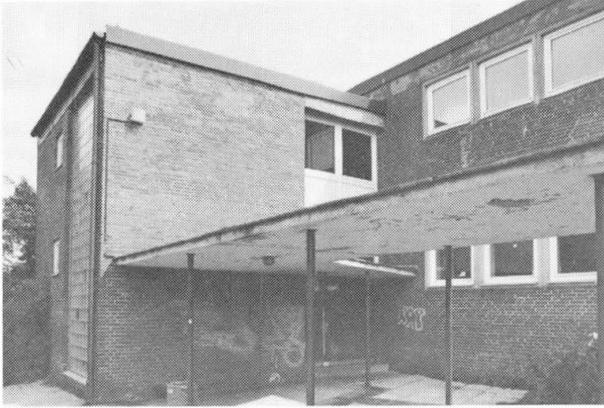
Bei den Fassaden der in Bild 3 und 4 dargestellten Gebäude handelt es sich um einschaliges Verblendmauerwerk. Die Steine wurden bei einer Prüfung nach DIN 52 252 Teil 1 (Tauchversuch) als nicht ausreichend frostbeständig eingestuft. Vor etwa 15 Jahren wurde die Fassade B aus Bild 3 mit einem Hydrophobierungsmittel, laut Datenblatt ein Polysiloxan, behandelt, und die

Fassade C, dargestellt in Bild 4, ebenfalls vor etwa 15 Jahren hydrophobiert. Bild 5 und 6 zeigen ausgewählte Bereiche der Fassaden B und C in Nahaufnahme. Neben Abplatzungen mit 5 bis 10 mm Scherbendicke sind deutliche Abblätterungen des Steinmaterials und starke Fugenschäden zu erkennen.
