Strengthening of a Bridge with Epoxy Beam and Prestressed Steel
Renforcement d'un pont avec de l'époxi et des fils d'acier précontraints
Instandstellung einer Stahlbrücke mit Epoxyharz und Stahldrahtvorspannung

Victor L. ENGELHARDT
Civil Engineer
D.E.R.
Curitiba, PR, Brazil

The historical value of a metallic truss-frame "Warren-type" bridge us required a new process of bridge rehabilitation in 1975. Through the profiles that composed the lower chord, an epoxy beam was constructed with 40 steel wires, which was slightly prestressed with the objective of neutralizing the traction in the lower chord due to the structure's own weight. The epoxy mix that filled the space inside the deteriorated metallic profiles and the prestressed wires formed a new composite girder which had the characteristics required by the rehabilitation project.

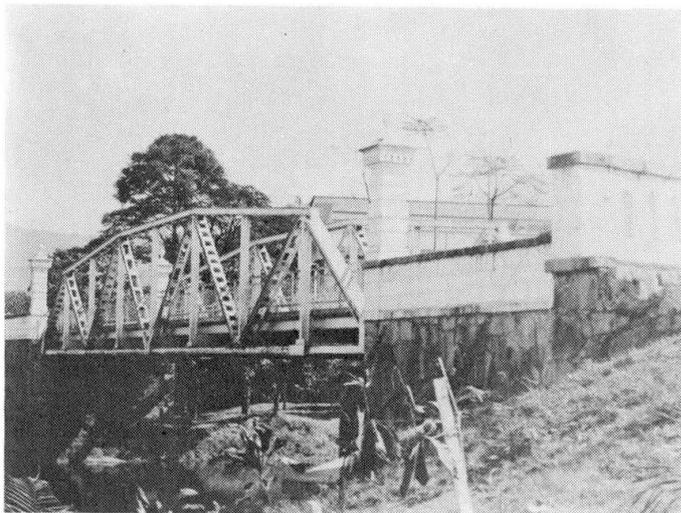
Fig. 1 General View

Its superstructure consists of a double metallic truss-frame "Warren" type with a 35.20 meters span and rests on a masonry infrastructure of excellent quality. Due to the proximity of the sea, lack of maintenance and total carelessness the bridge structure was so thoroughly eroded by the corrosion that its crumbling was foreseen even without traffic.

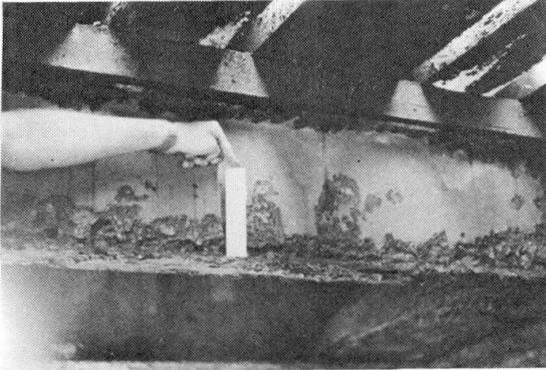
Fig. 2 Corrosion details

2.2.1 The truss-frame lower chord was almost completely deteriorated due the corrosion.

2.1.3 The metallic beams which supported the wood road surface were in an advanced stage of corrosion and could not be strenghtened (they were substituted by new parts).

- Cleaning with sand blast all the structure.
- Use new metallic reinforcements mainly in knots and superior chord.
- Through the profiles that composed the lower chord an epoxy beam was constructed with 40 steel wires $\phi 5 \text{ mm}$ which was slightly prestressed in order to neutralize the traction in the lower chord due the structure's own weight. The epoxy mix that filled the space inside the prestressed wires and the original profiles in addition to its great resistance for compressing and traction efforts due to its high adherence power, worked in order to form an unique block composite by old structure and reinforcements introduced.
- The compression tensions obtained with the samples moulded with the mix utilized in the rehabilitation were greater than ones obtained in the laboratory experiments as shown by the values indicated below:

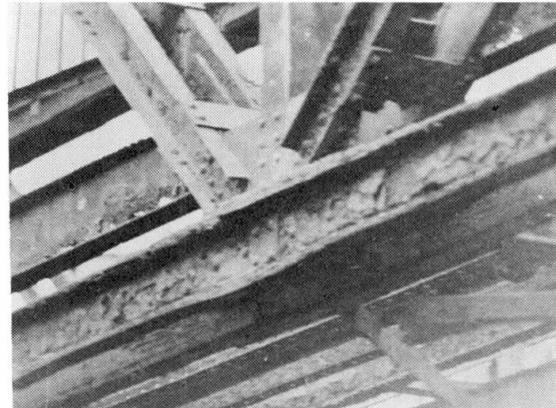
Fig. 3 Lower joints

2.1.2 The truss-frame lower joints were seriously damaged by the corrosion.

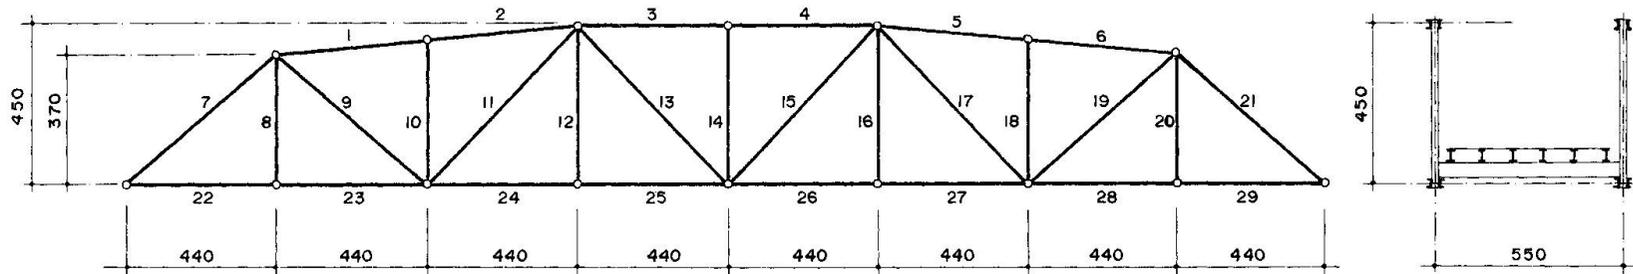
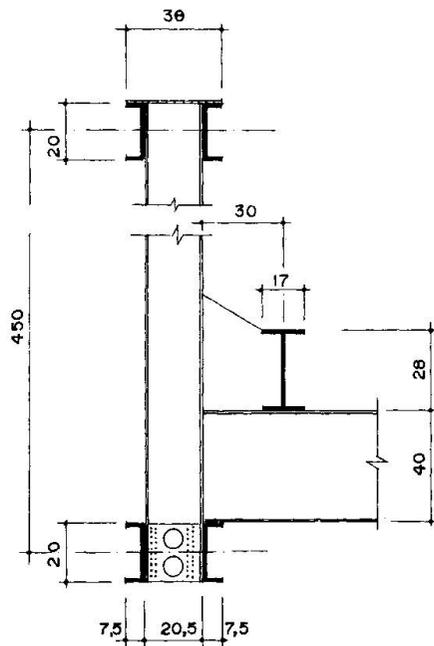
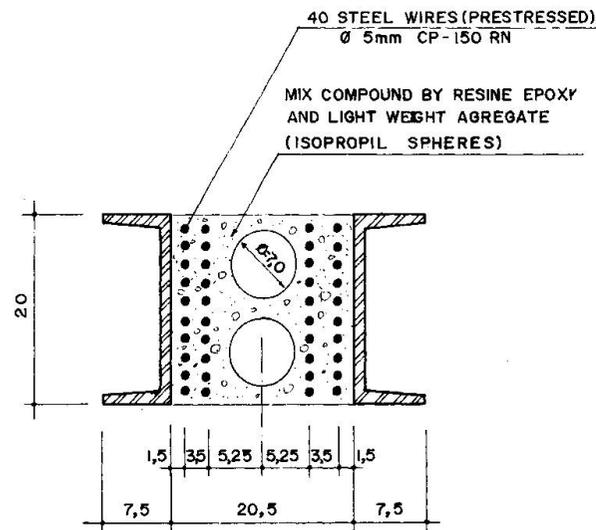
3. STRUCTURAL PLAN

ELEMENTS	ORIGINAL		WITH REINFORCEMENT	
	S M ² *E-4	I M ⁴ *E-5	S M ² *E-4	I M ⁴ *E-5
1 a 6	79,54	3820	119.70	7.852
7 = 21	80.89	3820	115.10	6.111
8 = 10 = 12	62.55	4.320	62.55	4.320
14 = 16 = 18	"	"	"	"
20	"	"	"	"
9 = 19	75.34	2.797	93.35	2.797
11 = 17	63.87	1.890	79.01	1.890
13 = 15	48.48	1.234	55.64	1.234
22 a 29	183.30	22.770	183.30	22.770
30 a 37	32.20	1.850	32.20	1.850
38 a 45	—	—	7.86	
46 a 53	—	—	315.17	9.33

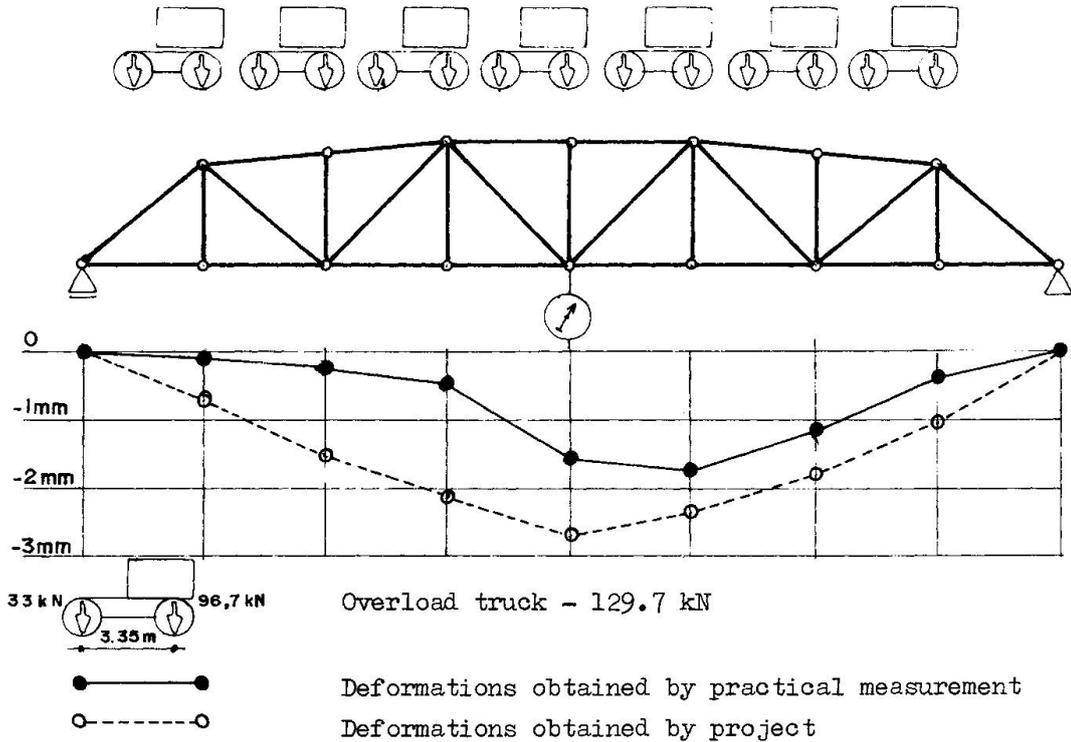
In order to check the structure's behavior another serie of tests were executed with an overload truck weighting 129.7 kN, in january 1989.

The tests were realized with the truck parking in 7 stations, at same time the deformations were indicated through a deflectometer (accuracy 1/100 mm) installed in the middle of the bridge.

With these results were possible to confront the deflections obtained by project and practically. We can observe in figure above that the deformations measured were always smaller than the theoretical deformations, consequently showing the good performance of the structure.
