Artikel: Advanced repair techniques for reinforced concrete structures

Autor: Sato, Yuji / Fuse, Tatsuro

Advanced Repair Techniques for Reinforced Concrete Structures

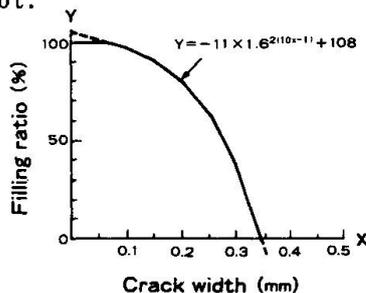
Fig.1 Crack width and filling ratio

Until recently, a low viscosity resin had been used to fill minute concrete cracks in exterior walls due to rain leakage. However, NTT discovered in the buildings repaired that the resin did not coagulate but instead flowed downwards. To confirm this experimentally, NTT injected the low viscosity resin into a crack in an existing RC wall. Test samples of the crack were taken from the RC wall after the resin coagulated. The relationship between the crack width and the filling ratio for the samples taken from the highest point along the crack is shown in Fig.1. As indicated in Fig.1, the injected low viscosity resin flowed downward in cracks more than 0.1 mm in width.

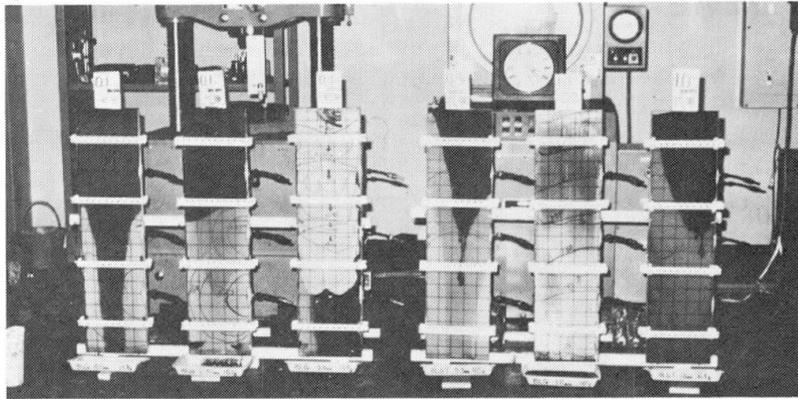
Fig.2 Test results for crack model

Filling tests using both resins were performed on crack models. The models used in the test and the results are shown in Fig.2. Each model was made of two clear acrylic panels that were placed together to form a specified crack width. Resin was injected into three holes spaced at 25 cm apart along the seam of each model on the right side as shown in Fig.2. In the case of the 0.1 mm in width crack, both types of resin did not flow downwards. For the cracks 0.3 mm and 1.0 mm in width, the low viscosity resin flowed downwards, but the high viscosity one did not.

Crack width	0.1 mm	0.3 mm	1.0 mm
Viscosity resin	low high	low high	low high

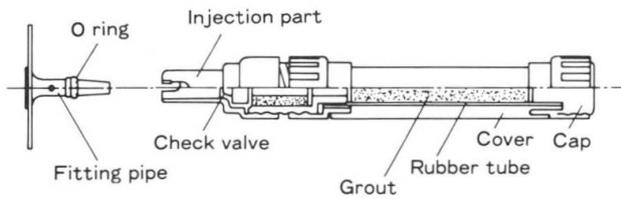
Fig.3 Injector (cartridge type)

The injector adopted is a cartridge type and the part containing the resin is a synthetic rubber balloon, as shown in Fig.3 and Fig.4. The resin is slowly injected using the balloon's contractile pressure (2.5 kg/cm² for 25mm in diameter), and the amount of resin packed can be controlled easily. After the injectors are inserted into the drilled holes along the crack, the crack is filled

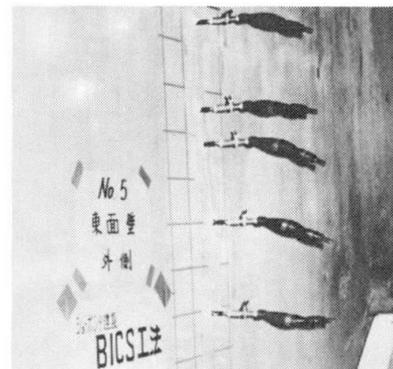
Fig.4 View of injection

with resin. This injection method greatly simplifies the work and improves work safety [2]. A picture of the injection work is shown in Fig.4.

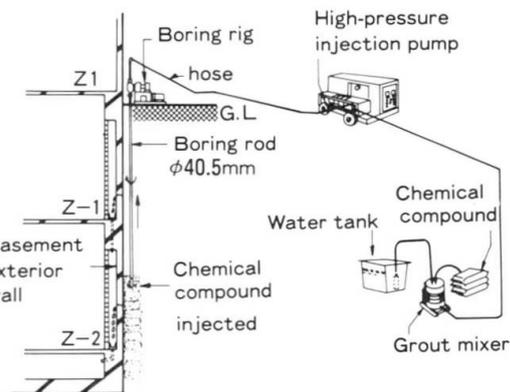
Fig.5 Filling system

The new method uses a chemical compound to stop underground water leakage. The chemical compound is pumped into the ground outside the basement walls at high pressure. The activated silica in the chemical compound reacts to the calcium hydroxide produced by the reaction between water and cement. A silicic acid calcium produced by the reaction enters with water into

the concrete defects, becomes implanted, grows and finally fills up the defect. This method is shown in Fig.5.

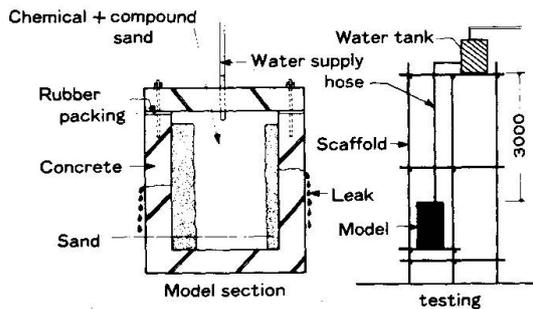
Fig.6 Test model

Six models in the shape of boxes and constructed of concrete panels with defects such as cracking and honeycombing were used in the testing. The inside of a box was regarded as the outside of a basement wall and the outside was considered the inside of a basement wall. Model configuration and the test method are shown in Fig.6. Chemical compounds with soil samples were mixed and placed into the models. Water was then pumped into them at 3 ton/m² pressure from a water tank placed three meters above the models. Leakage from the models was measured continuously. Chemical compound mixings are shown in Table 2. The effects of the various compound mixings on water leakage are compared and shown in Fig.7. In the case of a fat mix agent (cement 300 kg/m³, chemical compound 18 kg/m³), water leakage was reduced by 96.1 - 99.7% by the 30th day of testing. In the case of a lean mix agent (cement 150 kg/m³, chemical compound 15 kg/m³), leakage only decreased 30.2% by the 30th day of testing.

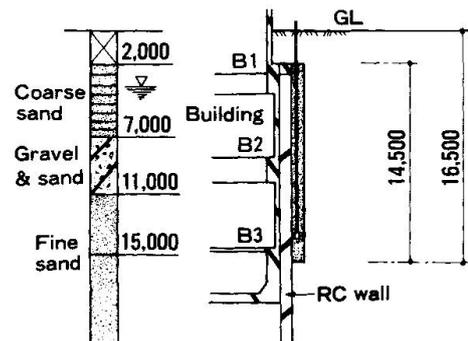
Fig.8 Testing in existing building

The test was performed on the external perimeter walls of the third basement (see Fig.8). The mixing of the chemical compound used was exactly the same as that of No.6 in Table 2. Boring rods were driven in 25 cm from the outer surface of the exterior walls to the required depth. The chemical compound was injected into the rods, 23 in total. During the injection, the rods were pulled up at 10 cm/step.

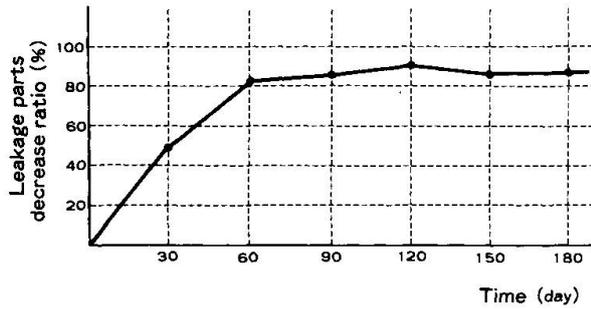
Fig.9 Eye observation

The number of leaks was 88, and all of them were observed carefully by eye. The amount of leakage for six of these leaks was measured. Eye observations are shown in Fig.9. The number of leaks decreased 52% by the 30th day of testing and 86% by the 90th day. The measurements for six leaks are shown in Fig.10. The number of leaks by the 110th day of the testing was one. As each day passed, the effect of this method was noticeable.

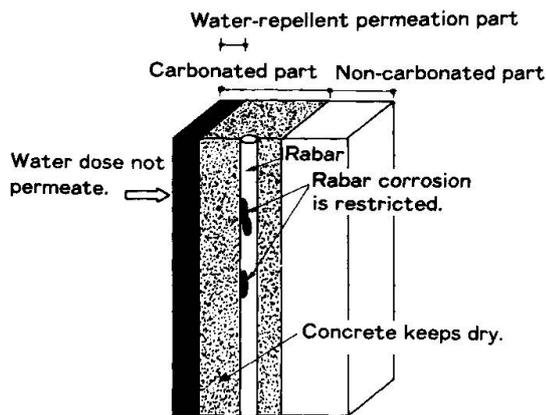
Fig.11 Concept of the method

The method of restricting concrete carbonation has generally been adopted in Japan to improve the durability of concrete structures. However, concrete carbonation and the coverage concrete thickness for rebar vary widely. This means that the concrete around some rebar in existing buildings has probably carbonated, even if a building is not old. Therefore, NTT developed the method of restricting rebar corrosion in the carbonated concrete [4], as shown in Fig.11.

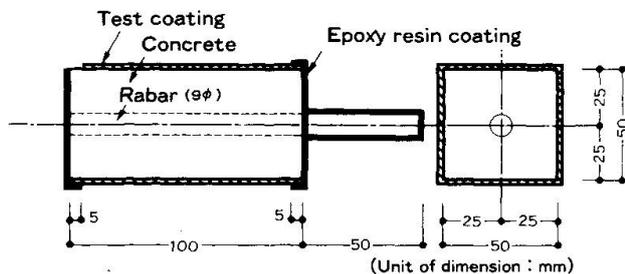
Fig.12 Test sample

An accelerated aging test was performed to confirm the effect of restriction. A reinforced concrete sample used in the testing is shown in Fig.12. After the con-

crete samples were forcibly carbonated to the rebar position, the surface of the samples were painted with various coatings. Next, the samples were alternately placed in wet or dry environment every seven days. This procedure accelerated rebar corrosion. The test extended over 110 days. The code No. for the various coatings samples used are listed in Table 3.

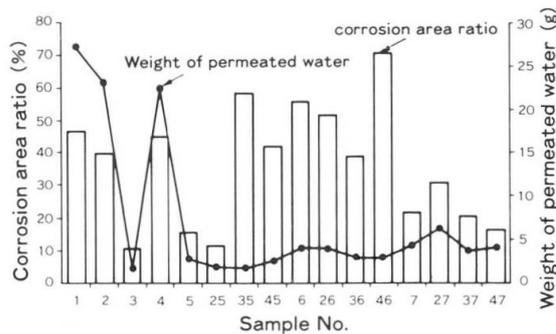
Fig.13 Test results
(corrosion area ratio)

The ratio of the corrosion area to the entire surface area of the rebar and the average weight of permeated water are shown in Fig.13. The weight of permeated water is the weight of a sample in the wet environment minus its weight in the dry environment. Samples of the rebar corrosion are shown in Fig.14. As indicated in Fig.13 and Fig.14, impermeability to water was satisfied in the case of the samples coated with the water-repellent silane coatings (No.3), waterproof coatings (No.5,6,7), and the water-repellent and waterproof complex coatings (No.25-47).
