Zeitschrift: IABSE reports = Rapports AIPC = IVBH Berichte
Band: 57/1/57/2 (1989)

Artikel: Advanced repair techniques for reinforced concrete structures
Autor: Sato, Yuji / Fuse, Tatsuro
DOI: <https://doi.org/10.5169/seals-44307>

Advanced Repair Techniques for Reinforced Concrete Structures

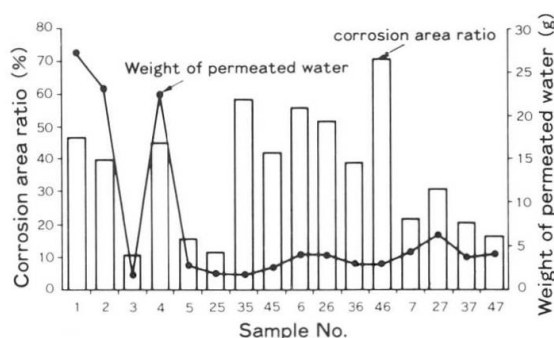
Fig.13 Test results
(corrosion area ratio)

The ratio of the corrosion area to the entire surface area of the rebar and the average weight of permeated water are shown in Fig.13. The weight of permeated water is the weight of a sample in the wet environment minus its weight in the dry environment. Samples of the rebar corrosion are shown in Fig.14. As indicated in Fig.13 and Fig.14, impermeability to water was satisfied in the case of the samples coated with the water-repellent silane coatings (No.3), waterproof coatings (No.5,6,7), and the water-repellent and waterproof complex coatings (No.25-47).
