Artikel: Fatigue strength of corroded steel plates from old railway bridge
Autor: Abe, Hidehiko
DOI: <https://doi.org/10.5169/seals-44213>

Fatigue Strength of Corroded Steel Plates from Old Railway Bridge

Hidehiko ABE
Prof. of Civil Eng.
Univ. of Utsunomiya
Utsunomiya, Japan

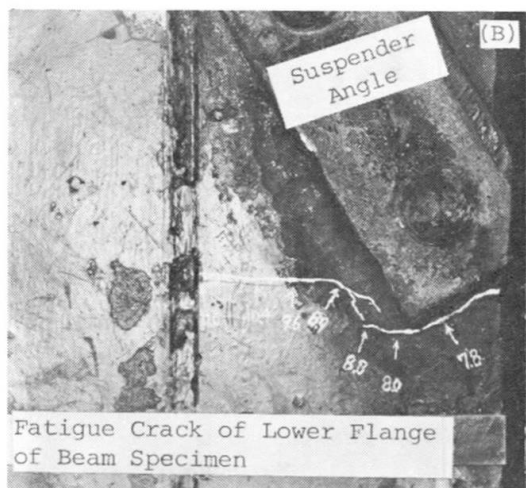
Fatigue Rupture of Heavily Corroded Plate

While the cracks were initiated at the bottoms of pits formed by corrosion in all the plate type specimens, they started from the edges of rivet holes in the riveted specimens and from the spot of the attachment for suspension of the lower lateral members in the beam type specimens. Several photos of fractured specimens also are shown.

In a heavily corroded steel plate, the fatigue strength is drastically lowered to as low as 140 MPa to 100 MPa in reference to the remaining cross-sectional area, of stress range at two million cycles, because of severe stress concentration at the corrosion pit and because of reduction of the cross-sectional area. But the fatigue strength of elements which involve stress concentration inherently, such as riveted plates, are relatively less influenced by corrosion.
