**Artikel:** A 12 year case study of a reinforced concrete building

**Autor:** Parrott, Leslie

## A 12 Year Case Study of a Reinforced Concrete Building

**Leslie PARROTT**  
Research Engineer  
British Cement Assoc.  
Slough, UK

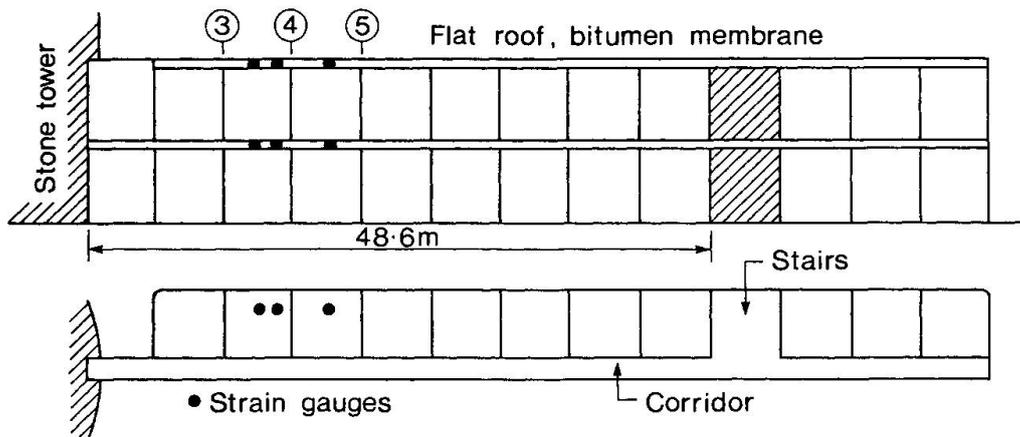
Fig. 1 Elevation and plan of two-storey office structure

A diagram of the two-storey office building is shown in Figure 1. There are twelve bays each 5.4m long with a stairway at the ninth bay providing some longitudinal restraint. The 4.4m wide offices are accessed by 1.3m wide corridors on the ground and first floors. The longer portion of the building between the stairway and an old stone tower can move longitudinally by virtue of a movement joint at the interface of the tower and office corridors. At this interface and for one bay the width of the structure is reduced to that of the corridor and the walls are fully glazed. The continuous floor and roof slabs were cast in-situ on precast concrete cross beams that were supported by a frame of precast columns and longitudinal beams.

The in-situ and precast concretes were made with lightweight coarse aggregate and a natural sand. 100mm cube strengths at 7, 28 and 182 days were 35.9, 42.4 and 55.0 MPa respectively. The mix constituents per cubic metre were 170kg free water, 350kg Portland cement, 730kg zone 2 sea dredged sand and 600 kg of lightweight aggregate plus about 100kg of absorbed water.

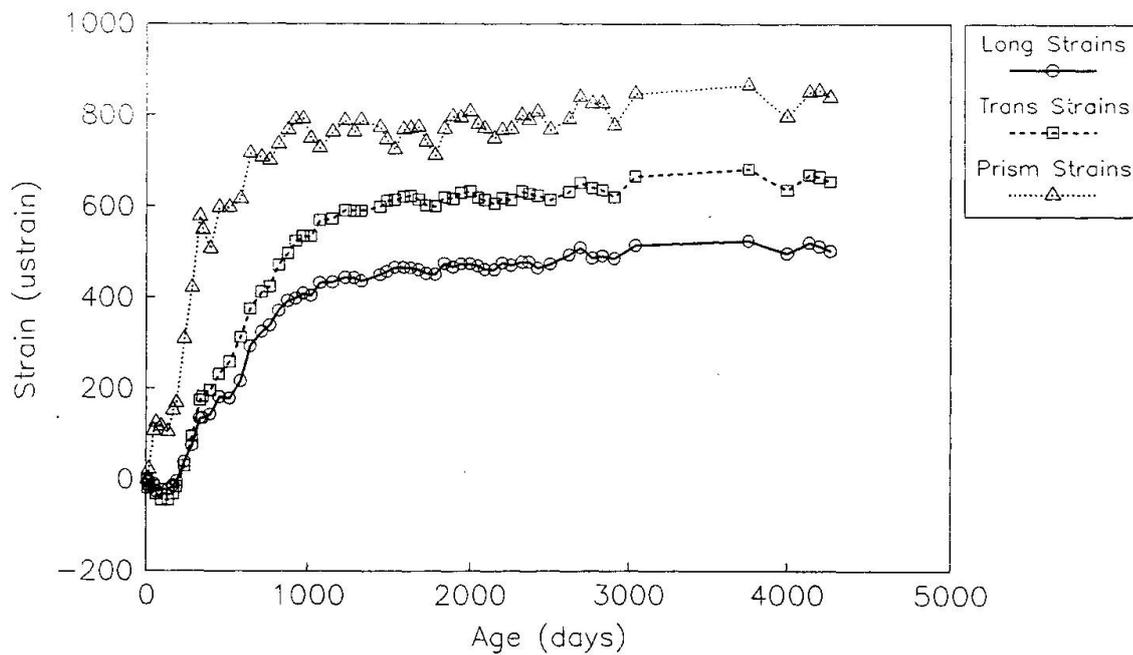
Fig. 2 Strains in prisms; longitudinal and transverse strains at quarter span, bay 3-4 in floor.

Six prisms were stored beneath the roof for long-term measurements of shrinkage and weight loss. The shrinkage results in Figure 2 suggest that approximate moisture equilibrium was reached after about 3 years and this was consistent with the weight loss measurements: thereafter the small increase in shrinkage was accompanied by a slight gain of weight that was indicative of carbonation [2].

Figure 2 shows that initially longitudinal strains are slightly larger than transverse strains at quarter-span in the floor. This is consistent with the expected, small flexural stresses. After about 250 days the transverse strains exceed the longitudinal strains and this indicates that axial tensile stresses develop at later ages. Similar patterns of transverse and longitudinal strain were observed at mid-span in bays 3-4 and 4-5 of the floor.

The calculated strains for bay 4-5 of the floor slab are shown in Figure 3. There were only small differences in shrinkage between the three instrumented sections. The shrinkage of the floor slab developed more slowly than the prism shrinkage (Fig 2) and appears to be stabilizing at a smaller, final strain. These effects are attributable to differences in drying path length [3]. The stress-induced strains exhibit the expected pattern for flexural loading but they are superposed by the development of tensile strains.

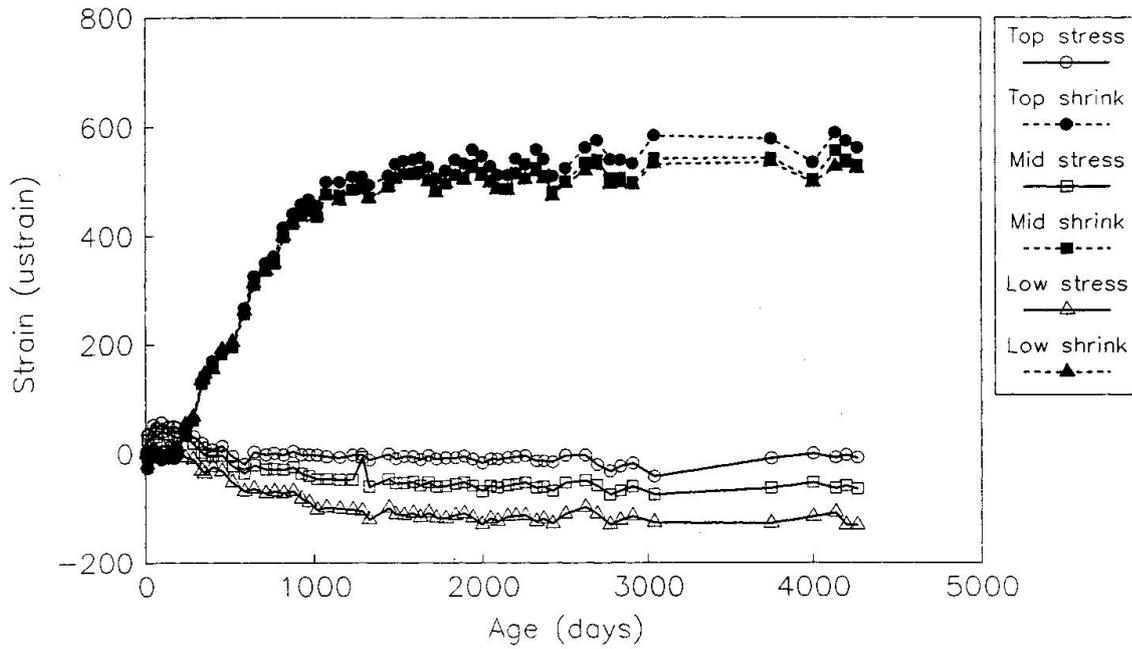
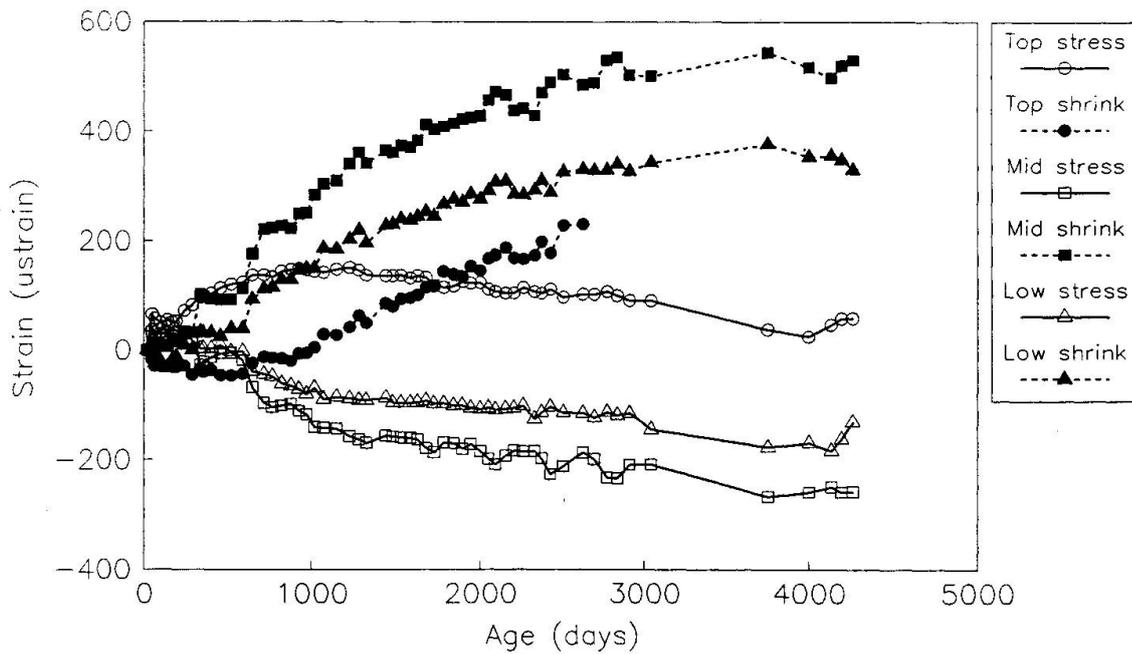
Fig. 3 Shrinkage and stress-induced strains in floor(upper) and roof(lower).

The calculated strains for the roof slab in Figure 3 show that shrinkage developed more slowly than that in the floor. Although the roof slab was similar in thickness to the floor slab drying was retarded by the waterproof layer on its upper surface. The stress-induced strains exhibit the expected pattern for flexural loading but they are superposed by the slow development of small tensile strains. The tensile strains in the roof develop more slowly than those in the floor.

The strain patterns in Figure 3 suggest that longitudinal drying shrinkages of the floor and, to a lesser extent, the roof are restrained and thus cause the development of longitudinal tensile stresses. This is consistent with the similarity in shape and period of occurrence of the shrinkage versus age and stress-induced strain versus age curves. Restraint may have derived from the columns, longitudinal beams, internal block walls and the foundation.
