A 12 Year Case Study of a Reinforced Concrete Building

Leslie PARROTT
Research Engineer
British Cement Assoc.
Slough, UK

SUMMARY

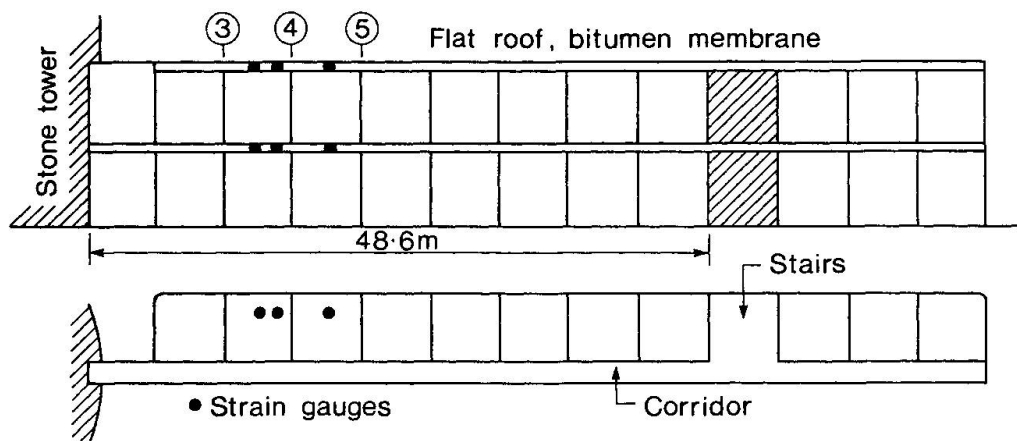
A diagram of the two-storey office building is shown in Figure 1. There are twelve bays each 5.4m long with a stairway at the ninth bay providing some longitudinal restraint. The 4.4m wide offices are accessed by 1.3m wide corridors on the ground and first floors. The longer portion of the building between the stairway and an old stone tower can move longitudinally by virtue of a movement joint at the interface of the tower and office corridors. At this interface and for one bay the width of the structure is reduced to that of the corridor and the walls are fully glazed. The continuous floor and roof slabs were cast in-situ on precast concrete cross beams that were supported by a frame of precast columns and longitudinal beams.

Fig. 1 Elevation and plan of two-storey office structure

The in-situ and precast concretes were made with lightweight coarse aggregate and a natural sand. 100mm cube strengths at 7, 28 and 182 days were 35.9, 42.4 and 55.0 MPa respectively. The mix constituents per cubic metre were 170kg free water, 350kg Portland cement, 730kg zone 2 sea dredged sand and 600 kg of lightweight aggregate plus about 100kg of absorbed water.

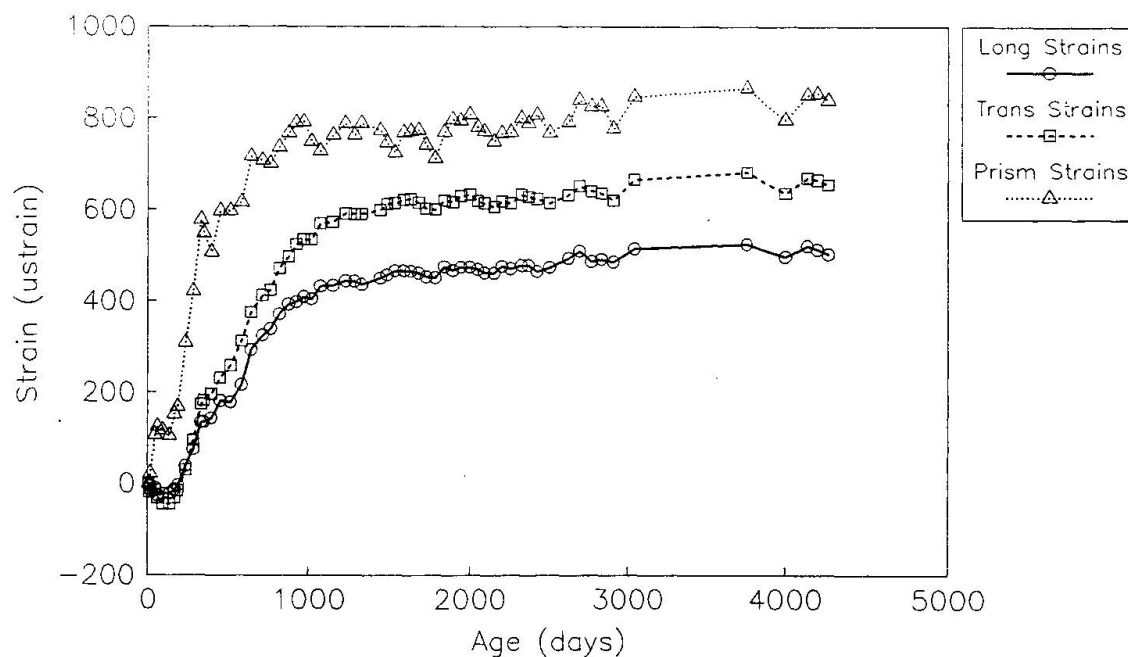
First floor, Quarter span, bay 3-4

Six prisms were stored beneath the roof for long-term measurements of shrinkage and weight loss. The shrinkage results in Figure 2 suggest that approximate moisture equilibrium was reached after about 3 years and this was consistent with the weight loss measurements: thereafter the small increase in shrinkage was accompanied by a slight gain of weight that was indicative of carbonation [2].

Fig. 2 Strains in prisms; longitudinal and transverse strains at quarter span, bay 3-4 in floor.

Figure 2 shows that initially longitudinal strains are slightly larger than transverse strains at quarter-span in the floor. This is consistent with the expected, small flexural stresses. After about 250 days the transverse strains exceed the longitudinal strains and this indicates that axial tensile stresses develop at later ages. Similar patterns of transverse and longitudinal strain were observed at mid-span in bays 3-4 and 4-5 of the floor.

The calculated strains for bay 4-5 of the floor slab are shown in Figure 3. There were only small differences in shrinkage between the three instrumented sections. The shrinkage of the floor slab developed more slowly than the prism shrinkage (Fig 2) and appears to be stabilizing at a smaller, final strain. These effects are attributable to differences in drying path length [3]. The stress-induced strains exhibit the expected pattern for flexural loading but they are superposed by the development of tensile strains.

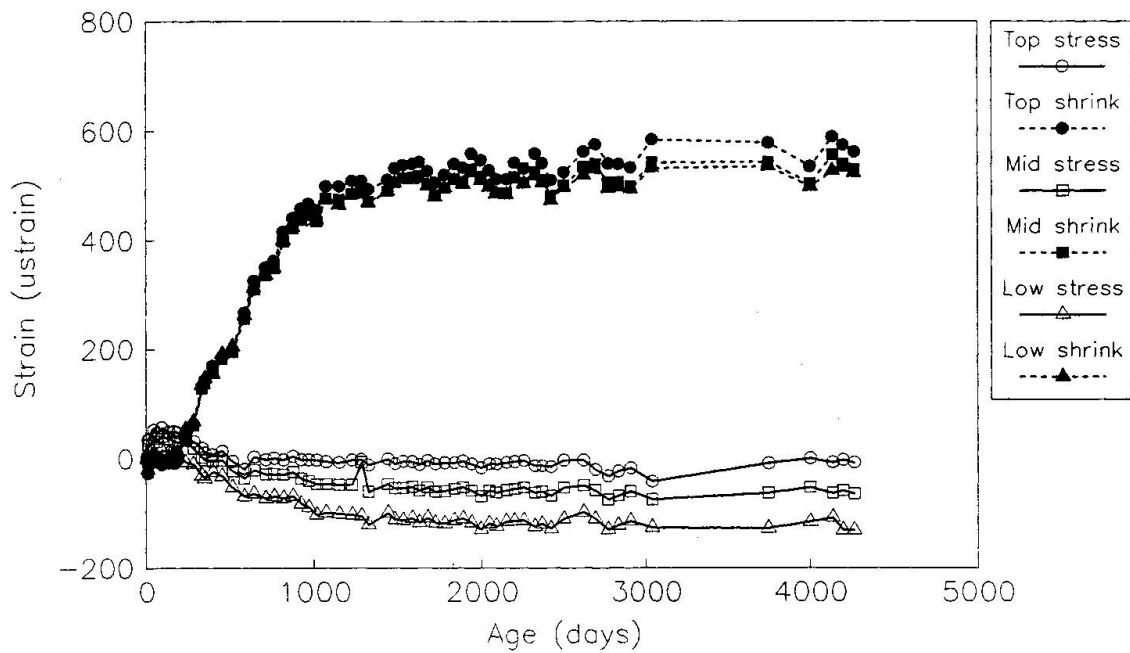
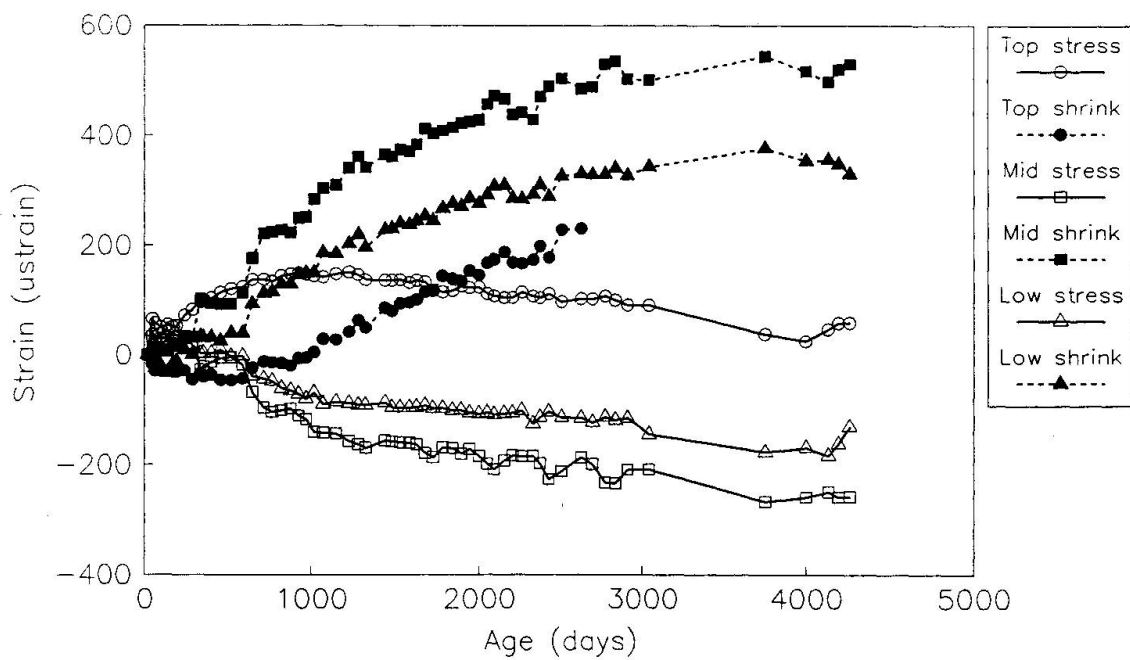
The calculated strains for the roof slab in Figure 3 show that shrinkage developed more slowly than that in the floor. Although the roof slab was similar in thickness to the floor slab drying was retarded by the waterproof layer on its upper surface. The stress-induced strains exhibit the expected pattern for flexural loading but they are superposed by the slow development of small tensile strains. The tensile strains in the roof develop more slowly than those in the floor.

Fig. 3 Shrinkage and stress-induced strains in floor(upper) and roof(lower).

The strain patterns in Figure 3 suggest that longitudinal drying shrinkages of the floor and, to a lesser extent, the roof are restrained and thus cause the development of longitudinal tensile stresses. This is consistent with the similarity in shape and period of occurrence of the shrinkage versus age and stress-induced strain versus age curves. Restraint may have derived from the columns, longitudinal beams, internal block walls and the foundation.
