Zeitschrift: IABSE reports = Rapports AIPC = IVBH Berichte
Band: 57/1/57/2 (1989)

Rubrik: Workshops

New Methods in the Rehabilitation of Prestressed Concrete Structures
Nouvelles méthodes pour l'assainissement des ouvrages en béton précontraint
Neue Verfahren bei der Instandsetzung von Spannbetonbauwerken

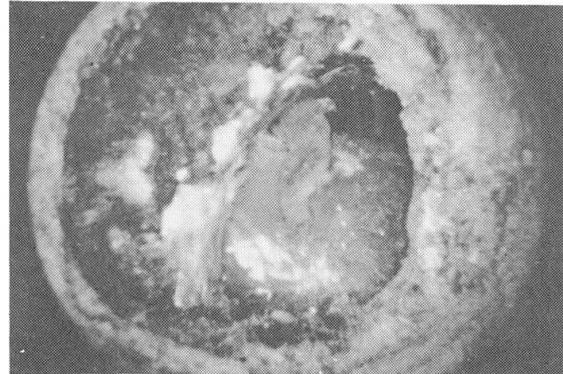
Fig.4 The opened tendon seen through the borescope. The cavity is proof of insufficient injection.

The far greater risk of damage lies not in drilling but in the opening of the sheathing itself. Therefore the opening must be carefully surveyed. This is done by means of the borescope. This accessory, too, is meanwhile considered as belonging to the state of the art in rehabilitation works.

What is seen through the borescope can be recorded photographically and so be documented. This is a new development with opening the sheathings, because it allows everyone involved to check that the tendon was not damaged when opening the sheathing.

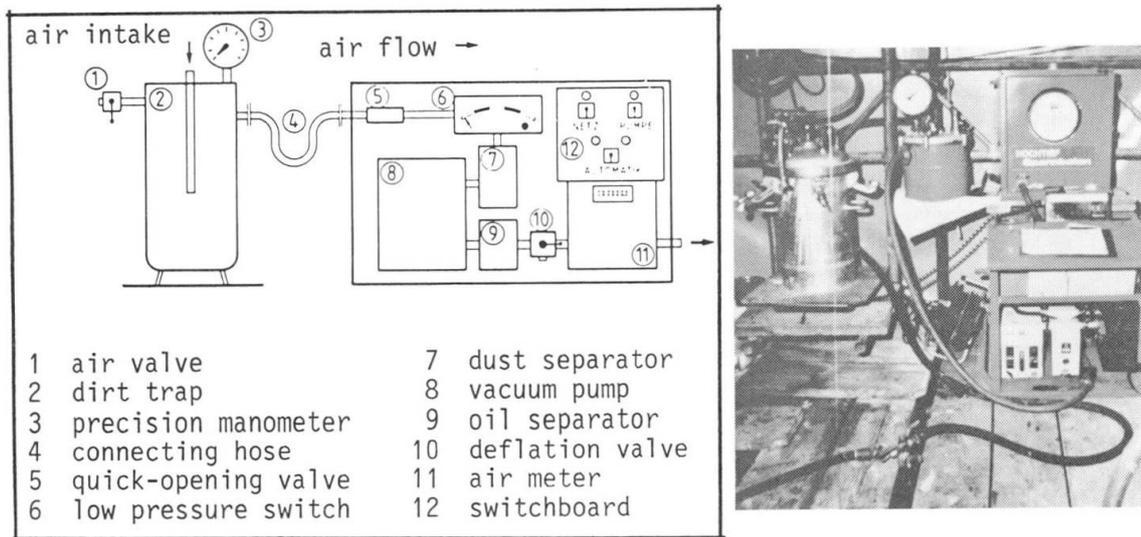
Figs. 5 + 6 The vacuum procedure.

Prior to the injection, the volume of the cavity is determined by measuring the pumped-off quantity of air down to a pressure of 400 mbar behind the vacuum pump. During an earlier check, the hose connections and the void were leakage-tested at 100 mbar. Leakages localized through hissing noises were sealed. In preparation of the injection, the underpressure is lowered to 50 mbar. Post pump injection assists the subsequent filling of the cavity.

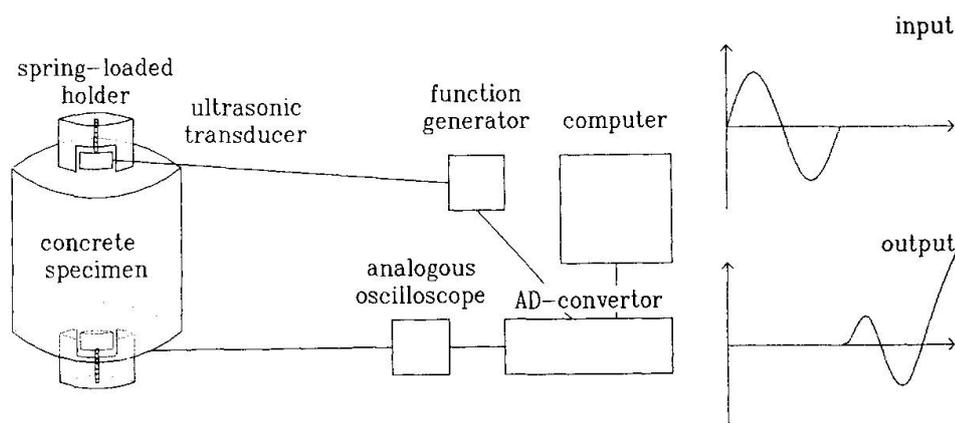
Fig. 1: Schematic diagram of test setup

The transducers were applied to the concrete specimen in each separate ultrasonic measurement according to Fig. 1. In order to bring about a reproducible coupling the probes were mounted against a spring- loaded holder which produced a constant contact pressure. A coupling medium was applied between the probes and the concrete.

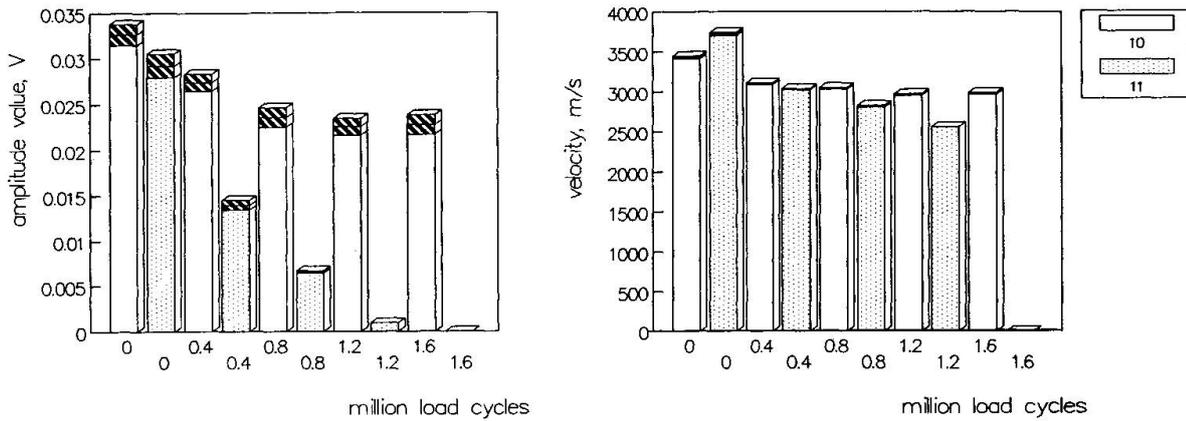
Fig. 2: Mean values with standard deviations of eight repeated measurements from specimens 10 and 11, at different stages of loading. Amplitude of first received sound wave, left and Velocity, right.

Mean values of velocities and amplitudes from signals measured with renewed coupling are presented in Fig. 2 together with the corresponding standard deviations.

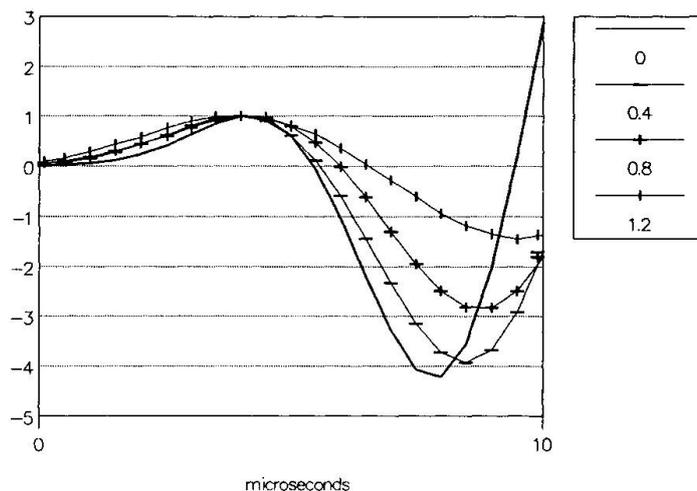
Fig. 4: First parts of received waveforms from specimen 11 at 0, 0.4, 0.8 and 1.2 million cycles. Amplitude values are normalized with respect to the first received peak.

The duration of the first received wave was shown to be changed due to cracks. The appearance of this wave is shown in Fig. 4 for one of the specimens at different degrees of cracking.

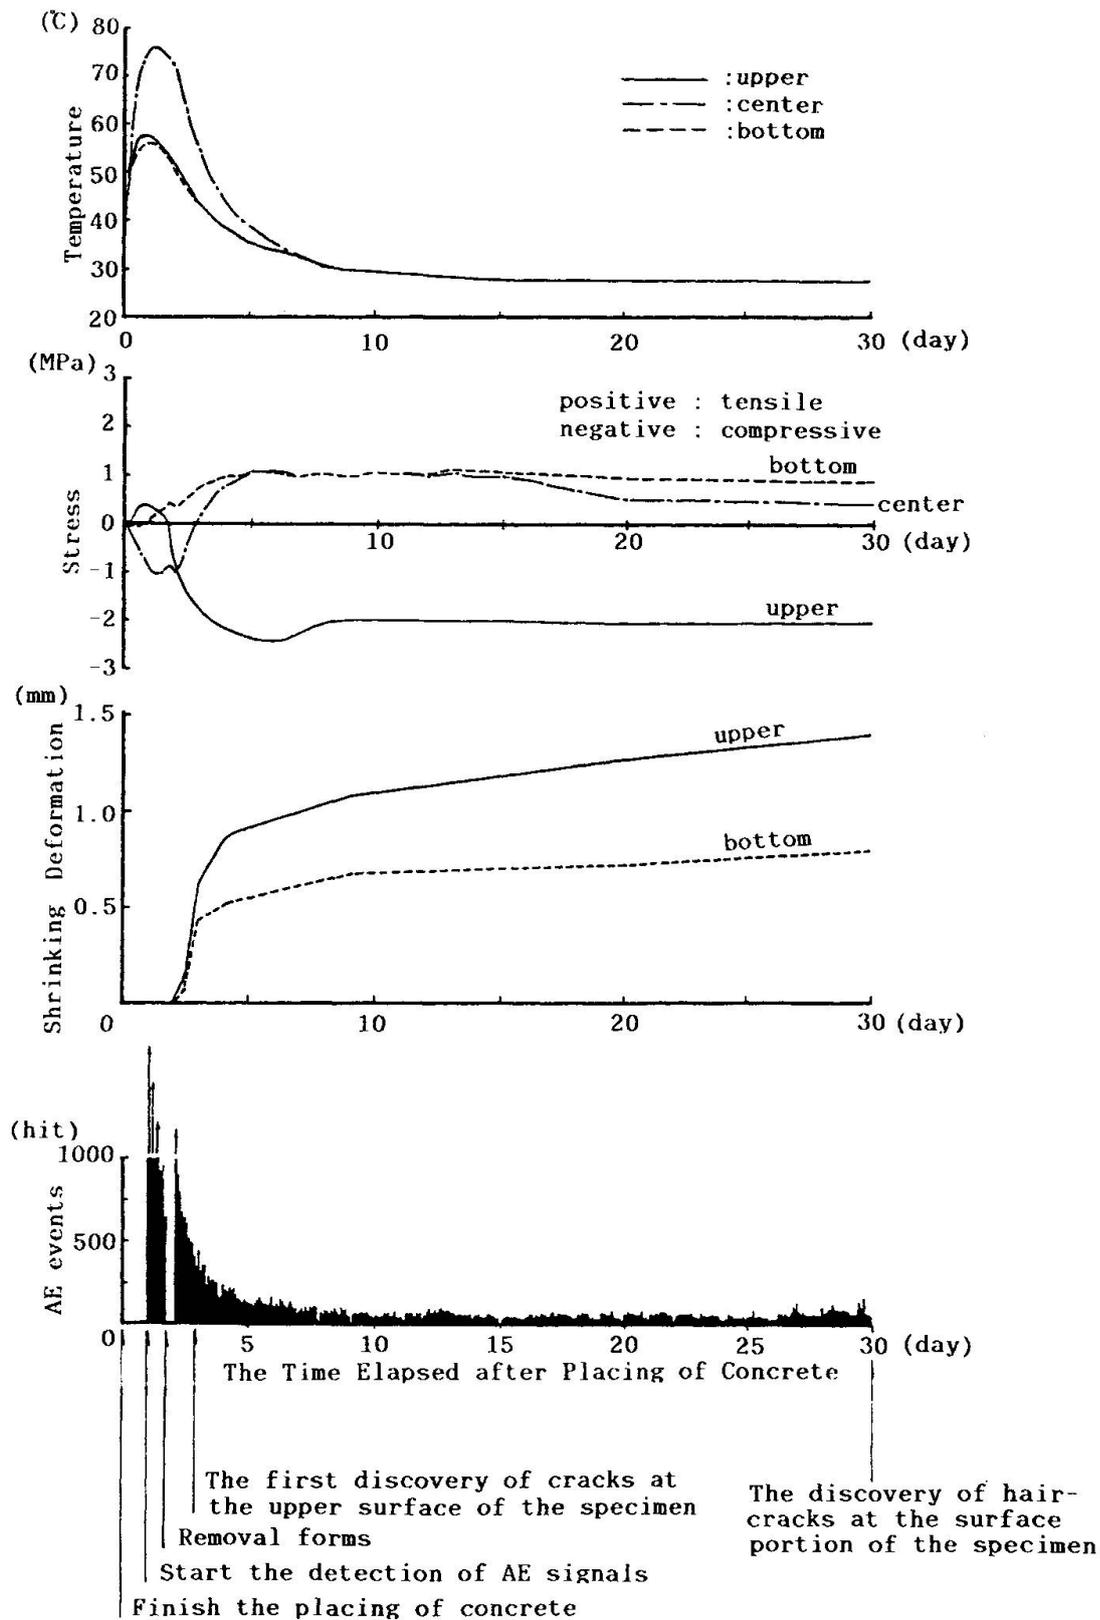
Fig. 3 The Time Elapsed versus Temperature, Longitudinal Stress, Longitudinal Deformation and AE Events

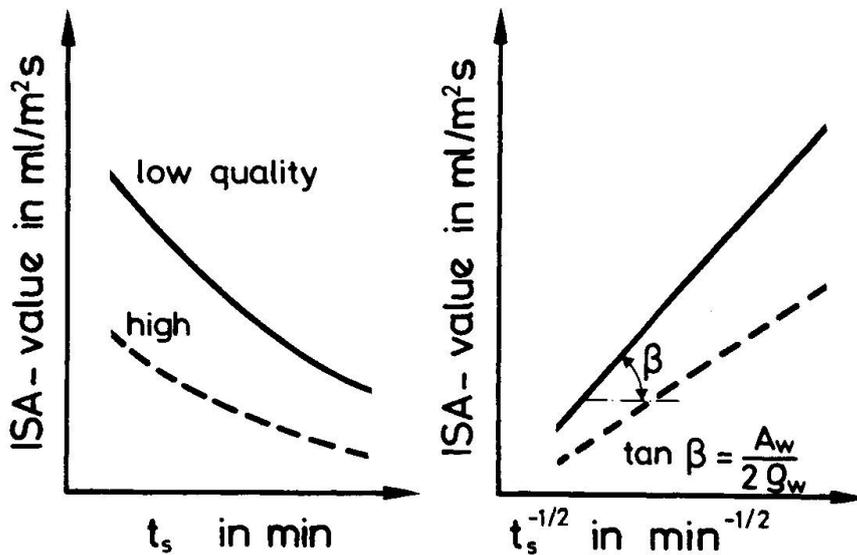
Fig. 5: Development of ISA-value vs. suction time

The ISA-value is the non-steady, threedimensional flux of water. It can be approximately expressed with Equ.(2) (see Fig. 5):

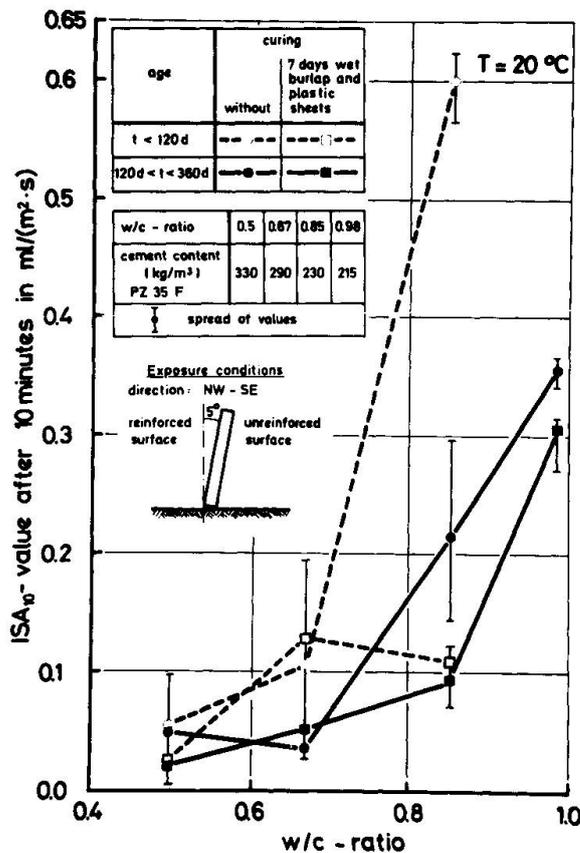
Fig. 6: Results of ISA_{10} -tests on the unreinforced surface of walls vs. w/c-ratio

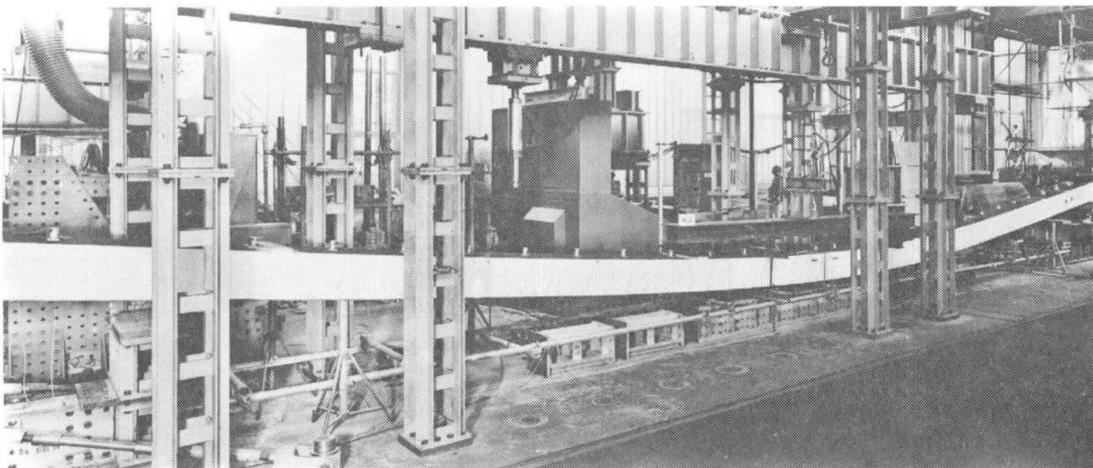
Fig. 3 Spannbetonträger A3 im Prüfstand mit einer Durchbiegung von $w = 65 \text{ cm}$ in der Mitte

Die Ermittlung der Tragfähigkeit der Spannbetonträger erfolgte durch Belastungsversuche (Fig. 3). Es zeigte sich, daß alle drei untersuchten Träger bei einer durch Einzellasten simulierten Gleichlast ein weitgehend ähnliches Trag- und Verformungsverhalten aufweisen. Der Beginn der Rißbildung erfolgte bei den Trägern A1 und A3 bei verhältnismäßig niedrigen Lasten, etwa bei $p = 0,5 p_0$ bzw. $1,5 p_0$ der mit $p_0 = 0,66 \text{ kN/m}$ (A1 und A2) bzw. $p_0 = 0,77 \text{ kN/m}$ (A3) angesetzten Gebrauchslast (Gewicht der Schilder plus Schneelast). Bei dem wesentlich kürzeren Träger A2 wurden erste Risse bei einer Last von ca. $p/p_0 = 3,5$ beobachtet. Mit zunehmender Belastung stellten sich ganz erhebliche Durchbiegungen ein, die bei Versuchsende ca. 450 bis 650 mm betrug. Erreicht wurde jedoch immer das in der statischen Berechnung ausgewiesene Bruchmoment. Das Versagen der Träger war gekennzeichnet durch eine zunehmende Durchbiegung (Fig. 4), ohne weitere Lastaufnahme infolge einer

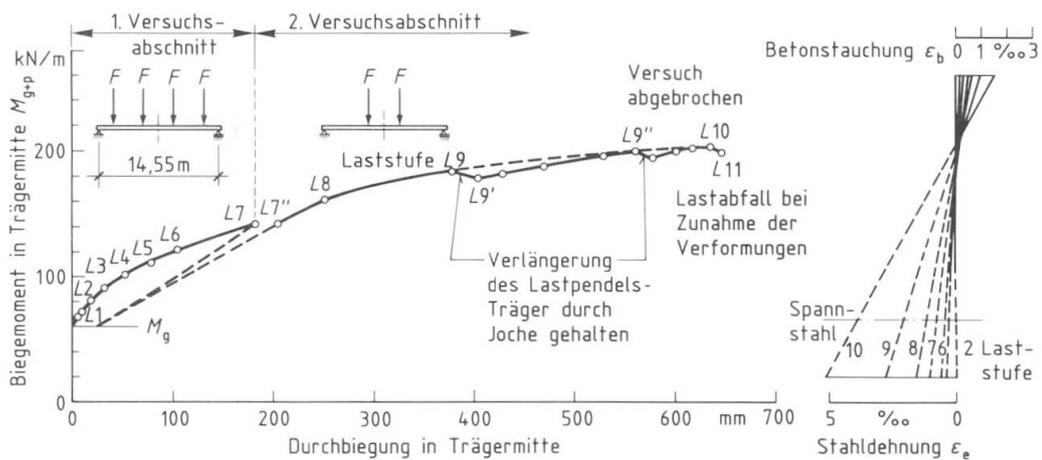
Fig. 4 Versuchsergebnisse für den Spannbetonträger A3 - Biegemoment - Durchbiegung (links) und Dehnungsverteilung über die Querschnittshöhe (rechts)

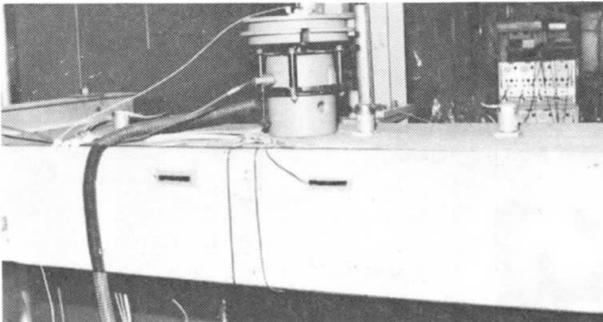
Fig. 5 Elektrodynamischer Schwinger zur Bauteilerregung und Geophone zur Aufnahme der Schwinggeschwindigkeit bzw. -beschleunigung

Um zukünftig den baulichen Zustand einfacher vorgespannter Tragelemente leichter erfassen zu können, wurde der Träger A3 zusätzlich mit Hilfe eines zerstörungsfreien, auf Schwingungsmessungen basierenden Prüfungsverfahrens [5] untersucht (Fig. 5). Im vorliegenden Fall konnte die zunehmende Schädigung des Trägers und damit die Abnahme der Tragfähigkeit gut aus den gemessenen Antwortspektren abgelesen werden (Fig. 6). Berechnet man aus den Eigenfrequenzveränderungen die Steifigkeitsreduzierung des Gesamtsystems, so ergibt sich in Übereinstimmung mit den Ergebnissen des statischen Versuchs nach dem 1. Versuchsabschnitt ein Wert von ca. 11 % und nach dem 2. Versuchsabschnitt ein Wert von ca. 35-40 %.
