Zeitschrift: IABSE reports = Rapports AIPC = IVBH Berichte
Band: 57/1/57/2 (1989)

Rubrik: Workshop 1: In-situ inspection

New Methods in the Rehabilitation of Prestressed Concrete Structures
Nouvelles méthodes pour l'assainissement des ouvrages en béton précontraint
Neue Verfahren bei der Instandsetzung von Spannbetonbauwerken

Ultrasonic Testing of Concrete

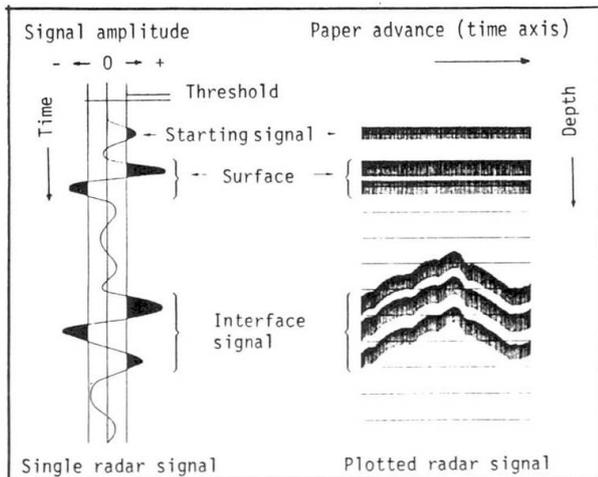
Fig.1 Graphic recording of a radar signal.

Formerly, the radar technique could only be used for the detection of reinforcement near the concrete surface. Meanwhile, the measuring technique has advanced to a point where it is possible to detect in bridges the transverse prestressed reinforcement beneath the non-prestressed reinforcement through the bridge cap as well as through the asphalt surfacing layer.

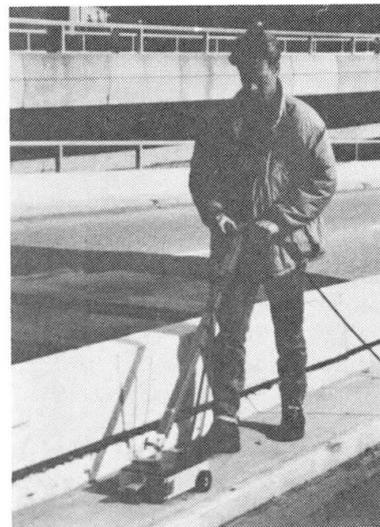
Fig.2 Guiding the radar antenna for the detection of transverse prestressed reinforcement

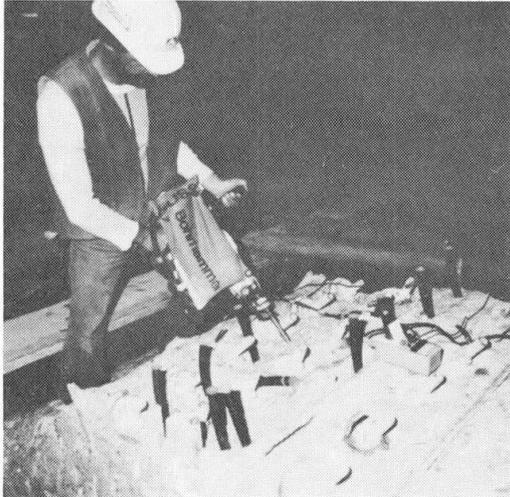
Fig.3 Drill hammer with auto-
matic switch-off

Safe and non-destructive hitting of a sheathing may just be regarded as a routine procedure. In wet drilling, a reduced electrical resistance shortly before the sheathing is reached, ensures that the drilling machine is automatically switched off. In dry drilling, an automatic switch-off device is inserted into the low-voltage circuit between drill hammer and the reinforcement. At the least contact between drill hammer bit and metal the drill hammer is switched off.

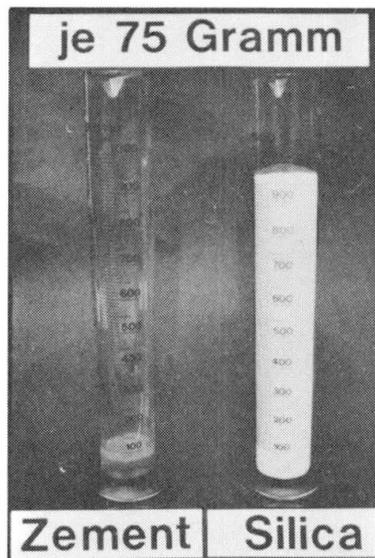
Fig.7 Comparison of volume

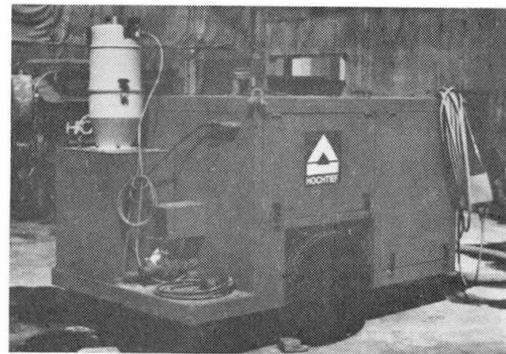
Fig.8 Batching device for loading the compressed air flow with synthetic silicic acid of $200 \text{ m}^2/\text{g}$ fineness.

We use synthetic amorphous silica, with a degree of purity of more than 98 %.

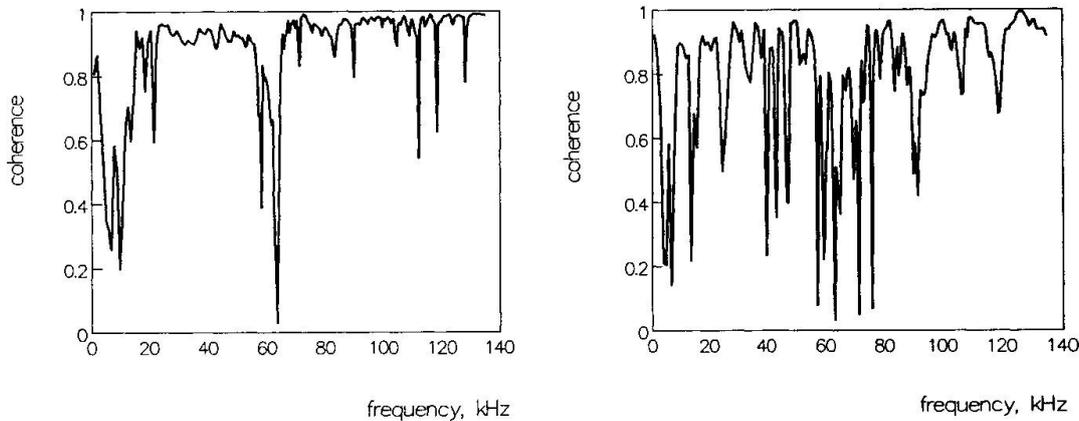
Fig. 3: Coherence functions for measurements on specimen number 11 at the initial stage, left, and after 0.8 million load cycles, right.

Apart from the deviations that can be calculated for selected analysis parameters, the reproducibility can be studied by calculation of the averaged coherence function between input and output signals. By this means a picture is obtained of how well the included frequencies are reproduced in all of the received signal. The coherence of the repeated measurements was therefore registered in each measurement stage. Calculated coherence functions for one of the cylinders are shown in Fig. 3 referring to two different occasions.

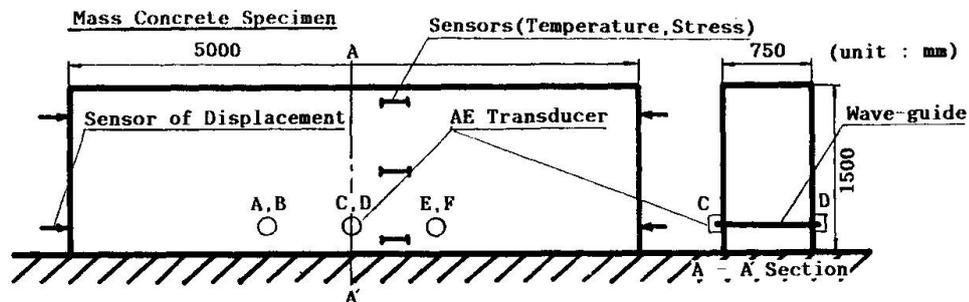
Fig. 1 Mass Concrete Specimen and Locations of Sensors

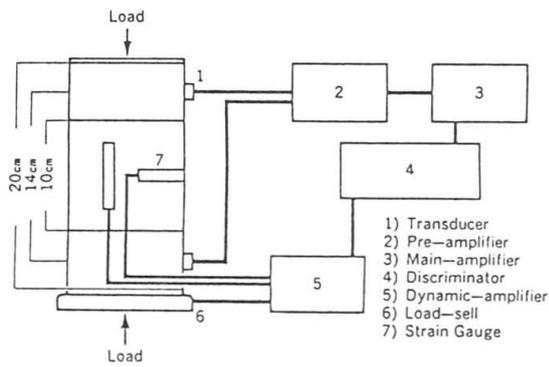
Fig. 5 Uniaxial Compressive Loading System and AE Measurement System

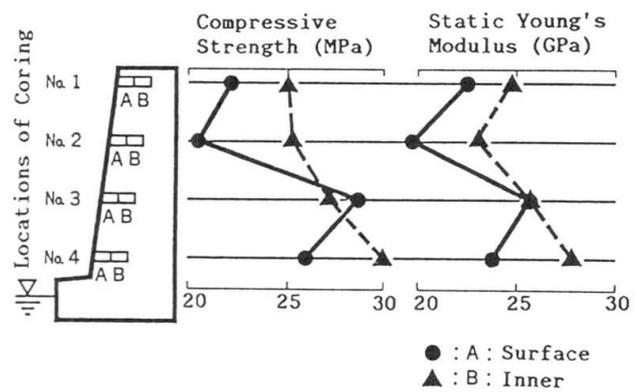
Fig. 4 Compressive Strength and Static Young's Modulus of The Core Specimens

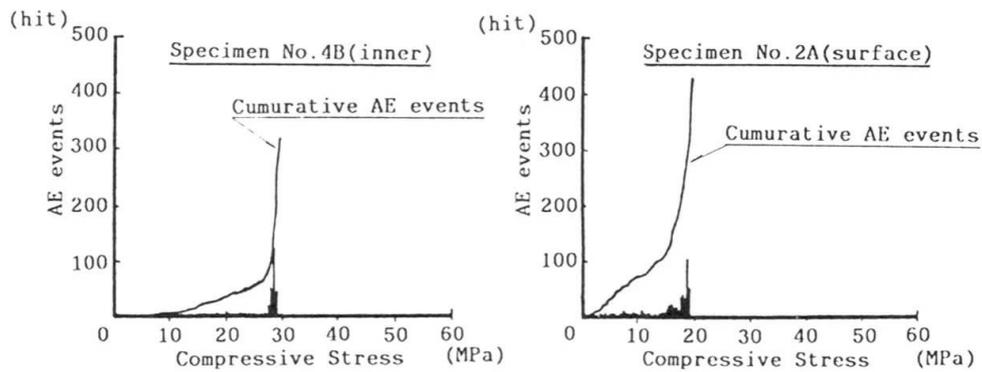
Fig. 6 Relationship between Compressive Stress and AE Events during Uniaxial Compressive Testing

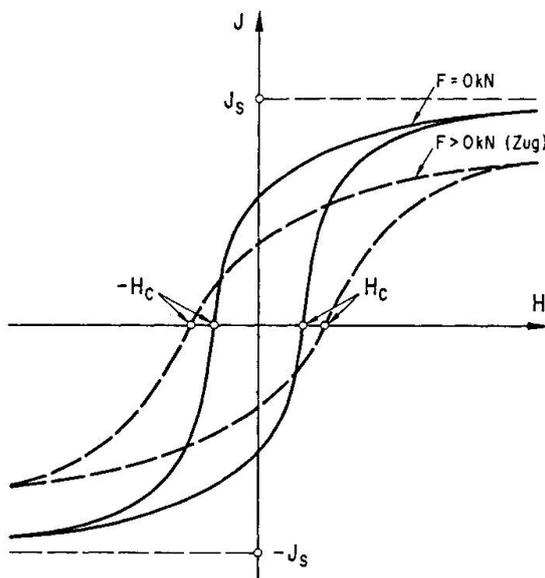
Fig.1 Magnetoelastic effect on prestressing steel

The magnetoelastic effect is based on the principle that the magnetic properties of a ferromagnetic wire change under the influence of a tensile or compressive force. The (J,H) curve which describes the magnetic behavior of a ferromagnetic material is deformed under application of a tensile force (see Fig.1).

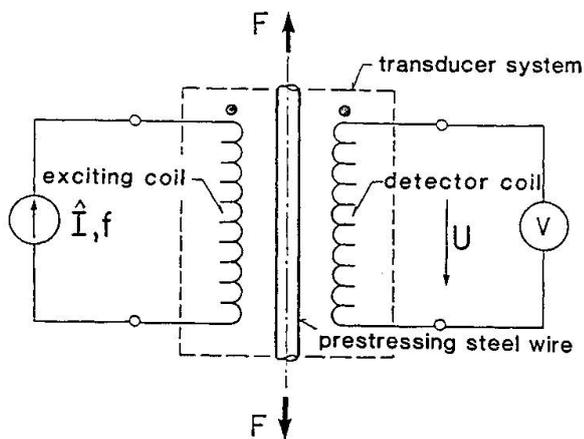
Fig.2 Magnetoelastic F-measurement

An alternating current measurement impulse with a superposed alternating current burst as shown in Fig. 3 is applied to the exciting coil (see Fig. 2). The finite flanks of the measurement pulse limit the amplitude of the induced disturbing impulses in the detector winding. The current impulse at the onset drives the magnetization of the prestressing steel into saturation. This creates a defined working point on the (J,H) curve and serves to improve the repeatability of the measurement. The amplitude is then reduced to a second lower level. The actual measurement begins with the onset of the superimposed sinusoidal oscillation. This sinusoidal current induces a sinusoidal measurement voltage in the detector winding. This is measured with an RMS-voltmeter. The amplitude of the AC voltage at the output of the detector winding will be smaller or larger as a function of the magnitude of the mechanical tensile force in the prestressing steel.

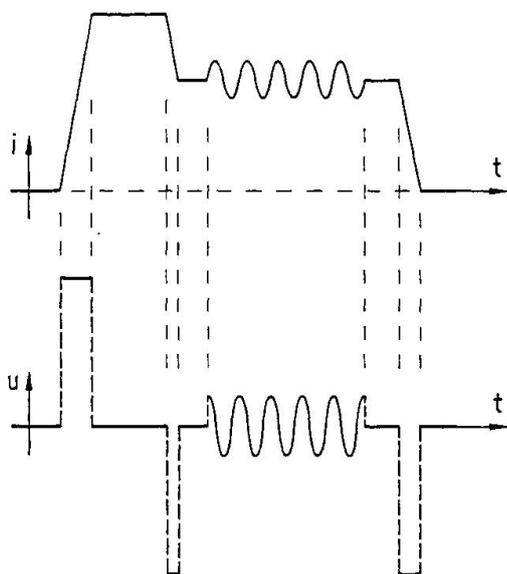
Fig.3 Excitation- and detectionsignal

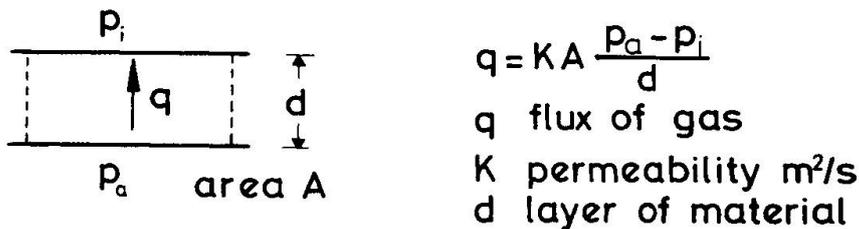
Fig. 1: Hagen-Poiseuille's Law

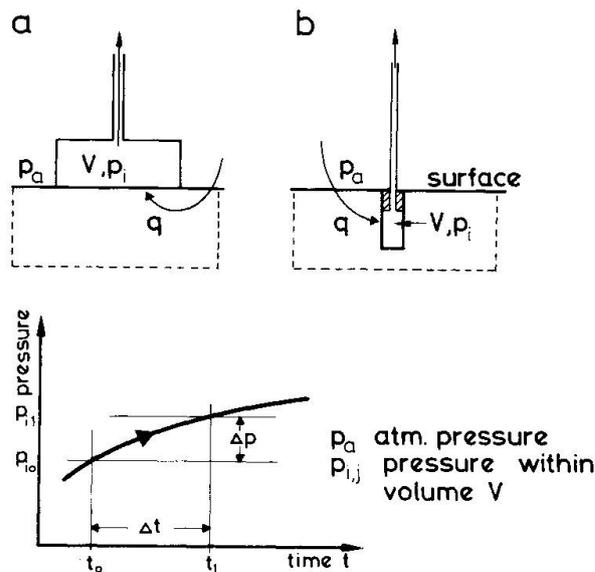
Fig. 2: Permeability test of Schönlin-Hilsdorf (a) and Figg (b)

Permeability testing: These tests are used for the assessment of concrete quality and curing [2], [5]. The driving potential is a pressure difference either below or above the atmospheric pressure (medium: air or nitrogen). The permeability K for the stationary flow of nonsorbent gas is described by the Hagen-Poiseuille law (Fig. 1). The principal set-up of the permeability test of Schönlin-Hilsdorf (a, [2]) and Figg (b, [3]) are shown in Fig. 2. Both methods work in the unsteady pressure range. The lapse of time Δt is measured during which a defined initial pressure $p_{i,0}$ is relaxed by a defined difference Δp of the known gas volume V . The time difference Δt is used to express the permeability index [2].

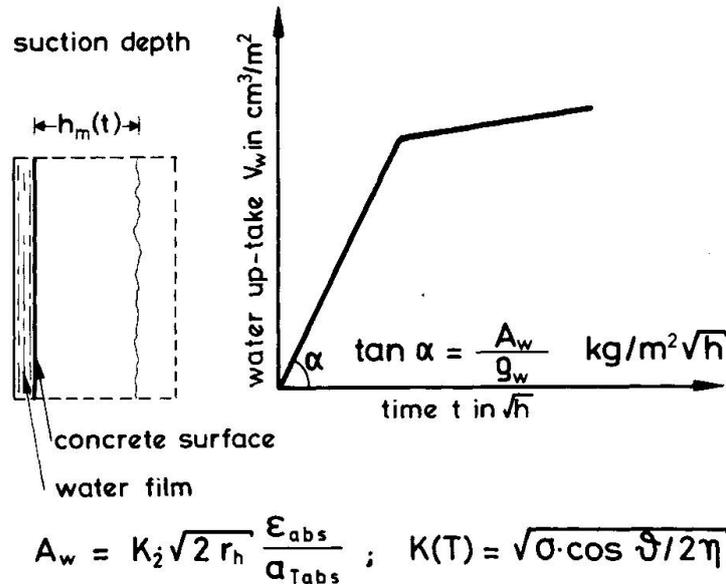
Fig. 3: Capillary water absorption

Absorption tests: These tests serve the same purpose as permeability tests. Their results may also be used for durability prediction [6]. The ingress of water occurs by capillary suction. Transport of water by capillary tension is described by Bernoulli's law. Assuming a one-dimensional flow at the on-set of suction, the volume of water v_w per unit contact area can be expressed by (s. Fig. 3):

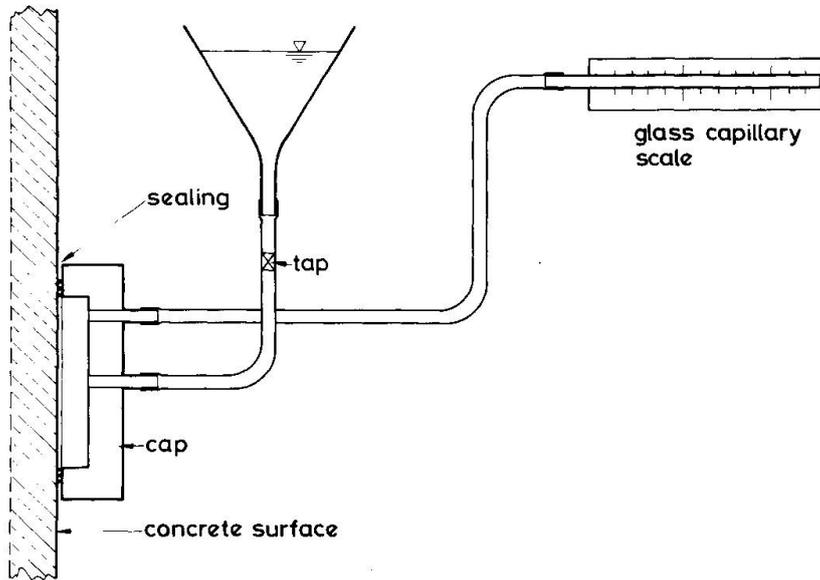
Fig. 4: Set-up of ISAT

test set-up. A cap is sealed onto the concrete surface and then filled with water with a small pressure head. The rate of water intake can be derived from the rate of the retracting meniscus of the scaled glass capillary, after closing the tap. The ISA-value is taken at certain time values t_s .

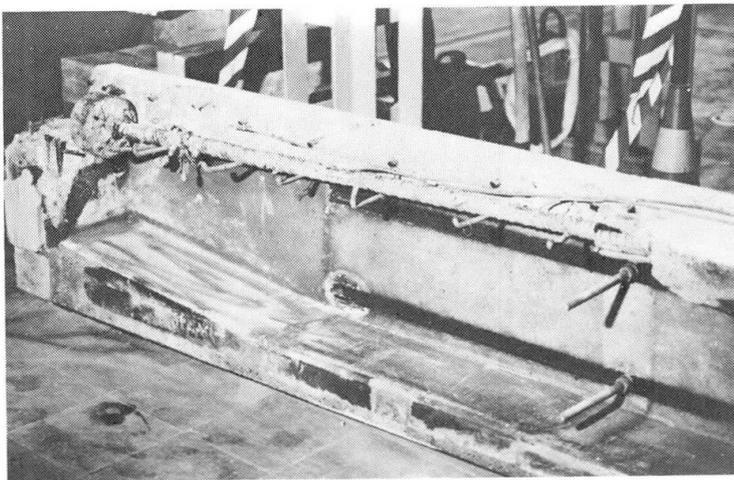
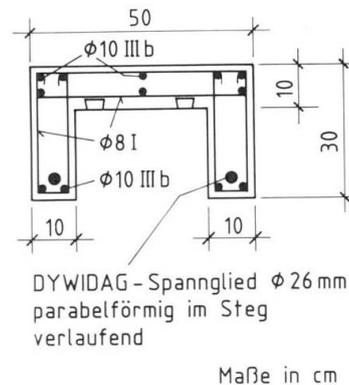
Fig. 2 Abmessungen und Bewehrung sowie Verankerung der Spannglieder

Für die vorgesehenen Prüfungen standen zwei ausgebaute Brückenriegel sowie ein dritter zum gleichen Zeitpunkt hergestellter, jedoch seither in unmittelbarer Nähe der Stadtautobahn eingelagerter Riegel zur Verfügung. Die konstruktive Ausbildung der Bauteile ist aus Fig. 2 zu ersehen.

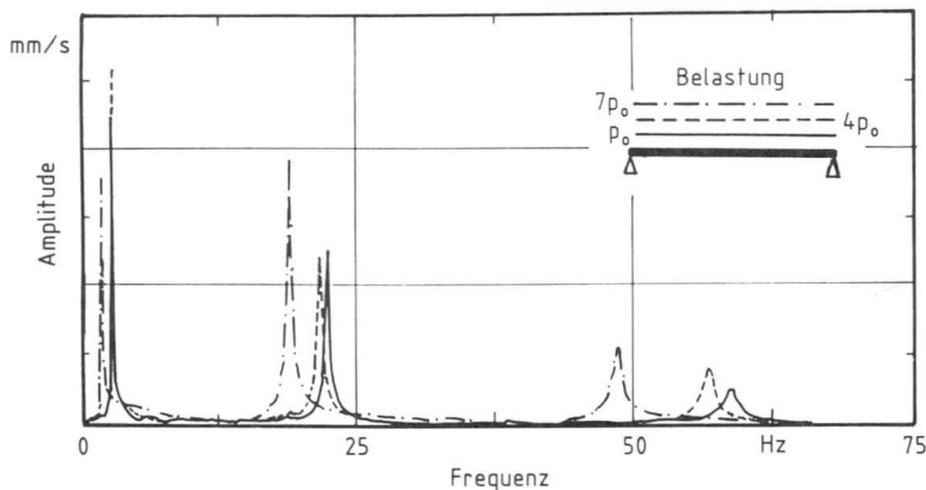
Fig. 6 Veränderung des Schwinggeschwindigkeits-Antwortspektrums in Abhängigkeit vom Grad der Schädigung

Um zukünftig den baulichen Zustand einfacher vorgespannter Tragelemente leichter erfassen zu können, wurde der Träger A3 zusätzlich mit Hilfe eines zerstörungsfreien, auf Schwingungsmessungen basierenden Prüfungsverfahrens [5] untersucht (Fig. 5). Im vorliegenden Fall konnte die zunehmende Schädigung des Trägers und damit die Abnahme der Tragfähigkeit gut aus den gemessenen Antwortspektren abgelesen werden (Fig. 6). Berechnet man aus den Eigenfrequenzveränderungen die Steifigkeitsreduzierung des Gesamtsystems, so ergibt sich in Übereinstimmung mit den Ergebnissen des statischen Versuchs nach dem 1. Versuchsabschnitt ein Wert von ca. 11 % und nach dem 2. Versuchsabschnitt ein Wert von ca. 35-40 %.

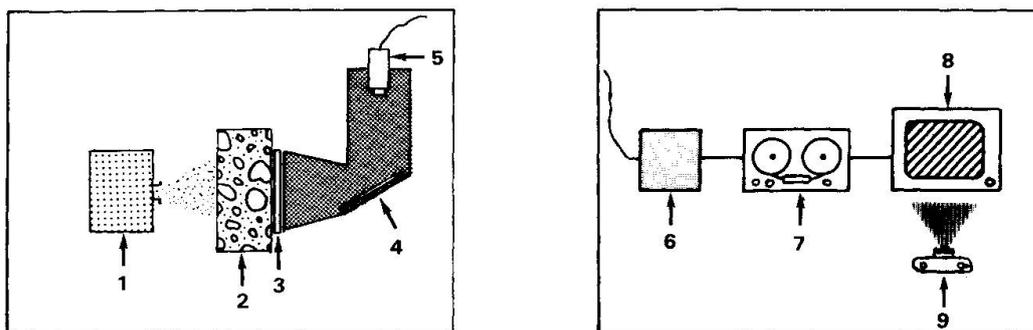
Fig. 1 - Schéma de principe de la chaîne de radioscopie

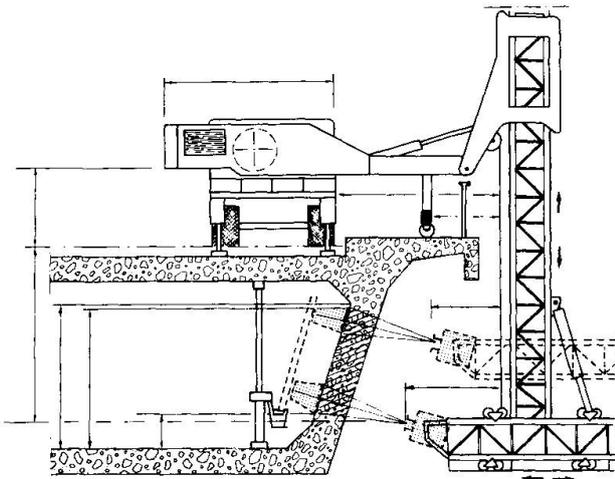
La figure 2 montre la disposition de l'émetteur et du récepteur dont les déplacements sont complètement indépendants. La synchronisation des mouvements est obtenue au niveau des commandes.

Fig. 2 : radioscopie d'une âme de voussoir.

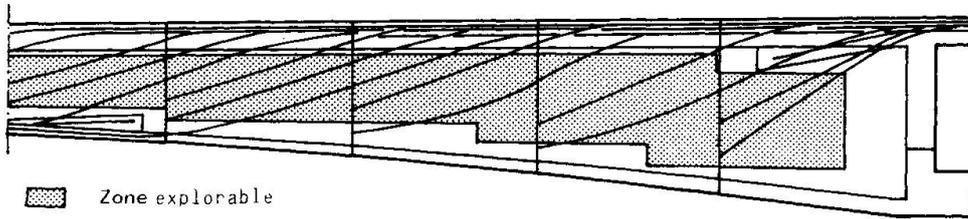
Fig. 3 : Zone explorable sur 5 voussoirs de 3 mètres, soit 30 mètres de câbles

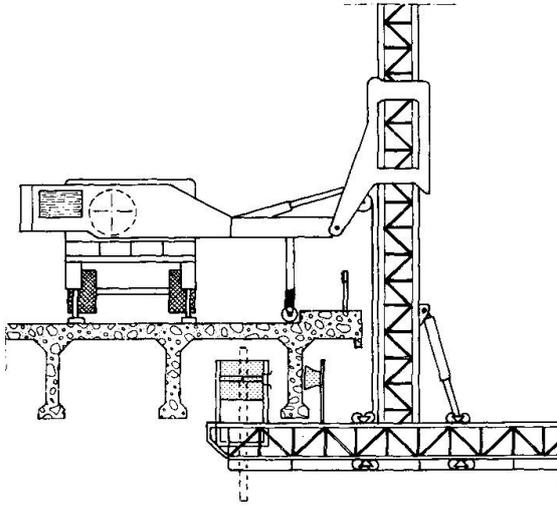
Sur la figure 4 on voit qu'émetteur et récepteur sont portés ensemble par la passerelle. La synchronisation des mouvements en est ainsi simplifiée par rapport à la version précédente. La mise en place est sensiblement plus rapide.

Fig. 4 : radioscopie d'une âme de poutre

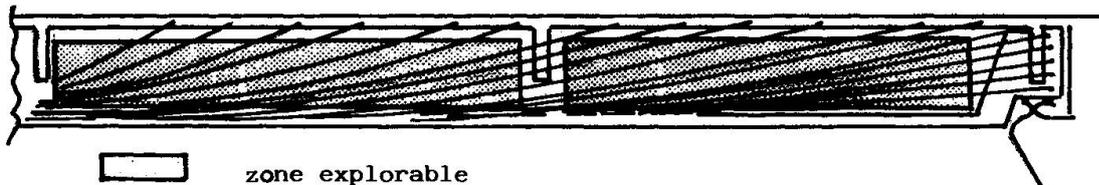
Fig. 5 : Zone explorable sur une âme de poutre
