Zeitschrift: IABSE reports = Rapports AIPC = IVBH Berichte
Band: 57/1/57/2 (1989)

Rubrik: Workshop 2: Life-span considerations

Life Expectancy Studies of Reinforced Concrete Using Microcomputer

Remaining Service Life of Corroding Structures
Durée de vie restante de structures corrodées
Restlebensdauer von korrodierten Stahlbetonbauten

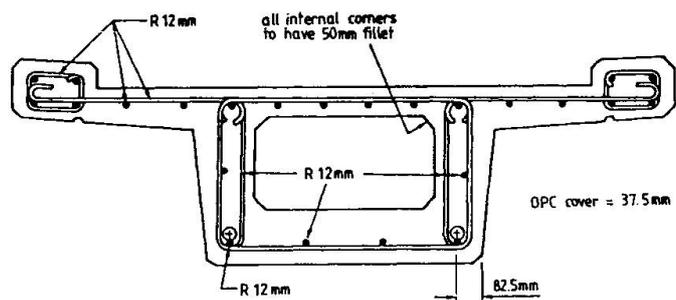
Fig.2 Foot-bridge: X-section

Figure 2 shows a section of the foot-bridge used as the example. For this illustration we shall consider the service life in terms of the deck (slab) only. In order to determine the service life of a structure it is necessary to identify the influencing factors, their actual effects and the respective failure mechanisms. This is called "Failure Mode and Effect Analysis" (FMEA). A check list of the factors, mechanisms and their effects for structures can be obtained from various studies [8]. Corrosion of reinforcement as a result of carbonation of concrete is considered to be the most significant failure mode. Here we shall consider failure mechanisms mainly due to this factor. The effects of the other factors are implicitly included in variables that define the climatic conditions.

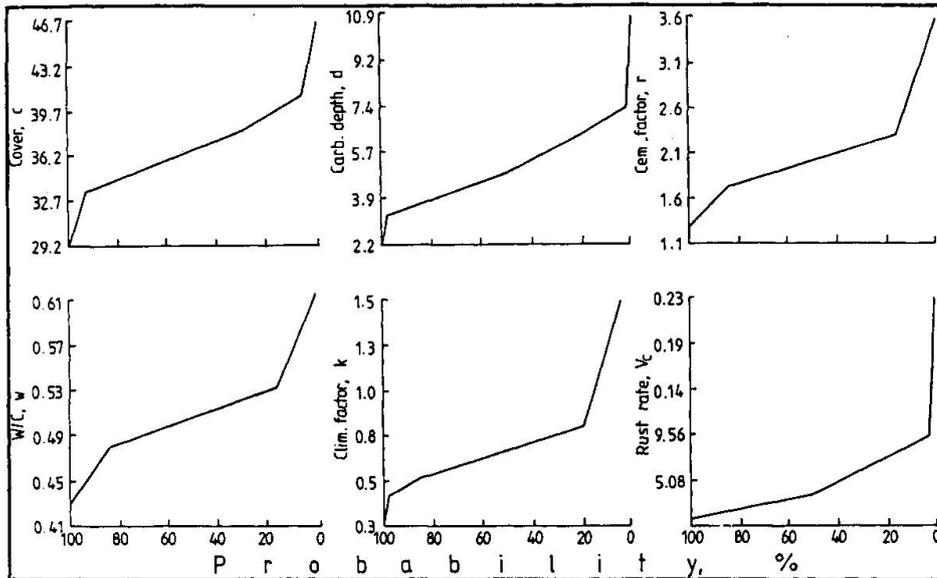
Fig.3 Uncertainty Profiles of variables in Life model

For economy of space the last term is discarded with the assumption that coating will not be employed. Our model now has seven variables. The diameter of bars d_i is considered to be deterministic (12 mm). The uncertainty profiles of the other six are shown in Figure 3. Venture profile of the service life is shown in Figure 4. The sensitivity profile shows the relative importance of the factors. The lengths of the darker bars are scaled to give the variations in the average value of the objective as influenced by changes in the respective uncertainty profiles. The lighter bars give the ratio of the total change in the average value of the objectives to the total change made in the average value of the variable.

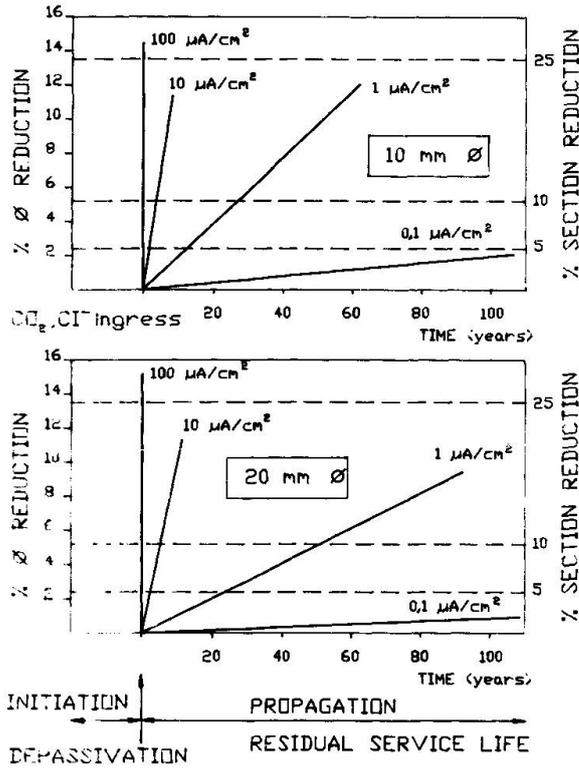
Fig. 1 - Rebar life time in function of its diameter and corrosion rate

Figure 1 is the result of jointly considering all these aspects. This figure allows the approximate calculation of the residual service life in terms of corrosion rates and of the loss in bar cross-section, assuming that this loss in diameter decreases linearly with the corrosion rate. The following relationship may be established from Figure 1.

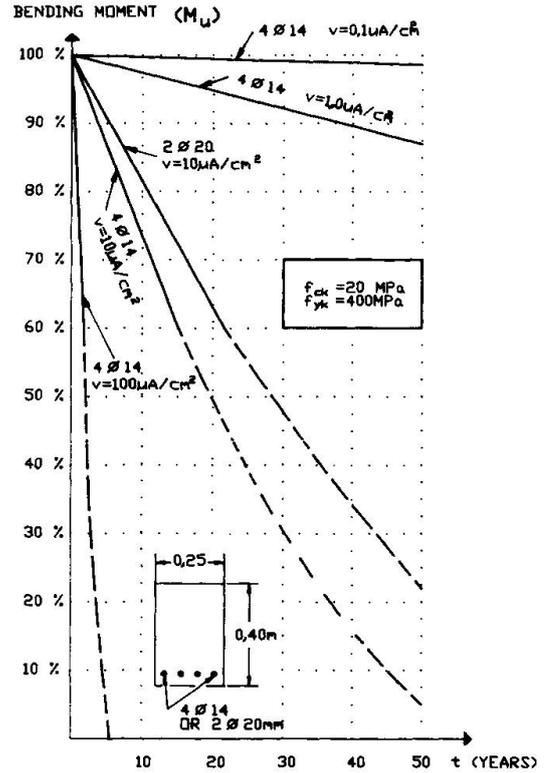
Fig. 2 - Loss in bending moment in function of the corrosion rate

In this way and bearing in mind the conventional hypotheses for reinforced concrete, the curves in figure 2 have been plotted, which show the decrease of the ultimate bending moment in terms of the time elapsed since the beginning of the reinforcement₂ corrosion (propagation time). Thus, while corrosion rates of 0.1 and 1 $\mu\text{A}/\text{cm}^2$ result in a slight decrease of the safety factor along the 50 years of the service life assumed, rates of 10 and 100 $\mu\text{A}/\text{cm}^2$ result in the disappearance of the safety factor in lifetimes of 16 and 2 years respectively, when the sections have been reinforced with 14 mm diameter rebars.

In figure 2, it can also be observed that cross-sections reinforced with higher diameter bars are less sensitive to the damages produced. Thus, with two reinforcements with the same steel ratio but with different₂ bar diameters (4 \emptyset 14 mm and 2 \emptyset 20 mm) and for the same corrosion rate (10 $\mu\text{A}/\text{cm}^2$), the loss of the safety factor is reached at different time lapses of 16 and 22 years, respectively, the corrosion damage being reached at an earlier time in the cross-section reinforced with the 14 mm diameter bar. The interest to use big-size rebars is thus shown in order to delay the damages if an adequate concrete cover is provided.

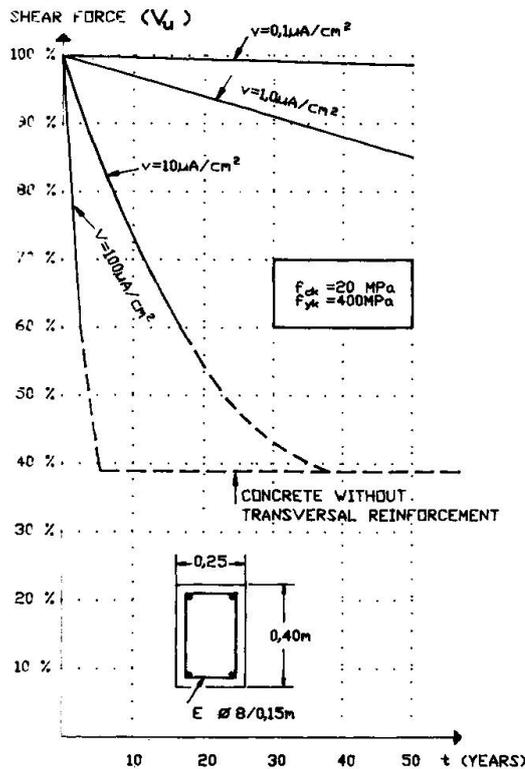
Fig. 3 - Loss in shear force in function of the corrosion rate

The decrease in the ultimate shear force of the same concrete cross-section reinforced with 8.0 mm diameter stirrups, located at 0.15 m distances, has also been investigated for different corrosion rates.

It is assumed that the deterioration of the longitudinal reinforcement is negligible, what may be true, upon the reinforcement having a thicker cover, and that the shear force can be estimated by adding the shear carried by the concrete to the shear analysed by the truss analogy, which consists of the concrete and the longitudinal and transversal reinforcements.

The curves in figure 3 have thus been plotted which show again that corrosion rates of 0.1 and $1 \mu\text{A}/\text{cm}^2$ scarcely impair that value of the shear force along the 50 years lifetime contemplated for the structure, while with corrosion rates of 10 and $100 \mu\text{A}/\text{cm}^2$ the safety factor becomes zero along periods of 15 and 2 years respectively. At the latter two corrosion rates, the web reinforcement collapses along 4 and 35 years periods, and, from that time, the shear force is exclusively carried by the concrete itself and by the longitudinal reinforcement. This situation is somewhat theoretical, since, after these time periods and at these corrosion rates, the derioration of the longitudinal reinforcement must also be quite considerable, and therefore the shear force carried by this reinforcement must also be largely smaller than the shear shown in the horizontal lengths of the curves shown in figure 3.

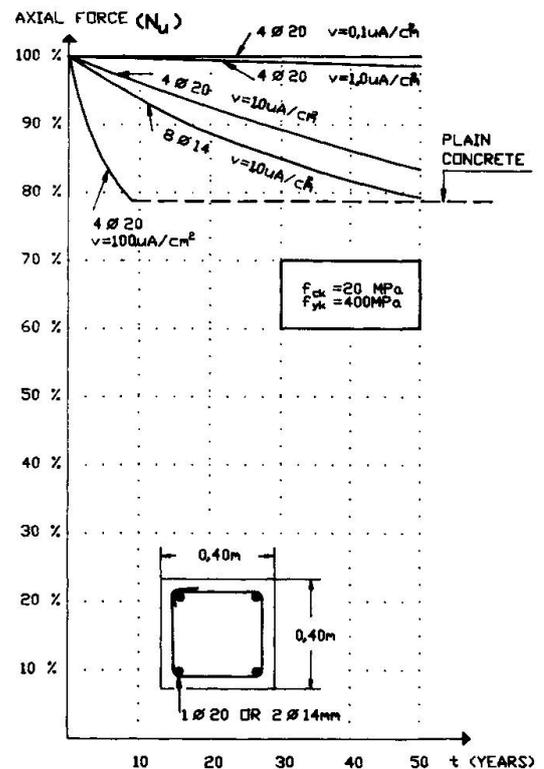
Fig. 4 - Loss in axial force in function of the corrosion rate

Finally, the reduction in the bearing capacity of a 0.40 x 0.40 m cross-section axially loaded, reinforced with rebars at its four corners has also been studied for the same corrosion rates as indicated in the foregoing cases.

The curves plotted in figure 4 shown the evolution of the axial force along the time elapsed from the beginning of the reinforcement corrosion and have been estimated by adding up the axial force carried by the concrete to that carried by the reinforcement. There has not been taken into consideration the possible buckling of the longitudinal reinforcement, when neither the concrete cover nor the transversal reinforcement, also deteriorated can duly brace it.

At the cross-section reinforced with a 20 mm diameter rod at each corner, the damage caused is significative for corrosion rates of $10 \mu\text{A}/\text{cm}^2$, so that, at 50 years life, most of the axial force is virtually carried by concrete alone. For corrosion rates of about $100 \mu\text{A}/\text{cm}^2$, the reinforcement disappears in its entire by before 10 years, so that the axial force is then carried by concrete only.

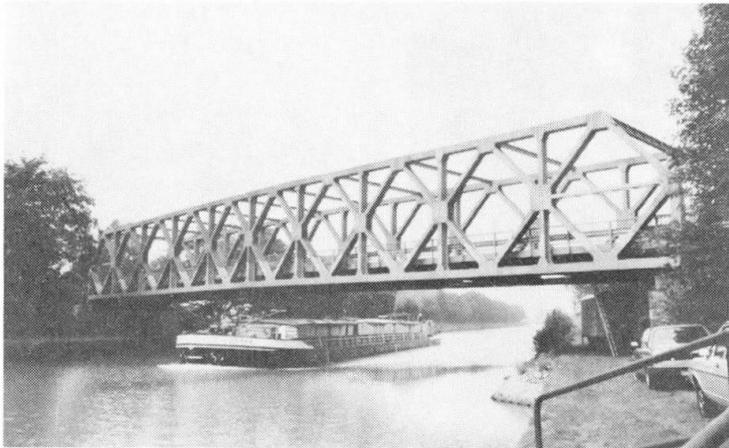
Figure 1.
Riveted highway
bridge of 59 m
span in north-west
Germany

The load bearing elements of the bridge (fig. 1) that crosses the Dortmund-Ems-Kanal near Osnabrück, are outlined in fig. 3. It was built in 1953, the rolled girders were produced in the thirties. During an inspection, cracks have been detected at some of the cross girders near the connection to the principal load bearing elements, trusses of 59 m span (fig. 4). The investigation of the bridge included strain measurements at longitudinal and cross girders under static load and under traffic flow and tests on the

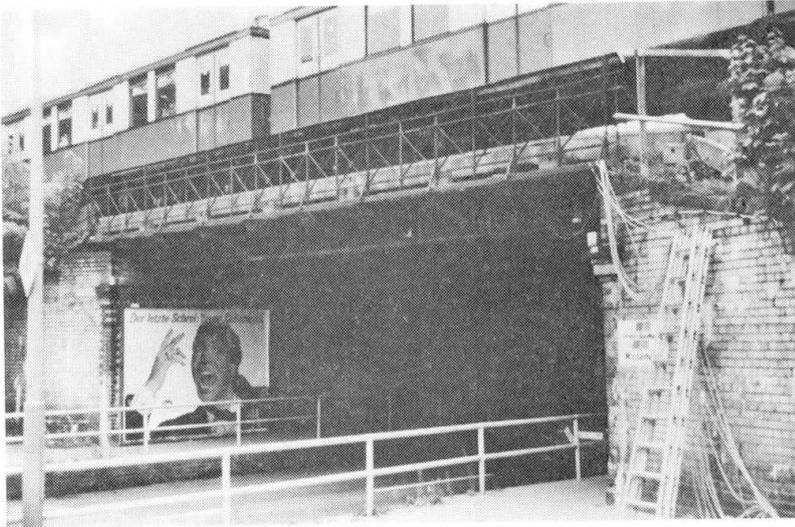
Figure 2.
Girder Bridge of
Berlin Metropol-
itan, replaced in
1988

Before the bridge was removed, we performed strain measurements at several points of the structure, at elements of the main girders and of cross girders. The stresses during the hours of measurement did not reach the cut-off limits of the standardized European Fatigue Strength Curves [6]. However, we do not know accurately which type of traffic passed the bridge during the nearly 100 years of the bridge's life in an eventful history.

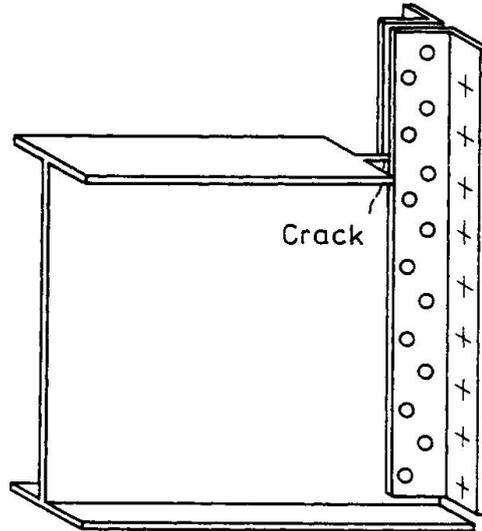
Figure 4.
 Structural detail at the connection of the cross girders to the main truss girder and the location of cracks

The crack growth tests offered the possibility to assess the amount of growing of a crack of a certain length which was not detected during an inspection within the time interval up to the next inspection (3 years). From the measurements, it turned out that the cracks (fig. 4) were caused by residual forces.

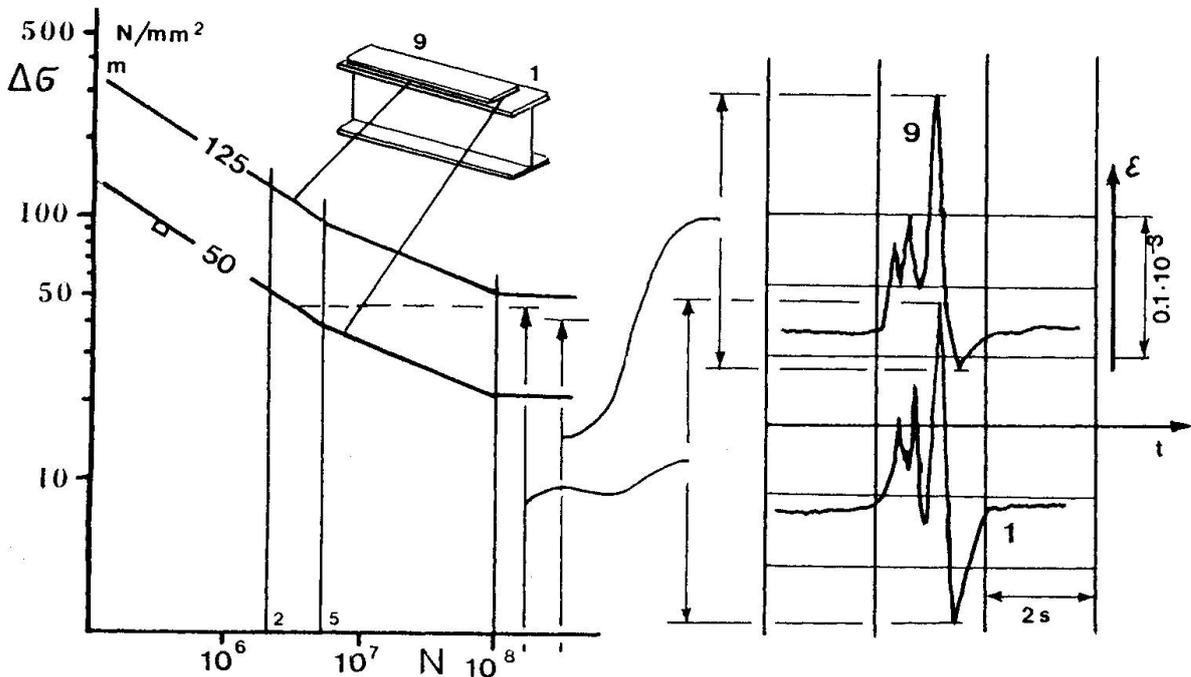
Figure 5 (below).
 Fatigue strength curves (categories 125 and 50) and maximum measured stress cycle at two measuring points at the central longitudinal girder during passing of a heavy vehicle.

material of the structural elements in question. The measurements under defined static load by a two-axle truck of about 20 t weight showed that the calculated stresses at the points of maximum stressing are considerably higher than the measured ones. From the measurements under traffic we obtained that only in very few cases of passing of heavy trucks, stresses exceeded the cut-off limits of the standardized fatigue curves [6] (fig. 5). In addition to the standardized material investigation, we performed crack growth tests on CT-specimens as recommended in ASTM E-647-83. The results in terms of the representing Paris equation (fig. 6)

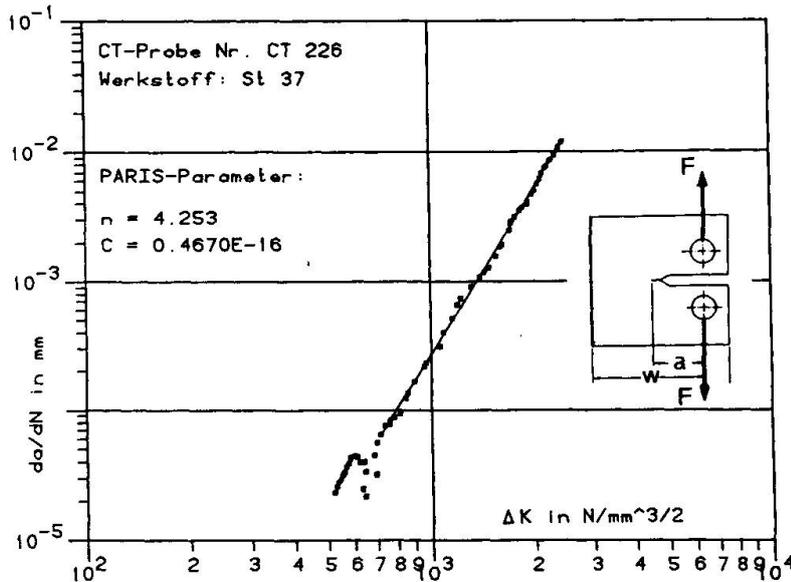
Figure 6:
Diagram of crack growth rate da/dN versus cyclic stress intensity ΔK as elaborated for a compact tension (CCT) specimen (ASTM E 647-83)

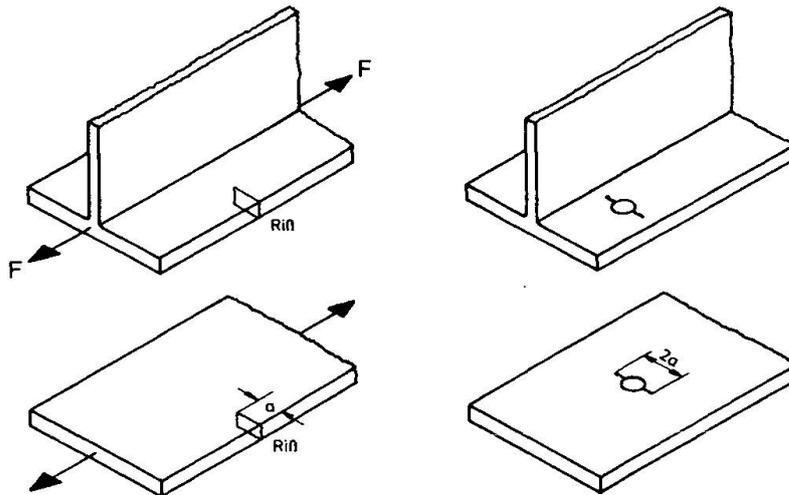
The application of fracture mechanics in the evaluation of remaining fatigue life implies the modelling of cracks in structural elements which can probably occur, fig. 7. The crack growth is only governed by the stress intensity at the crack's tip as expressed by the Paris equation (1). It is an advantage of the concept of fracture mechanics that it leads to a deeper insight into the problem of survival of structural members under cyclic loading than only the application of fatigue strength curves after calculation of cumulative damage by collectives of stresses. Fracture mechanics procedures are recommended when cracks have been observed, because the shape and the dimensions of the cracks are known as well as the surrounding stress fields.

Figure 7:
Crack pattern for
evaluating stress
intensity factors
and crack pro-
pagation

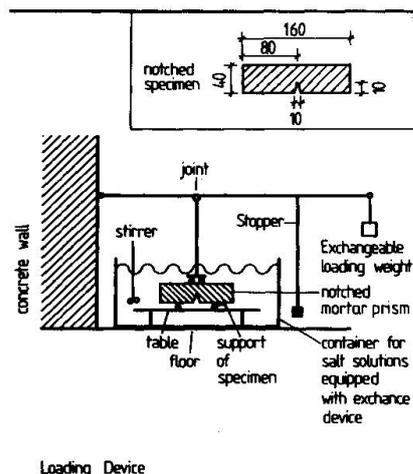
Unloaded specimens were stored in the same containers, so loaded and unloaded specimens were stored in the same solutions and under the same conditions. The load levels applied to the respective series may be taken from table 1, where the test program is summarized.

Fig.1: Loading Device for Stress Corrosion Tests

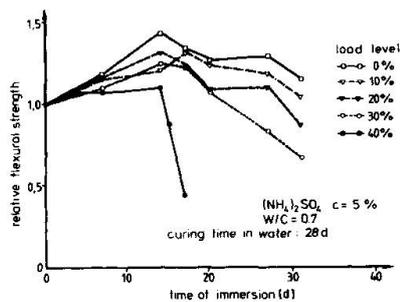
Fig.2: Stress Corrosion of Portland Cement Mortars

Effect of Load on Strength Development of Mortar Prisms

diminished and the deterioration of the specimens occurs at earlier times. At very high load levels no initial strength increase is observed. Thus, stress corrosion leads to a significant decline in flexural strength for loaded specimens compared to unloaded ones. The higher the load the earlier failure occurs. Similar results are obtained for other media [2,3,5]. Thus it may be concluded, that cementitious materials are subjected to stress corrosion in many common aggressive aqueous solutions.

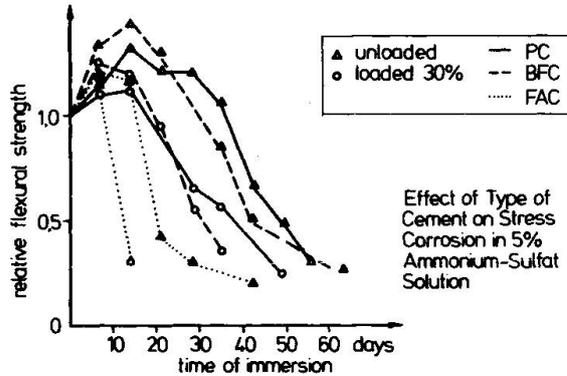
Fig. 3: Effect of Type of Cement on Stress Corrosion of Mortars

The type of cement affects the life time i.e. in ammonium sulfate solution the portland cement and the blast furnace slag cement specimens show a higher life time compared to the fly ash cement specimens respectively, because in the corrosion times involved the higher $\text{Ca}(\text{OH})_2$ content of the portland cement and the blast furnace slag cement pastes acts as a buffer. The strength decline is most pronounced for the fly ash cement. For the loaded specimens the same behaviour is observed. Portland cement and blast furnace slag cement show nearly the same strength decline with immersion time, whereas the fly ash cement shows very rapid failure. Thus, in stress corrosion the effect of the type of cement is the same as in ordinary corrosion of cementitious materials.

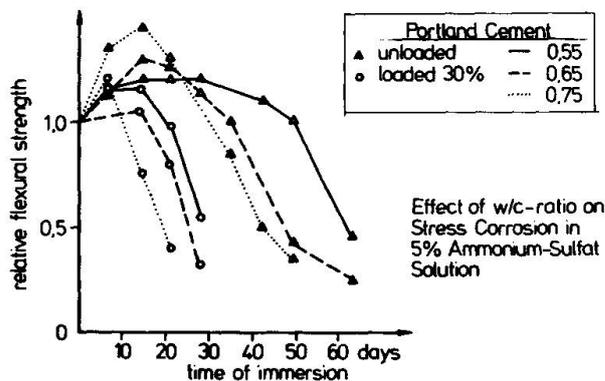
Fig.4: Effect of W/C-Ratio on Stress Corrosion of Portland Cement Mortars

more distinct with increasing w/c-ratio for loaded and unloaded specimens. Thus, in general the effect of w/c-ratio on stress corrosion is the same as during ordinary corrosion without mechanical stresses. However, when a mechanical stress is superimposed onto the chemical stress the differences in strength development seem to become smaller than those observed with unloaded specimens. Furthermore, it can be seen from fig's. 4 and 5 that the initial increase in strength increases with increasing w/c-ratio, i.e. with increasing capillary porosity. This is an indication that the initial strength increase of mortar specimens stored in ammonium sulfate solution is due to the formation of new phases inside the pore volume.

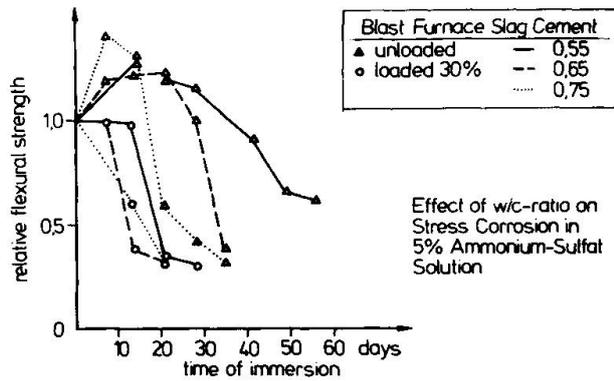
Fig.5: Effect of W/C-Ratio on Stress Corrosion of Blast Furnace Slag Cement Mortars

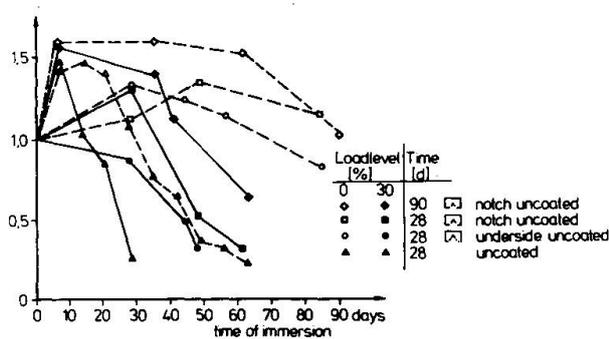
Fig. 6: Effect of Coated Mortar Prisms under Stress Corrosion 5% Ammonium-Sulfat Solution

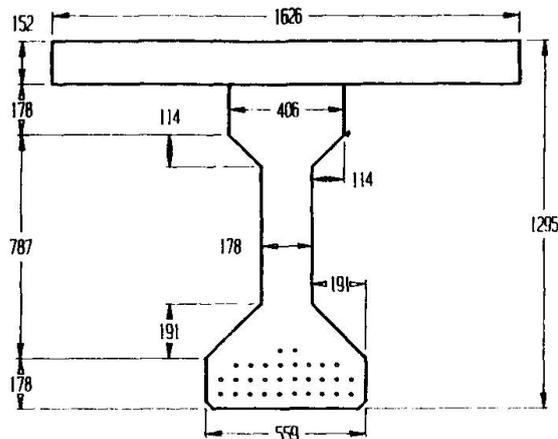
Figure 1 - Girder dimensions (in mm)

The girders are standard AASHTO-PCI Type III girders, and details of the girders are shown in Figure 1. The girders were 1143 mm. deep, 19.71 m. long, prestressed with thirty 13 mm. diameter 1724 MPa stress-relieved strands. Twenty-two of the strands had a straight profile in the bottom flange of the girders. The remaining eight strands were draped; the two hold-down points were located 1525 mm. either side of centerline. The strands were initially stressed to a design prestressing level of 1206 MPa. The construction records indicate that the girders were pulled to approximately 2 percent over this design prestress.

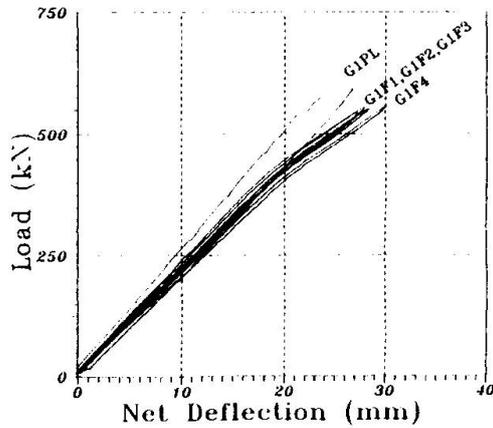
Figure 2 - Load-deflection for G1

The results of the tests on the first two specimens indicated that fatigue loading which produces strand stress ranges of less than 104 MPa has little or no effect on the ultimate strength and ductility of the member. The size of these girders and their close spacing in the field means that very little damage could have been done by fatigue since the sections were uncracked during their service life. The stress range in service was probably less than 20 MPa.

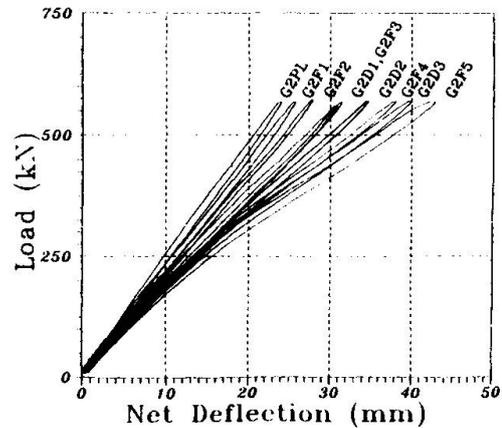
strands to simulate damage due to impact from a truck travelling underneath the bridge (G2D1). The beam was then subjected to fatigue loading (G2F3). Two bottom strands were then cut to simulate additional damage (G2D2), and the girder was fatigued again (G2F4). After this two more strands were cut (G2D3) and the fatigue load repeated (G2F5 and G2F6). One strand broke during G2F4, and at least another during G2F5. Figure 3 shows the load-deflection curves for static tests after each of these runs.

Figure 3 - Load-deflection for G2

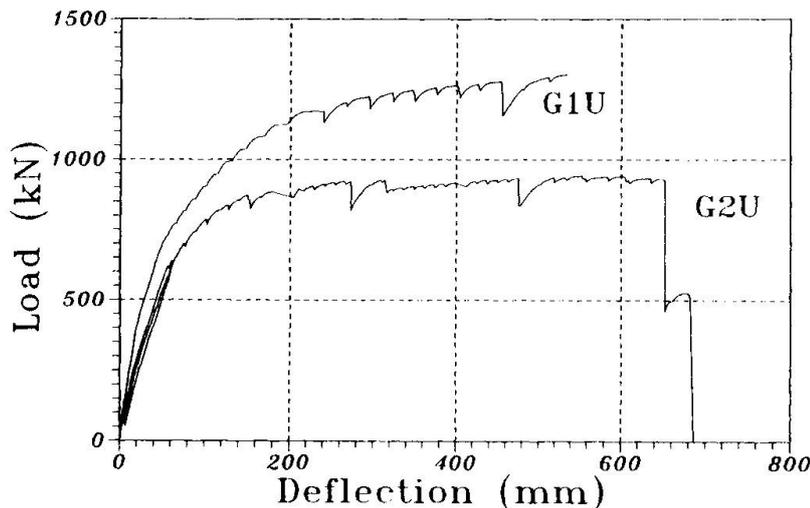
The failure for Girder 2 was similar, except that it occurred at a much lower load (890 kN) and somewhat higher deflection (635 mm.). This was due to: (1) the cutting of the strands and loss of concrete section and (2) fracture of at least two additional strands during G2F4 and G2F5. The cracking in Girder 2 during the last three loading runs was very severe, with large portions of the bottom flange completely separated from the girder.

Figure 4 - Load-deflection curves for ultimate tests.

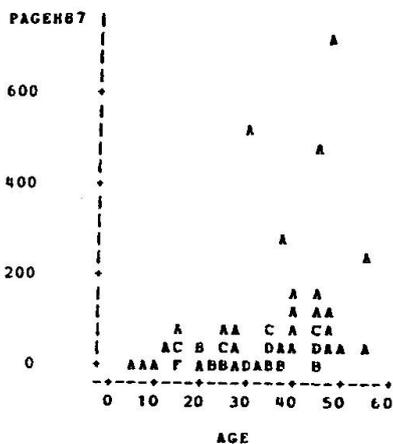
Fig. 3. Actual Age vs. Predicted age

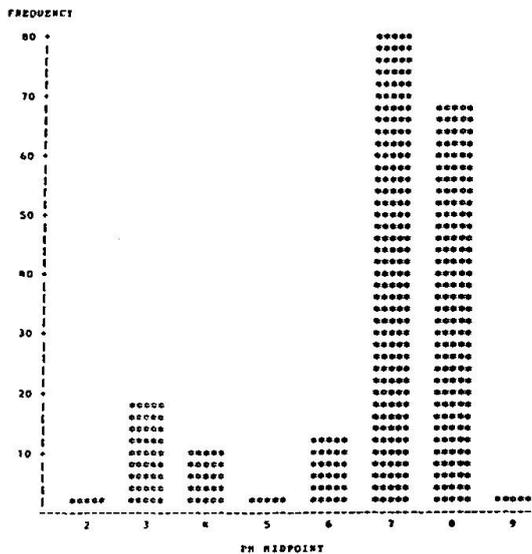
Figure 1. Binodal sample distr.

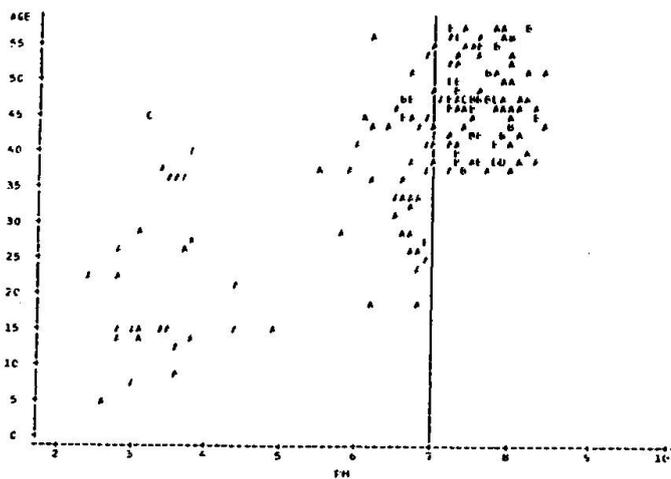
Fig. 2 . Boxing effect of sample data

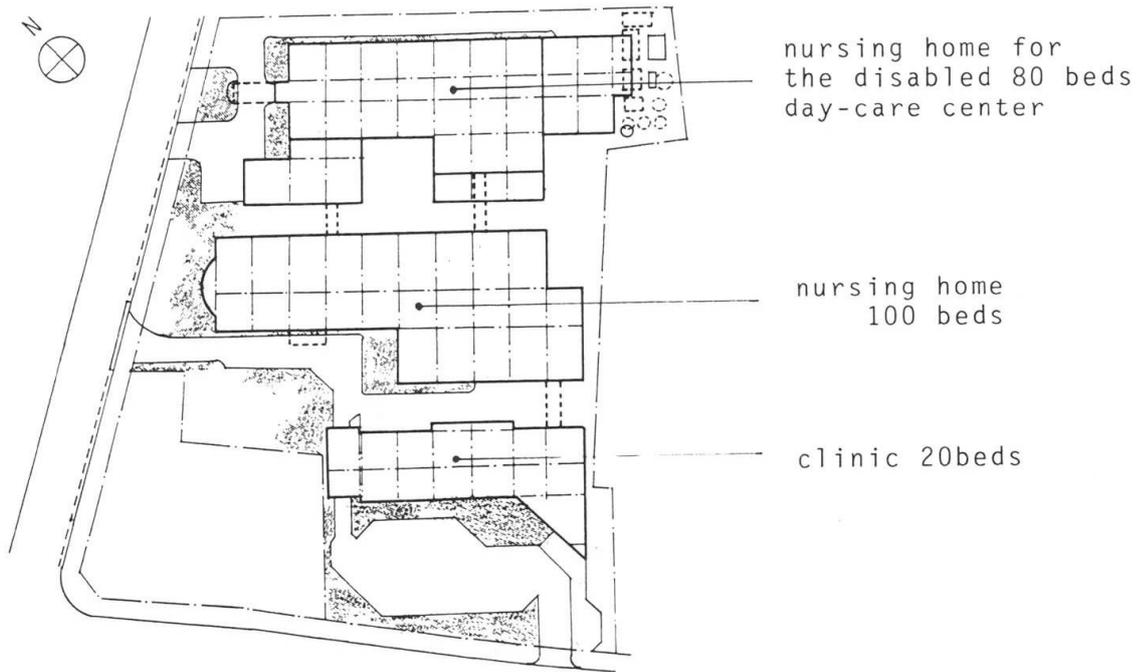
Fig. 1a Site plan of the complex

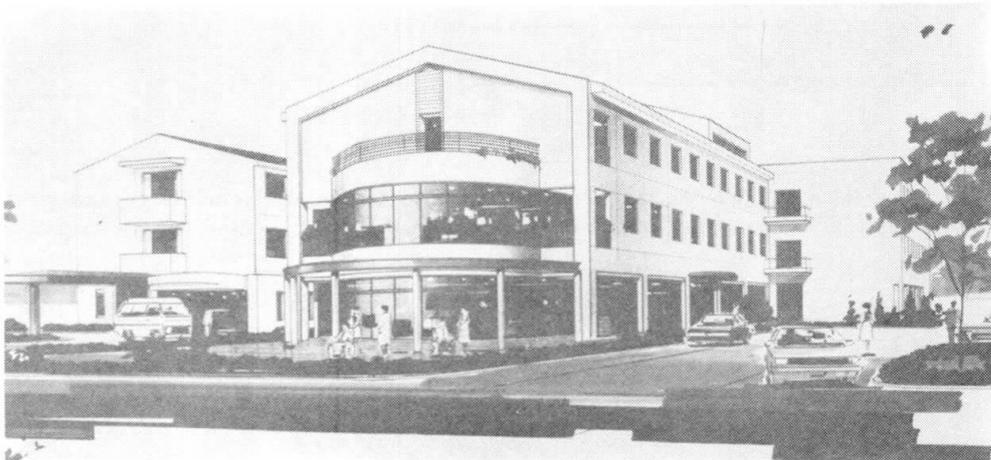
Fig. 1b Perspective of wings

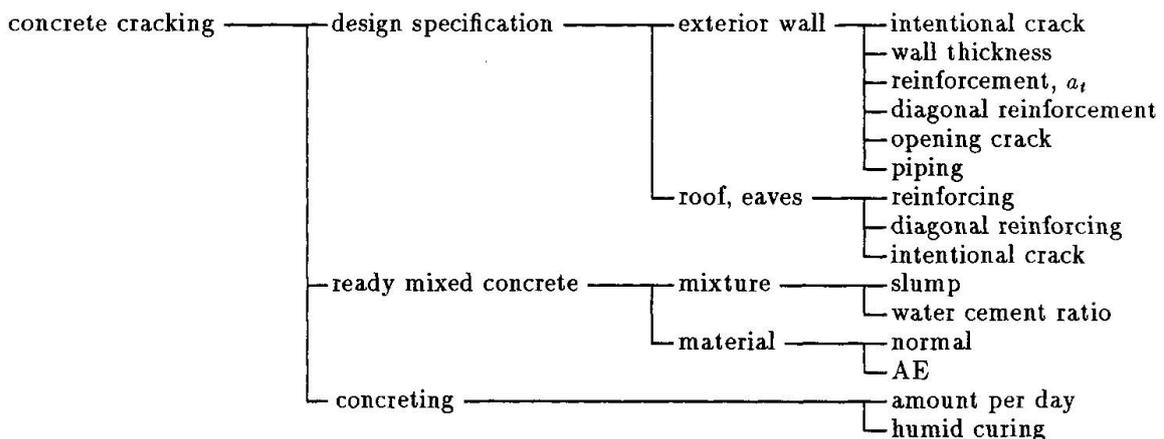
Furthermore, thus classified defects can be deployed more concretely from design and construction point of view. The following is an example of cracks which will be prevented as strictly as possible at each job stage.
