Zeitschrift: IABSE reports = Rapports AIPC = IVBH Berichte
Band: 57/1/57/2 (1989)

Rubrik: Workshop 2: Life-span considerations

Life Expectancy Studies of Reinforced Concrete Using Microcomputer

Remaining Service Life of Corroding Structures

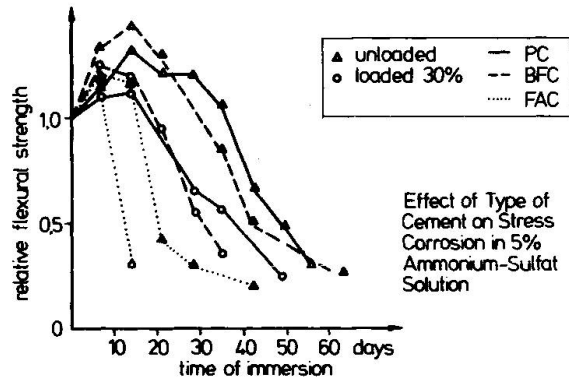
Fig. 3: Effect of Type of Cement on Stress Corrosion of Mortars

The type of cement affects the life time i.e. in ammonium sulfate solution the portland cement and the blast furnace slag cement specimens show a higher life time compared to the fly ash cement specimens respectively, because in the corrosion times involved the higher Ca(OH)_2 content of the portland cement and the blast furnace slag cement pastes acts as a buffer. The strength decline is most pronounced for the fly ash cement. For the loaded specimens the same behaviour is observed. Portland cement and blast furnace slag cement show nearly the same strength decline with immersion time, whereas the fly ash cement shows very rapid failure. Thus, in stress corrosion the effect of the type of cement is the same as in ordinary corrosion of cementitious materials.
