**Zeitschrift:** IABSE reports = Rapports AIPC = IVBH Berichte  
**Band:** 57/1/57/2 (1989)

**Rubrik:** Workshop 2: Life-span considerations

## Life Expectancy Studies of Reinforced Concrete Using Microcomputer

## **Remaining Service Life of Corroding Structures**

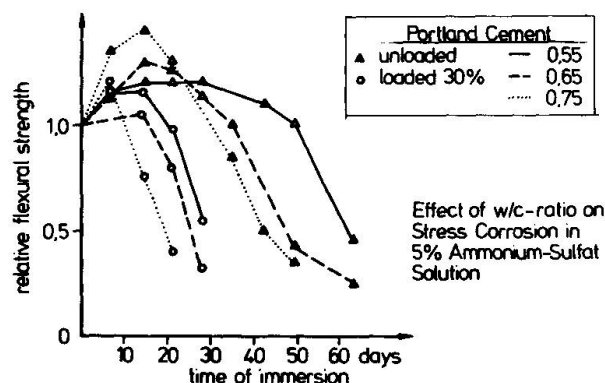
Fig.4: Effect of W/C-Ratio on Stress Corrosion of Portland Cement Mortars

more distinct with increasing w/c-ratio for loaded and unloaded specimens. Thus, in general the effect of w/c-ratio on stress corrosion is the same as during ordinary corrosion without mechanical stresses. However, when a mechanical stress is superimposed onto the chemical stress the differences in strength development seem to become smaller than those observed with unloaded specimens. Furthermore, it can be seen from fig's. 4 and 5 that the initial increase in strength increases with increasing w/c-ratio, i.e. with increasing capillary porosity. This is an indication that the initial strength increase of mortar specimens stored in ammonium sulfate solution is due to the formation of new phases inside the pore volume.

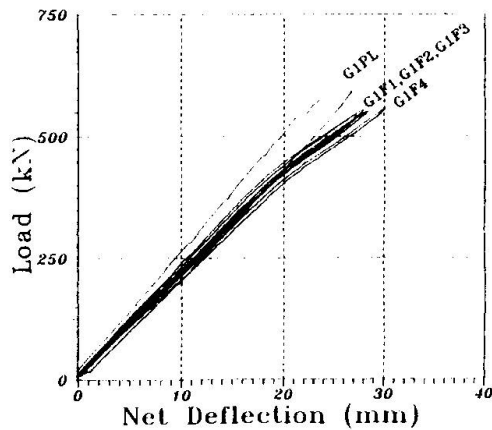
Figure 2 - Load-deflection for G1

The results of the tests on the first two specimens indicated that fatigue loading which produces strand stress ranges of less than 104 MPa has little or no effect on the ultimate strength and ductility of the member. The size of these girders and their close spacing in the field means that very little damage could have been done by fatigue since the sections were uncracked during their service life. The stress range in service was probably less than 20 MPa.

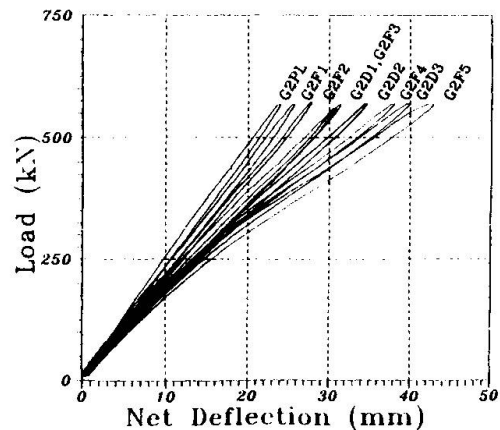
Figure 3 - Load-deflection for G2

strands to simulate damage due to impact from a truck travelling underneath the bridge (G2D1). The beam was then subjected to fatigue loading (G2F3). Two bottom strands were then cut to simulate additional damage (G2D2), and the girder was fatigued again (G2F4). After this two more strands were cut (G2D3) and the fatigue load repeated (G2F5 and G2F6). One strand broke during G2F4, and at least another during G2F5. Figure 3 shows the load-deflection curves for static tests after each of these runs.

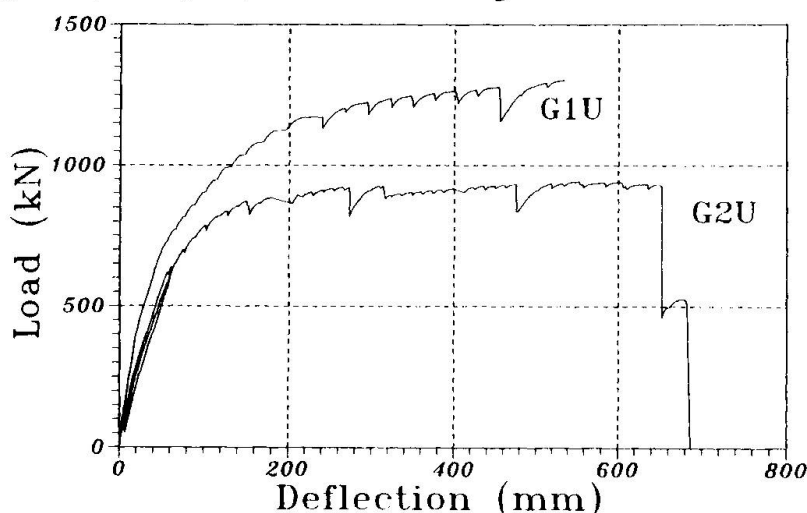
Figure 4 - Load-deflection curves for ultimate tests.

The failure for Girder 2 was similar, except that it occurred at a much lower load (890 kN) and somewhat higher deflection (635 mm.). This was due to: (1) the cutting of the strands and loss of concrete section and (2) fracture of at least two additional strands during G2F4 and G2F5. The cracking in Girder 2 during the last three loading runs was very severe, with large portions of the bottom flange completely separated from the girder.
