**Artikel:** Inspection program for the Lisbon suspension bridge  
**Autor:** Branco, Fernando / Costa, António C. / Azevedo, João  
**DOI:** <https://doi.org/10.5169/seals-44245>

**Inspection Program for the Lisbon Suspension Bridge**  
Programme d'inspection pour le pont suspendu de Lisbonne  
Untersuchungsprogramm für die Hängebrücke in Lissabon

The guidelines of the inspection program for the suspension bridge in Lisbon are presented. The program considered an overall inspection for corrosion and the analysis of the structural behaviour of several elements. The principal findings and the inspection techniques are presented.

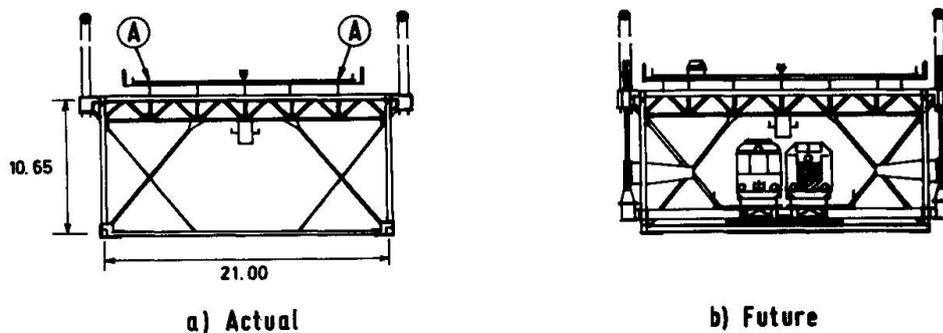
Fig. 2 - DECK CROSS SECTION.

The truss beam is, 10,6m high and 21m wide, suspended from the hangers (23m apart) about 70m above water level. Fig. 2 shows the actual cross section and the future situation with the train. The actual widening design considers the space between the border of the upper deck and the hangers.

At the first stage of the program, the corrosion inspection was implemented. At the columns only superficial corrosion was found, mostly at the interior of the base section. The concrete caissons were also observed and filmed under water to check for concrete degradation, but no relevant findings were obtained. At the cables hangers and cable bands, and with an external observation, only small spots of superficial corrosion were found. Due to the good external condition, an internal observation with electromagnetic techniques was not considered necessary at this stage. All the bars of the deck truss were also inspected and plots of the superficial corrosion along the bridge were drawn for each element (Fig. 3). Structural damage by corrosion was found only in a few nuts of the bolted connections which presented section reductions of more than 20%. It is estimated that about 2% of the deck bolts will need to be replaced shortly. During deck inspection some transversal bars located over the longitudinal girders (shown in Fig. 2 by A). It is estimated that 13% of the total number present this problems.
