Zeitschrift: IABSE reports = Rapports AIPC = IVBH Berichte
Band: 57/1/57/2 (1989)
Rubrik: Session 3: Durability aspects in design, detailing and construction

SESSION 3

DURABILITY ASPECTS IN DESIGN, DETAILING AND CONSTRUCTION

Durability Assessment from the Design Phase to Execution

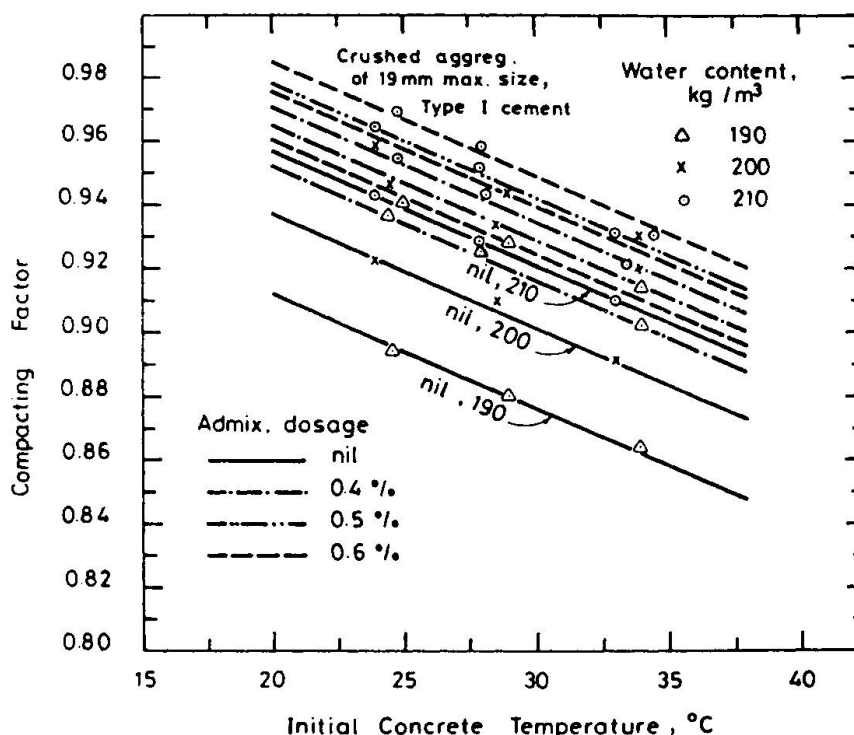
where CF is the compacting factor; T is the initial concrete temperature in degrees Celsius; m is the slope of the line, and k is the intercept.

Fig. 1 Compacting factor as influenced by initial concrete temperature, water content and dosage of retarding/reducing admixture
