Artikel: Maintenance programme of Shinkansen structures
Autor: Isoura, Katsutoshi
DOI: <https://doi.org/10.5169/seals-44279>

Maintenance Programme of Shinkansen Structures Programme d'entretien des ouvrages d'art du Shinkansen Wartungsprogramm für die Shinkansen-Bausubstanz

It is a quart of a century since the Tokaido Shinkansen was opened for public service. The structures that have supported the operation of the bullet train system without any accident are showing signs of deterioration. This paper is intended to describe an outline of the Shinkansen structures and their maintenance inspection system, and to indicate fatigue damages of steel structures and retrofitting programme.

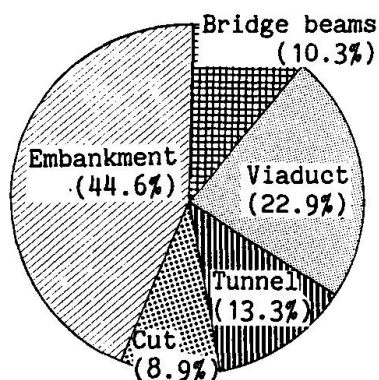
Fig. 1 Ratio of structures

The track structures of the Shinkansen were all designed in grade separation, and therefore include a number of varieties over the entire distance. Fig. 1 shows the ratio among various structures over the whole distance of the Tokaido Shinkansen, and Table 1, the number of bridges by type.

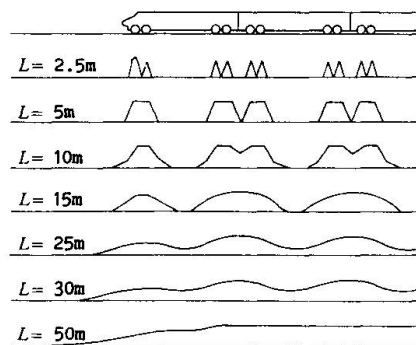
Fig. 3 Stringer stress waveform under train operation

When a Shinkansen train crosses a bridge, the stress variation, as shown in Fig. 3, occurs. In this way, the shorter the span, the more stress repetitions occur. In a stringer of about 2.5m long, for example, separate one stress cycle would

occur for each axle by calculation. In an actual bridge, however, the rail stiffness and the diffusion effect of the ties dampen them to about 50 million for members 6m or less in influence line length, 20 million for those 20m or less and about 3 million for those 25m or more in seventy years. In order to determine the fatigue strength used for design, on the other hand, the following points were studied. The fatigue test was conducted on various joints. As a result, considering that the butt welded joint has a fatigue limit of about 10 million stress cycles (110 MPa), its ratio to the fatigue strength at 2×10^6 (130 MPa) that had been used for design of steel bridges in conventional rail-road systems, that is, $130/110 (=1.18)$ was introduced as a load factor, which was multiplied by the average axle load of the Shinkansen (151kN), thus reaching the design load of 180kN which mentioned above.

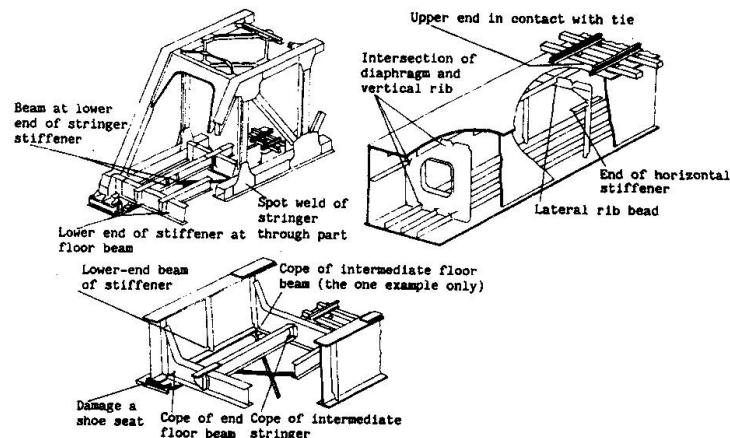
Fig. 4 Outline of damage

In the process of their service, however, some types of fatigue damage have been observed as shown in Fig. 4. Of these types of damage, some fatigue cracks which are comparatively rare in the conventional railroad system, have come up. A fatigue crack has not yet been detected at important portion of main members which lead to catastrophic failure where fatigue was assessed in the design stage. Fatigue cracks are, however, often discovered at such secondary members as side walks, connections of attached facilities and diaphragms or secondary local portions of the main members.

They are in many cases caused by the out-of-plane vibration or displacement of members, settlement of the fulcrum due to failure of the bearing or differential deflection of the main girder affecting stress-concentrated parts such as copes. A retrofitting procedure and improvement detail for some typical damage will be described below.

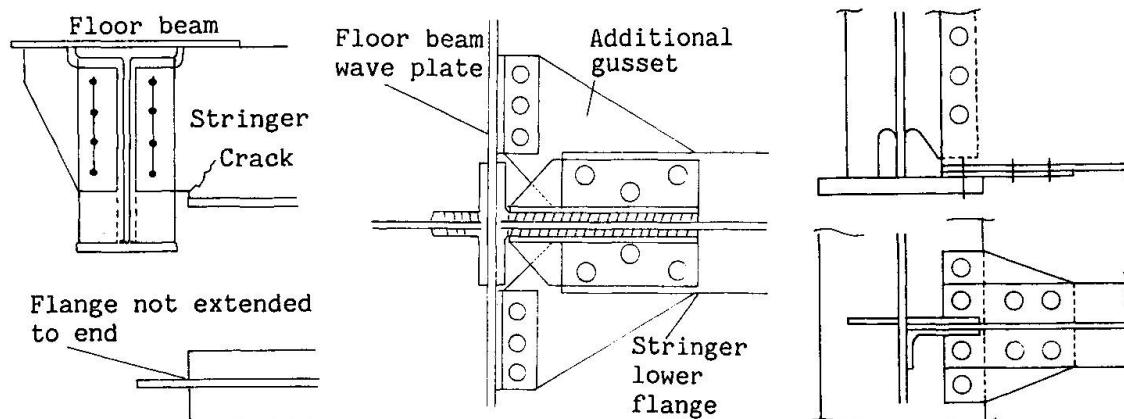
Fig. 8 Crack at stringer web plate

As shown in Fig. 8, this damage is a crack initiated at the stringer web plate of the through plate girder or the through truss bridge.

The stringer is a member which is directly subjected to the train load, and for the great effect of lateral force and impact by train. It is necessary to avoid a local stress concentration by improving the lateral rigidity or keeping the stress flow as continuous as possible. Some bridges employed at the time, however, had a lower flange of the stringer not connected to the floor beam, resulting in a vibration of the stringer. Furthermore, the stress concentration at the cope was combined to lead to cracking.

In order to get rid of this problem, it is necessary to increase the lateral rigidity of the stringer end as well to connect the lower flange with the floor beam web plate by extending the lower flange to the stringer end.

Fig. 10 shows a structural detail of connection of the stringer and floor beam used for subsequent designs.

Fig. 9 Repair drawing of stringer

Fig. 10 Improved details of stringer end

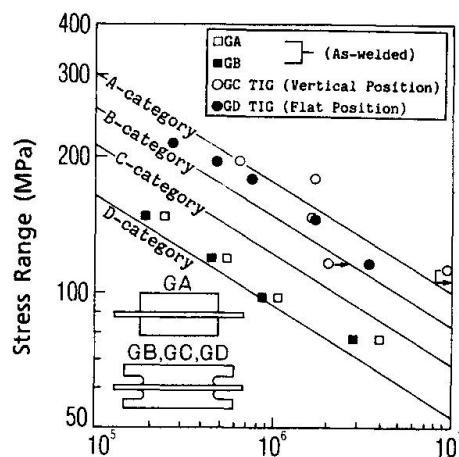
Fig. 16 Results of fatigue test

In order to improve fatigue performance of this transverse fillet welded joint, several methods are available. Among them, we have employed the tungsten inert arc gas (TIG) arc remelting process which is considered most economical for its effect. This welding process is a technique which is used to finish weld toes to smooth shapes by remelting the toes with non-consumable tungsten electrodes. Fig. 16 shows a fatigue test result with the effect of the TIG arc remelting process, indicating a considerably high effect.

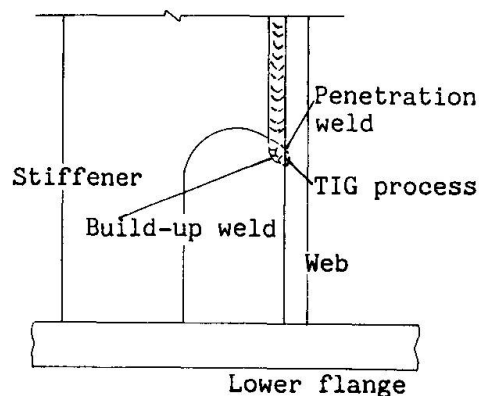
Fig. 17 TIG welding process

Fig. 17 shows an outline of the retrofitting process with TIG arc remelting. About ten thousand joints in actual bridges were finished following by this method.
