Artikel: Maintenance programme of Shinkansen structures

Maintenance Programme of Shinkansen Structures

Katsutoshi ISOURA
Civil Engineer
Central Japan Railway Co.
Tokyo, Japan

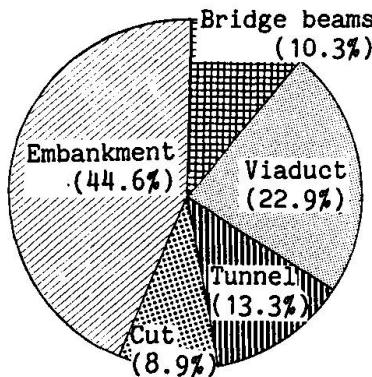
Fig. 1 Ratio of structures

The track structures of the Shinkansen were all designed in grade separation, and therefore include a number of varieties over the entire distance. Fig. 1 shows the ratio among various structures over the whole distance of the Tokaido Shinkansen, and Table 1, the number of bridges by type.

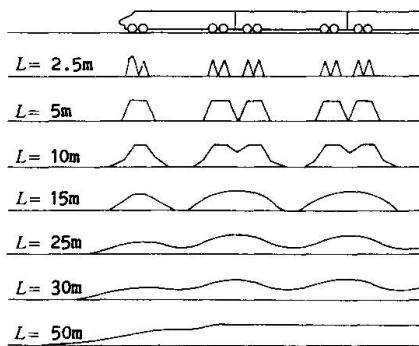
Fig. 3 Stringer stress waveform under train operation

When a Shinkansen train crosses a bridge, the stress variation, as shown in Fig. 3, occurs. In this way, the shorter the span, the more stress repetitions occur. In a stringer of about 2.5m long, for example, separate one stress cycle would

occur for each axle by calculation. In an actual bridge, however, the rail stiffness and the diffusion effect of the ties dampen them to about 50 million for members 6m or less in influence line length, 20 million for those 20m or less and about 3 million for those 25m or more in seventy years. In order to determine the fatigue strength used for design, on the other hand, the following points were studied. The fatigue test was conducted on various joints. As a result, considering that the butt welded joint has a fatigue limit of about 10 million stress cycles (110 MPa), its ratio to the fatigue strength at 2×10^6 (130 MPa) that had been used for design of steel bridges in conventional railroad systems, that is, $130/110 (=1.18)$ was introduced as a load factor, which was multiplied by the average axle load of the Shinkansen (151kN), thus reaching the design load of 180kN which mentioned above.

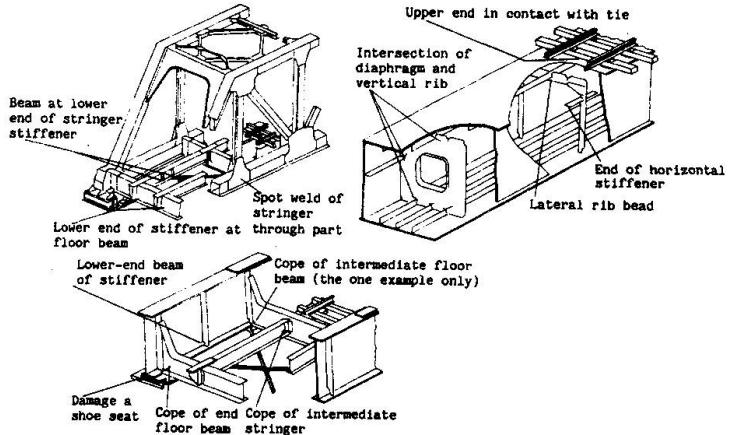
Fig. 4 Outline of damage

In the process of their service, however, some types of fatigue damage have been observed as shown in Fig. 4. Of these types of damage, some fatigue cracks which are comparatively rare in the conventional railroad system, have come up. A fatigue crack has not yet been detected at important portion of main members which lead to catastrophic failure where fatigue was assessed in the design stage. Fatigue cracks are, however, often discovered at such secondary members as side walks, connections of attached facilities and diaphragms or secondary local portions of the main members.

They are in many cases caused by the out-of-plane vibration or displacement of members, settlement of the fulcrum due to failure of the bearing or differential deflection of the main girder affecting stress-concentrated parts such as copes. A retrofitting procedure and improvement detail for some typical damage will be described below.

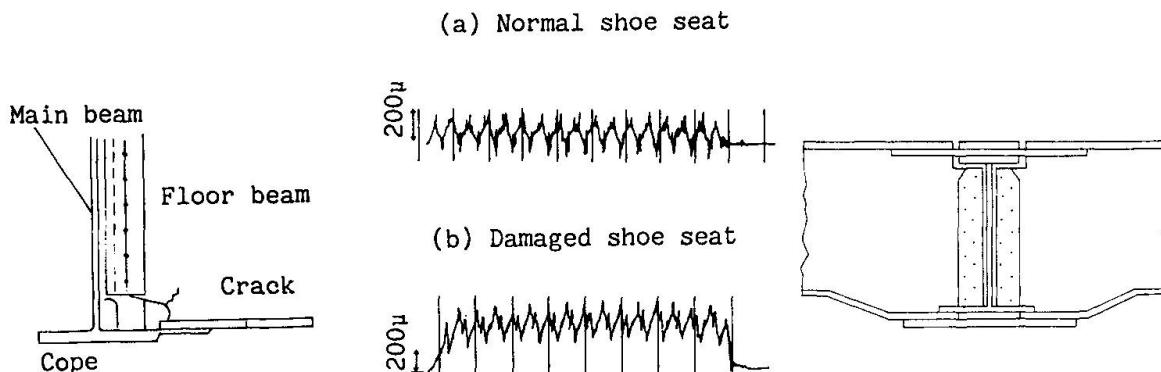
This damage is primarily caused by the settlement of bearing, therefore occurrences are significant in end floor beams. Causes and retrofitting methods were studied through various measurements on actual bridges, structural analysis and fatigue tests. The result described below were obtained.

- (1) The crack was caused by the fact that the end of lower flange of the floor beam was coped to connect with main girder which induced stress concentration. The settlement of supporting point was also one of causes of this fatigue damage. (See Fig. 6)
- (2) By applying an additional plate to the web plate to increase loading capacity, a sufficient reinforcing effect is obtained.
- (3) Based on those experiences the details of the currently designed bridge have been improved as shown in Fig. 7.

Fig. 5 Crack at floor beam cope

Fig. 6 Actually-measured strain waveform of floor beam

Fig. 7 Improved details of floor beam

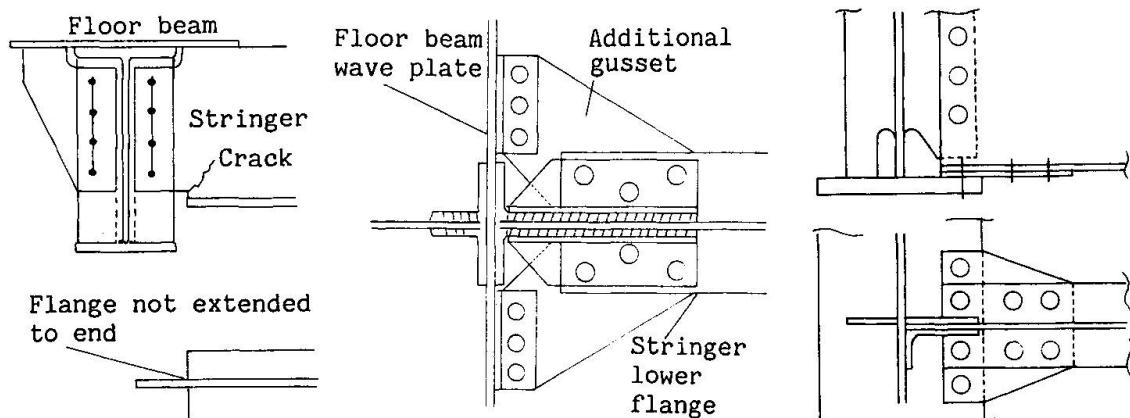
As shown in Fig. 8, this damage is a crack initiated at the stringer web plate of the through plate girder or the through truss bridge.

The stringer is a member which is directly subjected to the train load, and for the great effect of lateral force and impact by train. It is necessary to avoid a local stress concentration by improving the lateral rigidity or keeping the stress flow as continuous as possible. Some bridges employed at the time, however, had a lower flange of the stringer not connected to the floor beam, resulting in a vibration of the stringer. Furthermore, the stress concentration at the cope was combined to lead to cracking.

In order to get rid of this problem, it is necessary to increase the lateral rigidity of the stringer end as well as to connect the lower flange with the floor beam web plate by extending the lower flange to the stringer end.

Fig. 10 shows a structural detail of connection of the stringer and floor beam used for subsequent designs.

Fig. 8 Crack at stringer web plate

Fig. 9 Repair drawing of stringer

Fig. 10 Improved details of stringer end

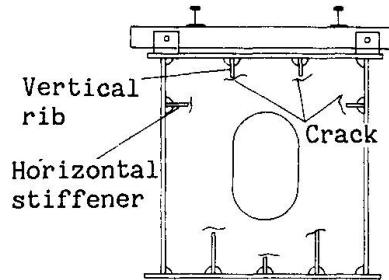
Fig. 11 Crack of box-section diaphragm

In the box-section girder bridge, a diaphragms are provided at intervals of 5 to 6m in order to improve the torsional rigidity. As shown in Fig. 11, fatigue

cracks were observed on the surface of diaphragm at the toe of fillet weld which connected longitudinal rib and diaphragm. The main causes of this phenomenon are high welding residual stress, stress concentration at weld toe and high structural constraint. A diaphragm with such a structural detail appears to develop an out-of-plane vibration with the passage of a train and develops considerable fatigue at the restrained weld.

This damage is repaired by drilling a stop hole at the crack tip, or re-welding after gouging and TIG arc remelted were applied at the toe of fillet welds. Also, in a current design, an out-of-plane vibration-proofing is considered or a diaphragm with a ribs (Fig. 12) is introduced.

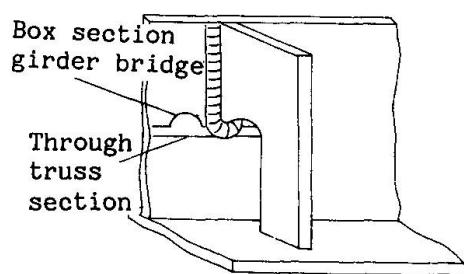
Fig. 14 Progress of cracking

This crack originated primarily at the toe or root of the fillet weld around the lower end of the vertical stiffener and grew horizontally into the base metal of the web plate. Such a crack may sometimes propagate along the weld toe, followed by progress in the direction horizontal to the base metal. Generally, the trend as shown in Fig. 14, is observed for the box-section girder and the truss stringer.

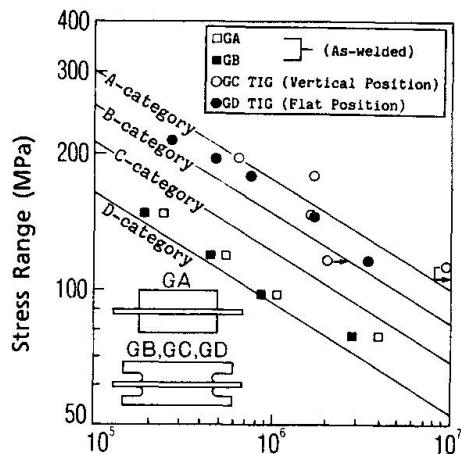
Fig. 16 Results of fatigue test

In order to improve fatigue performance of this transverse fillet welded joint, several methods are available. Among them, we have employed the tungsten inert arc gas (TIG) are remelting process which is considered most economical for its effect. This welding process is a technique which is used to finish weld toes to smooth shapes by remelting the toes with non-consumable tungsten electrodes. Fig. 16 shows a fatigue test result with the effect of the TIG arc remelting process, indicating a considerably high effect.

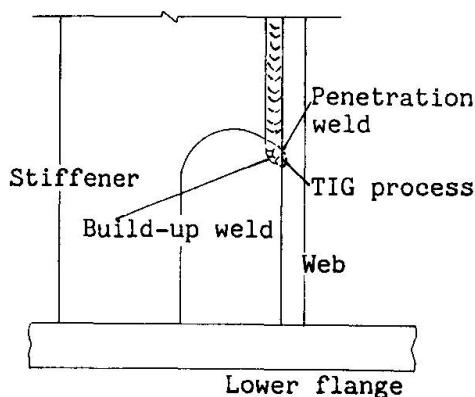
Fig. 17 TIG welding process

Fig. 17 shows an outline of the retrofitting process with TIG arc remelting. About ten thousand joints in actual bridges were finished following by this method.
