Artikel: Maintenance programme of Shinkansen structures
Autor: Isoura, Katsutoshi
DOI: <https://doi.org/10.5169/seals-44279>

Maintenance Programme of Shinkansen Structures
Programme d'entretien des ouvrages d'art du Shinkansen
Wartungsprogramm für die Shinkansen-Bausubstanz

Katsutoshi ISOURA
Civil Engineer
Central Japan Railway Co.
Tokyo, Japan

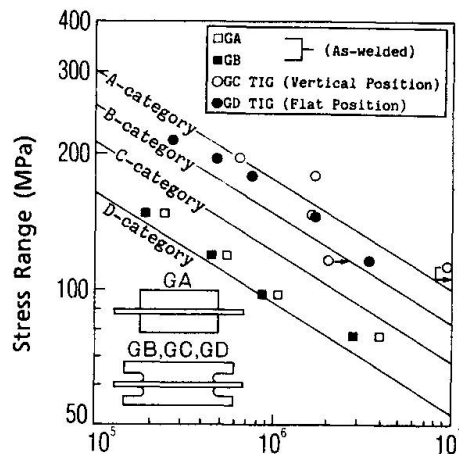
Fig. 16 Results of fatigue test

In order to improve fatigue performance of this transverse fillet welded joint, several methods are available. Among them, we have employed the tungsten inert arc gas (TIG) arc remelting process which is considered most economical for its effect. This welding process is a technique which is used to finish weld toes to smooth shapes by remelting the toes with non-consumable tungsten electrodes. Fig. 16 shows a fatigue test result with the effect of the TIG arc remelting process, indicating a considerably high effect.
