**Zeitschrift:** IABSE reports = Rapports AIPC = IVBH Berichte

**Band:** 57/1/57/2 (1989)

**Rubrik:** Presentation Session 1: General durability aspects

## Durability Research as an Investment Strategy

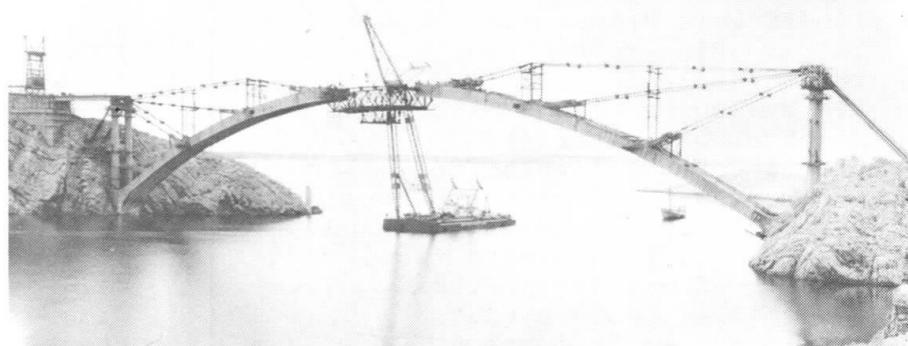
Fig 2. Reinforced concrete arch of Pag Island bridge during construction

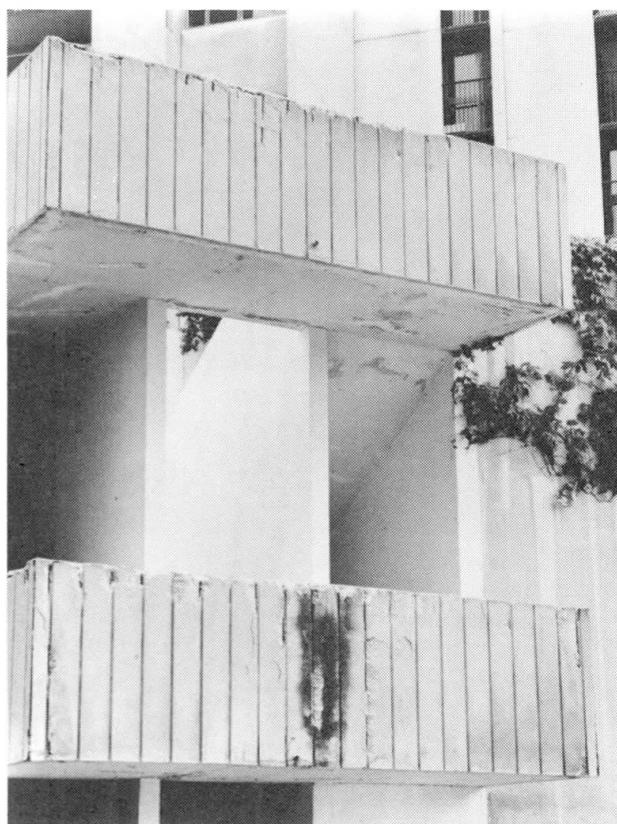
Fig.2 Béton mal traité

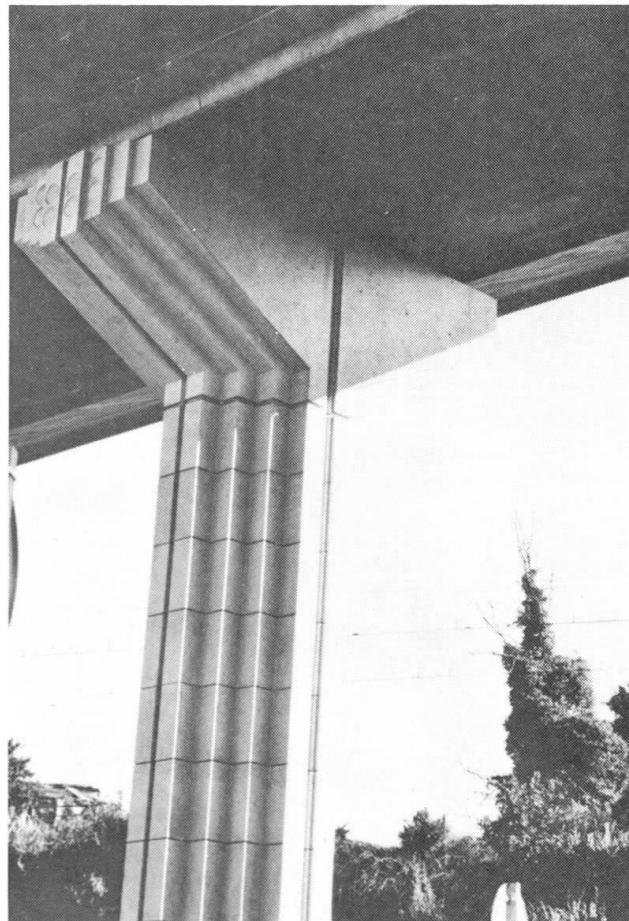
Fig.4 Pile soignée
