Zeitschrift: IABSE reports = Rapports AIPC = IVBH Berichte
Band: 57/1/57/2 (1989)

Rubrik: Presentation Session 4b: Assessment of structures

Expert System for Serviceability Rating of Concrete Bridges

A Strategy for Structures Suffering Fatigue Cracking

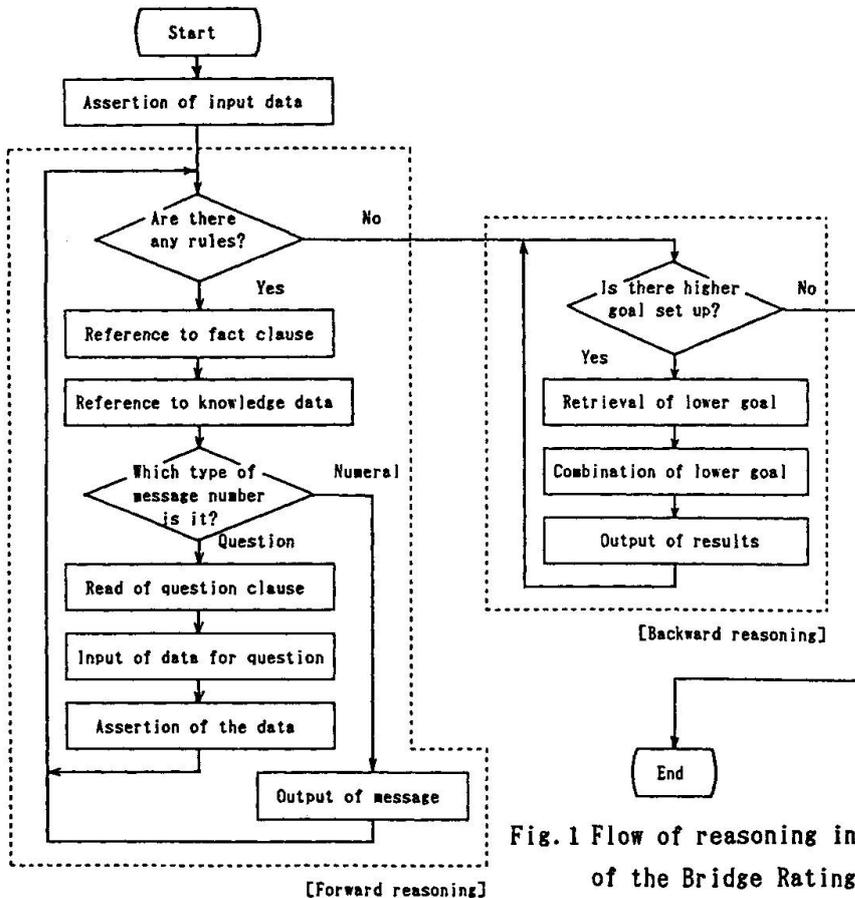
Fig.1 Flow of reasoning in inference engine of the Bridge Rating Expert System

Both forward and backward reasoning are used as the inference engine in the present expert system. The flow of reasoning in the inference engine of the expert system is shown in Fig.1[3]. The inference is performed separately on the slab and the main girder of a target bridge aiming at the diagnosis of the serviceability as a final goal along the flow of Fig.1. Therefore, two kinds of knowledge-base system are prepared for slabs and main girders, and are read immediately before diagnosis starts. In the flow of inferences shown in Fig.1, the forward reasoning process will continue until the arrival at the data item(basic factor) stage, for which the advanced inferences are difficult to perform. For example, an answer of "yes" or "no" for the deposition of free lime in reinforced concrete bridges halts any further inference. For such items(basic factors), suitable basic probabilities are assigned as an opinion from a series of knowledge fields and are joined

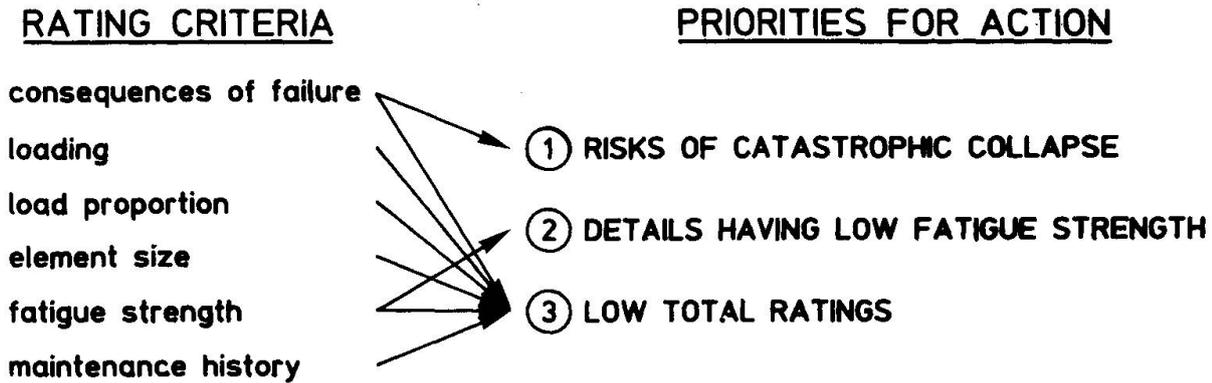
FIGURE 1 : Rating criteria and the use of ratings for setting priorities.

A list of the criteria used to rate fatigue-critical details is given in Figure 1. The most important criterion is the rating associated with the CONSEQUENCES OF FAILURE. The events following element failure due to cracking are estimated for each fatigue-critical detail. Situations where cracking at a detail could lead to catastrophic collapse of all or parts of the structure are given a rating of one. A rating of two is given to those details which could cause a local failure if cracking occurred. Local failure is defined as any failure which would compromise the use of the structure in service. Those details which, if failed, would cause cracking in adjacent elements are given a rating of three. Lastly, a rating of four is intended for those details on elements in highly redundant structures where removal of the element would not affect the performance of the structure. These ratings could be lowered to account for details sensitive to rapid fracture.

Although the total ratings are useful for setting priorities for repair and other modifications, their use, in exclusion of other considerations, is not recommended. An example of priorities is given in Figure 1. Situations where catastrophic collapse is possible are top priorities for action. Secondly, details having very low fatigue strengths should not be present in fatigue loaded structures; modification of all details having a fatigue-strength rating of one is the second priority.

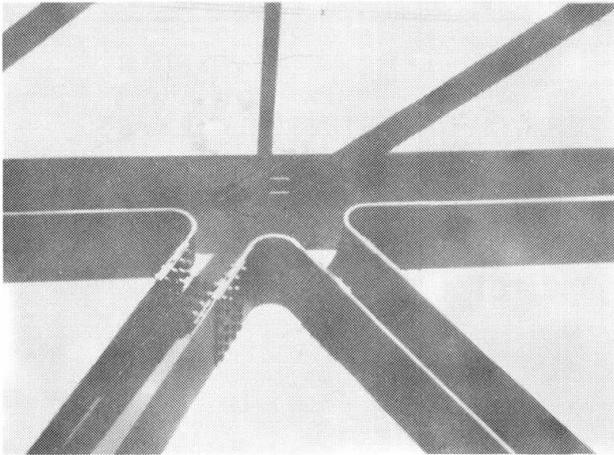
FIGURE 2 : An example of a fatigue-resistant detail.

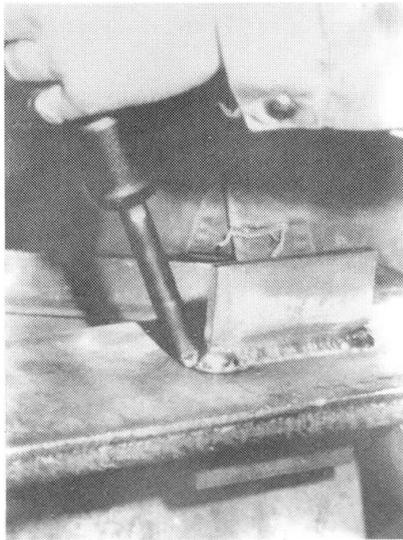
FIGURE 3 : Improvement methods, particularly hammer peening, may increase fatigue strength.

If used under appropriate conditions, several improvement methods, such as peening fillet-weld toes and grinding butt-weld reinforcement, are available to increase fatigue strength [2]. Hammer-peening methods, see Figure 3, usually provide the best improvement most economically for details having low fatigue strengths [3]. If the quality of the improvement can be assured, such methods provide useful alternatives to detail modification.

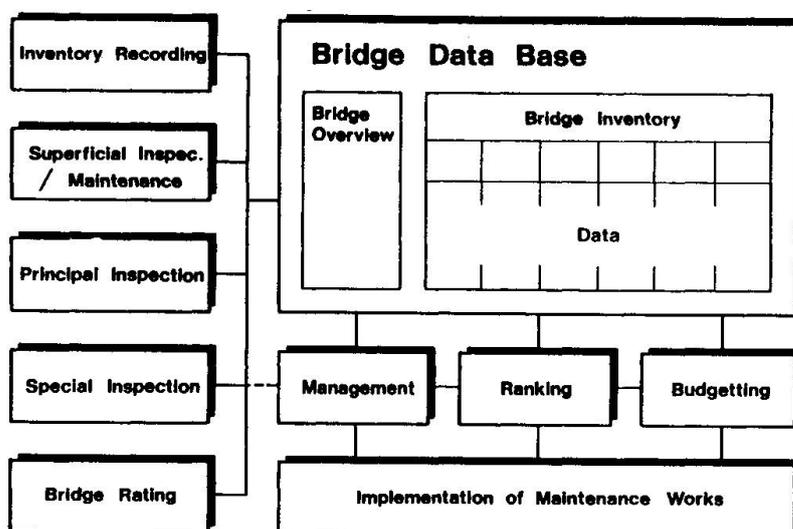
Fig. 1: Main activities covered by the system.

A country wide bridge management and maintenance organization has been established and the future members have been involved in the system design from the very beginning in order to secure its acceptance in the Central Administration as well as in the districts. Fig. 1 shows the main activities in the system:

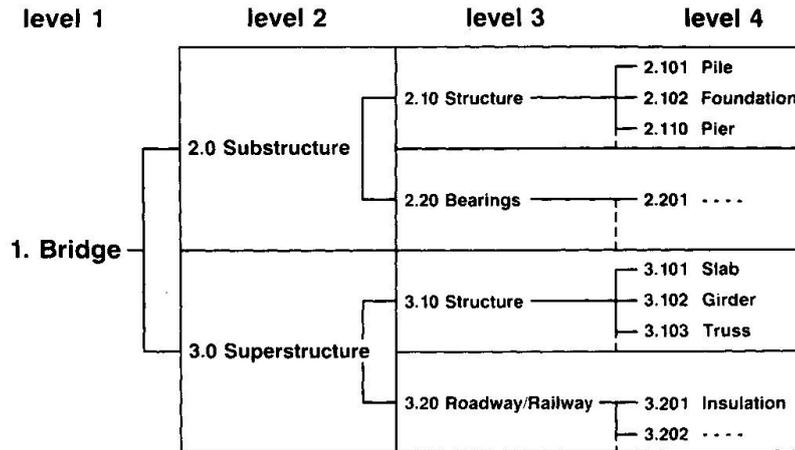
Fig. 2: Hierarchic structure shown with selected elements.

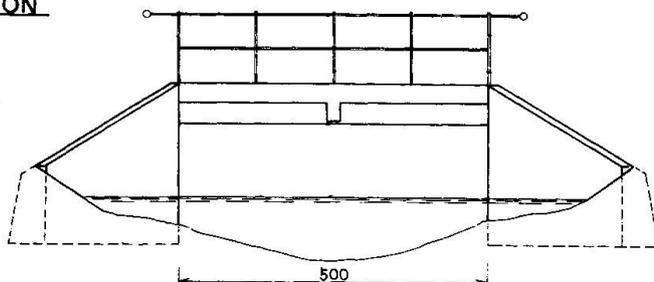
Figure 1.
Load tested road bridge.

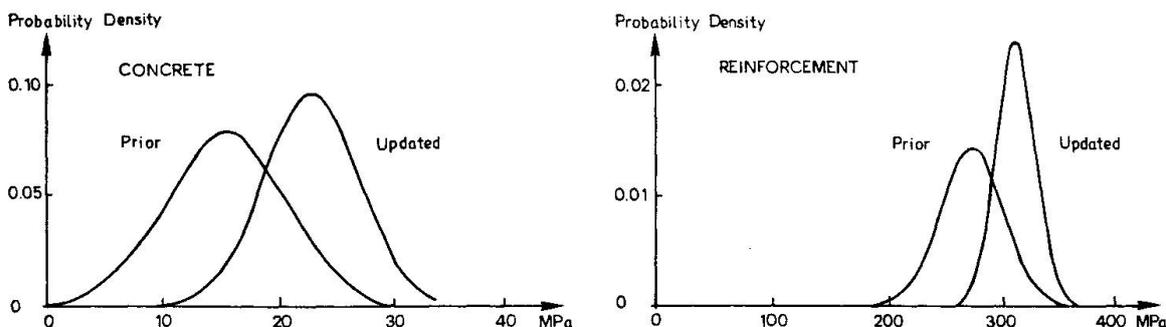
Figure 2: Probability density functions before (prior) and after (updated/posterior) observed material strengths are included.

Results from laboratory tests with concrete and steel samples have been used to update the probability density functions for concrete and reinforcement respectively as shown in Figure 2.

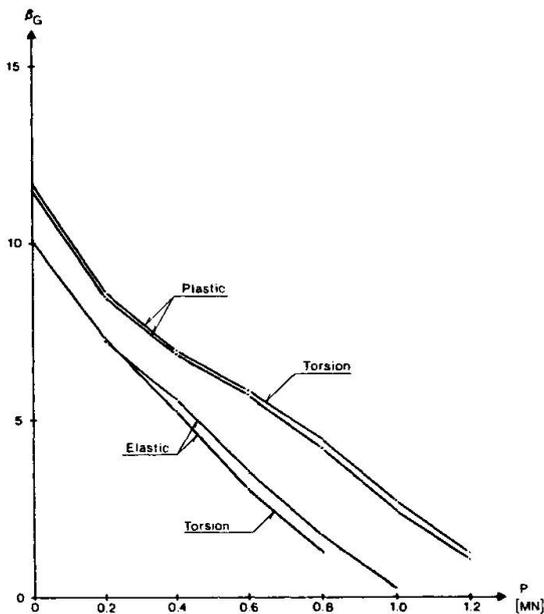
Figure 3: Reliability index β plotted against the variable load P

- 4 structural calculation models
- prior material strengths
- P deterministic

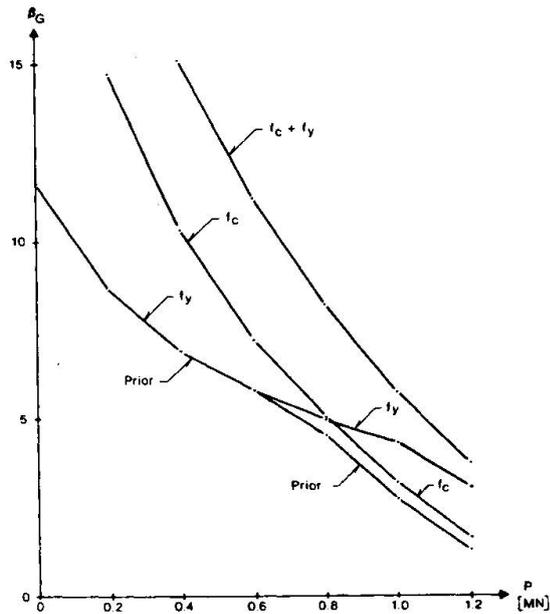
Figure 4: Reliability index β versus variable load P

- separate and combined updating of strengths f_c for concrete and f_y for reinforcement
- plastic model incl torsion
- deterministic load P , ($D(P)=0$)

The reliability index β is shown in Figure 4 for prior and updated strengths applied separately and in combination.

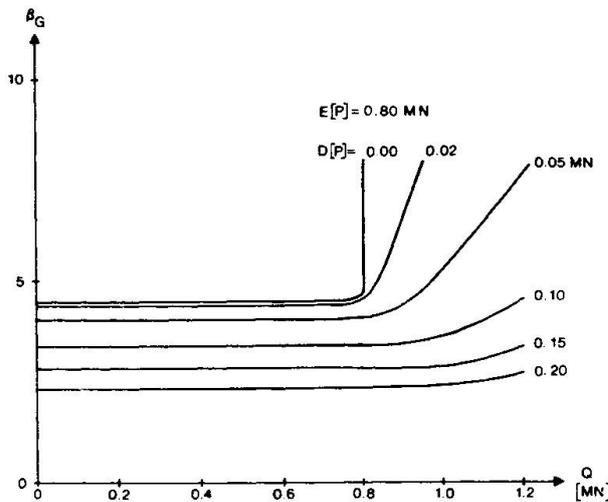
Figure 5: Reliability index β against the test load Q
 - $E(P) = 0.8$ MN, Plastic model incl. torsion, prior strengths,
 - six standard deviations $D(P)$.

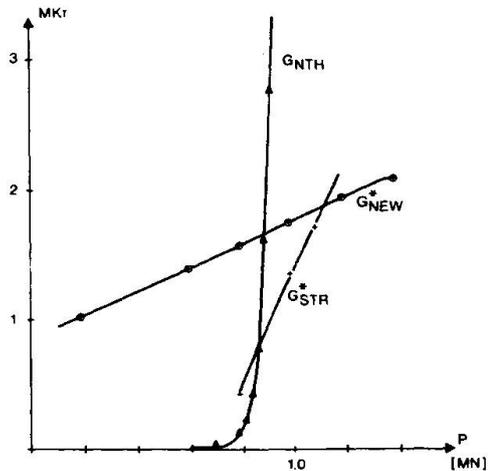
Figure 6: Minimum of expected total costs, G , for
 - unaltered bridge : G_{NTH}
 - strengthened bridge (FOR): G^*_{STR}
 - new bridge (NY) : G^*_{NEW}

For each load level the minimum total expected costs G_{NTH} , G^*_{STR} and G^*_{NEW} were determined. The minimum total costs are plotted in Figure 6.

For the considered alternative decisions, the expected cost will be a minimum if the bridge is used unaltered for low load levels and is replaced by a new bridge for high load levels, whereas strengthening will be preferable for intermediate load levels.

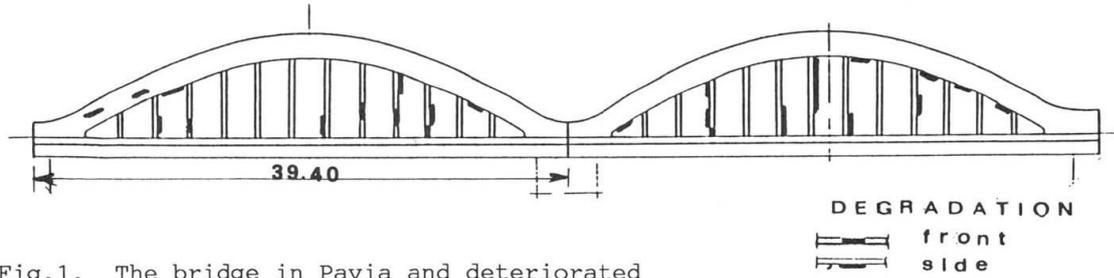
Fig.1. The bridge in Pavia and deteriorated parts in elevation

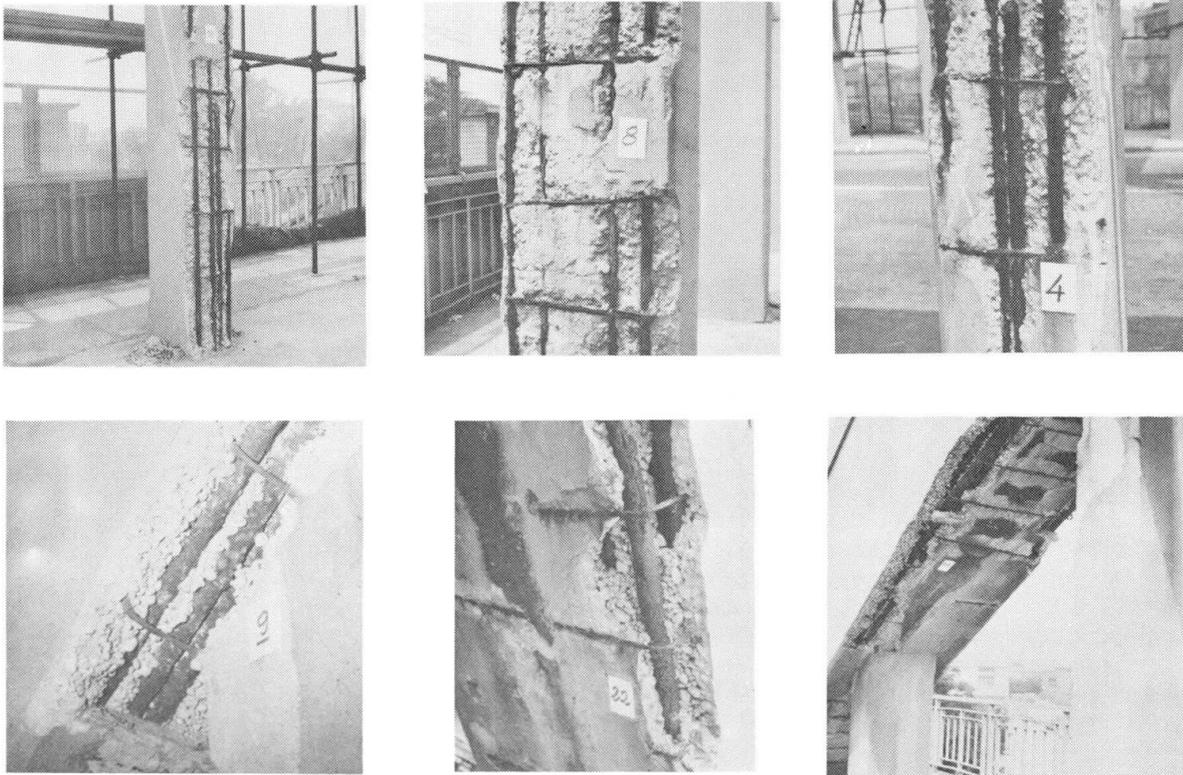
Fig.2. Corrosion of reinforcement and spalling of concrete on various elements of the bridge

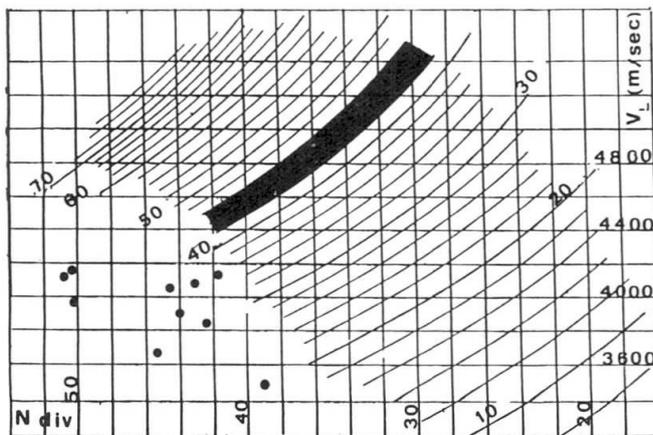
Fig.3. Decrease of ultrasonic pulse velocity for increasing path length (detecting intermediate cracks)

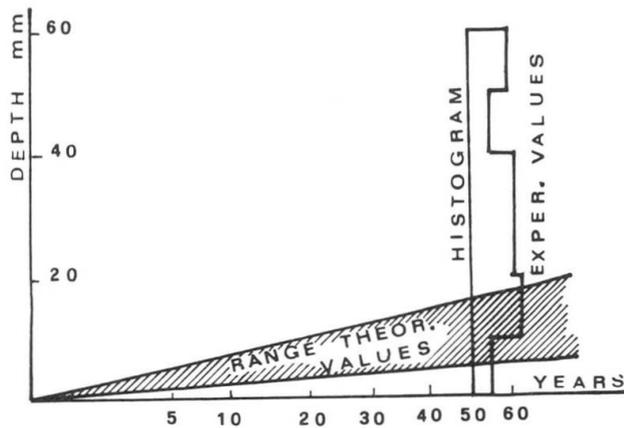
Fig.5. Carbonation depth vs time; plots indicate measured values.

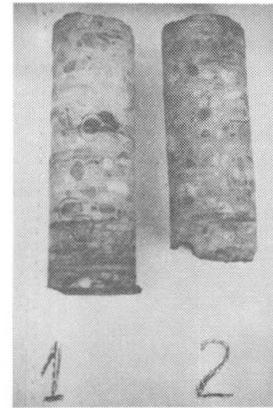
Fig.6. Drilled concrete cores.

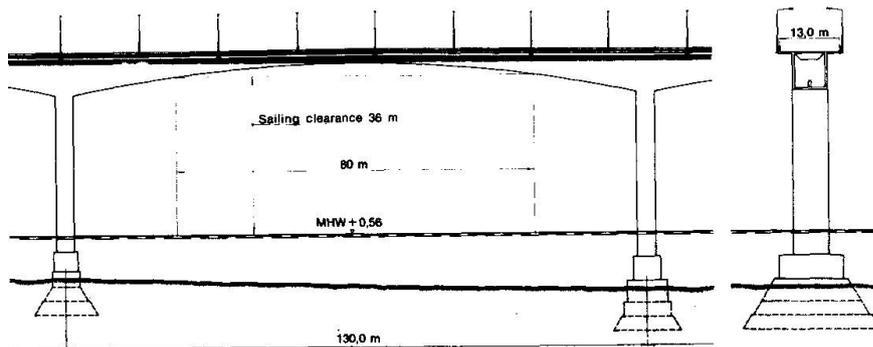
Fig. 1 Hochbrücke.

Die 1967–1972 gebaute Brücke zwischen dem schwedischen Festland und der im Südosten vorgelagerten Insel Öland ist mit 6.072 m Länge immer noch Europas längste Brücke. Sie besteht aus einem Hochbrückenteil, Fig. 1, mit $6 \times 130 \text{ m} + 2 \times 60 \text{ m}$ Spannweite in 36 m Höhe über der Schifffahrtsrinne, der als Spannbetonkastenkonstruktion im Freivorbau ausgeführt ist, und aus zwei Anschlussbrücken, Fig. 2, mit $23 \times 35 \text{ m}$ bzw. $124 \times 35 \text{ m}$ Spannweite, die als kontinuierliche Stahlbetonbalkenbrücken mit Hilfe von zwei Vorbauwagen am Platz fachweise betoniert wurden. Die Brückenbreite ist 13 m. Die Anschlussbrücke auf der Ölandseite folgt auf etwa 3,5 km Länge bei nur geringfügiger Steigung (1,7 %) der Wasseroberfläche, wobei der tiefste Punkt des Überbaus am Ölandwiderlager auf Kote +3,5 m liegt. Bei Dimensionierung und Ausführung des Überbaus wurde grosse Mühe auf gute Beständigkeit verwandt, um den erwarteten Frost-Tausalzbeanspruchungen widerstehen zu können. Überall wurde Beton K 40, in der Fahrbahn mit Luftzusatz, verwendet. Die Brückenoberfläche erhielt Gussasfaltisolierung, freiliegende Betonflächen wurden mit Silanpreparaten behandelt. Wasserdichte Fugen wurden mit fast 600 m Abstand eingebaut. Der Überbau der Brücke hat sich bisher gut bewährt.

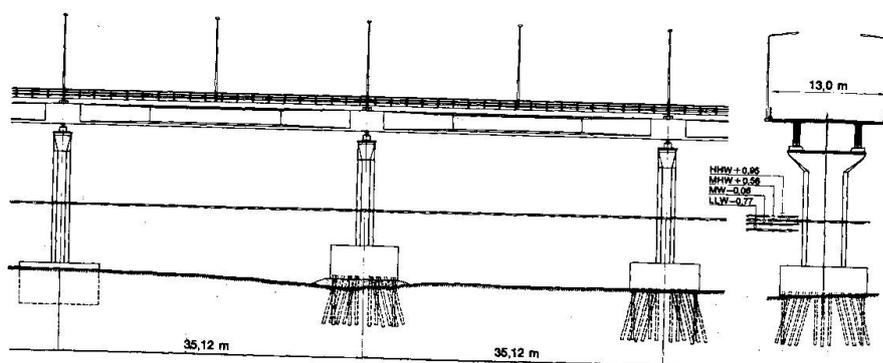
Fig. 2 Anschlussbrücken.

Der Unterbau besteht aus innerhalb von Spundwänden unter Wasser gegossenen Bodenplatten, die direkt auf dem Sand oder auf Pfahlrosten aus Betonschlagpfählen ruhen. Die Pfeilerschäfte sind im Bereich der niedrigen Anschlussbrücken massiv mit reichlichem Betonquerschnitt $c:a 2 \text{ m} \times 5 \text{ m}$, ausgeführt, der nach Auspumpen der Spundkammern im Trocknen gegossen wurde. Bewehrung liegt nur an den Ausenflächen. Sie ist für einen beachtlichen Eisdruck bemessen. Oberhalb der Pfeilerschäfte liegen Hammerkopfbalken, die für sich betoniert

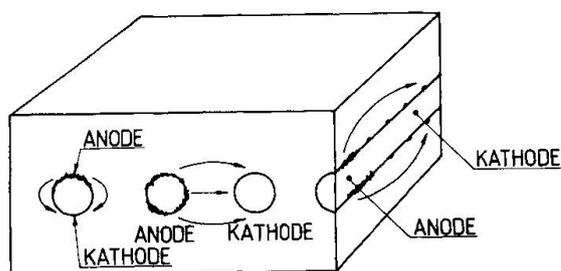
Fig. 6 Verschiedene Korrosionszellen. Der galvanische Strom fliesst in Richtung der Pfeile.

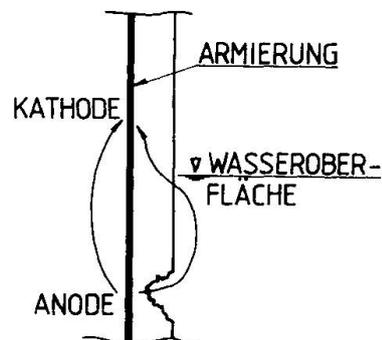
Fig. 7 Galvanische Korrosion unter der Wasseroberfläche.

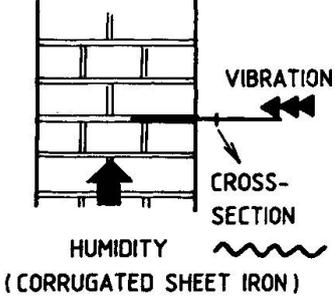
MECHANICAL METHODS	INJECTION OF MASONRY	ELECTROPHYSICAL METHODS
<p>a) <u>PUSHING IN METAL PLATES</u></p>

<p>b) <u>SAWING OF MASONRY AND PLACING OF HUMIDITY - PROOFING</u></p>

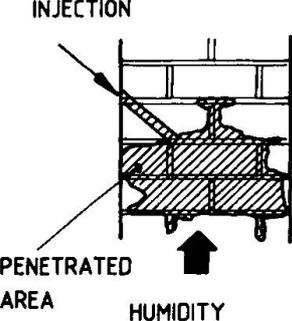
<p>INJECTION</p>

<p>GROUTING - MATERIALS :</p> <ul style="list-style-type: none"> • WATER - GLASS • SYNTHETIC - RESIN. • BITUMINOUS SLURRY <p>INJECTIONS :</p> <ul style="list-style-type: none"> • WITHOUT PRESSURE • WITH PRESSURE 	<p>(ELECTROSMOSIS)</p> <p>"PASSIVE METHOD"</p>

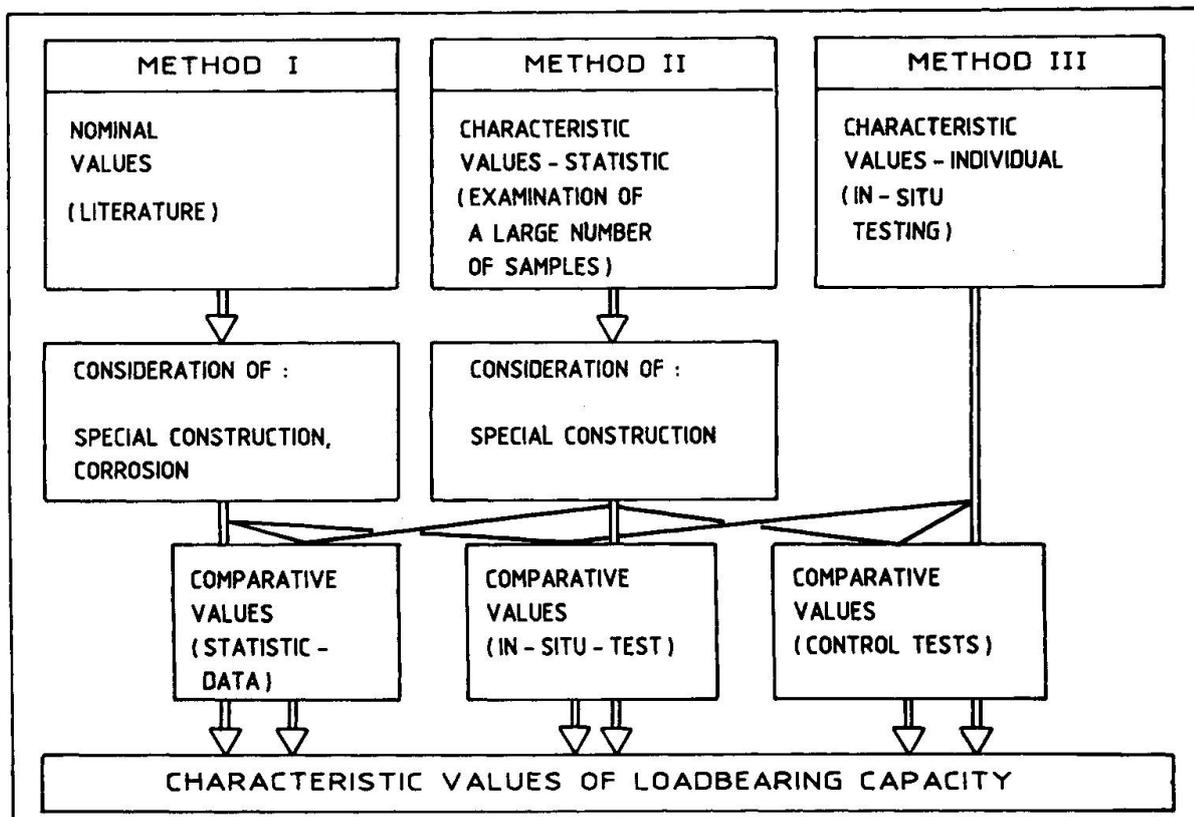
Fig.2 Consideration of actual loadbearing capacity

At present the characteristic values of actual compressive strength of masonry can be achieved in three different ways, as shown in Fig.2.

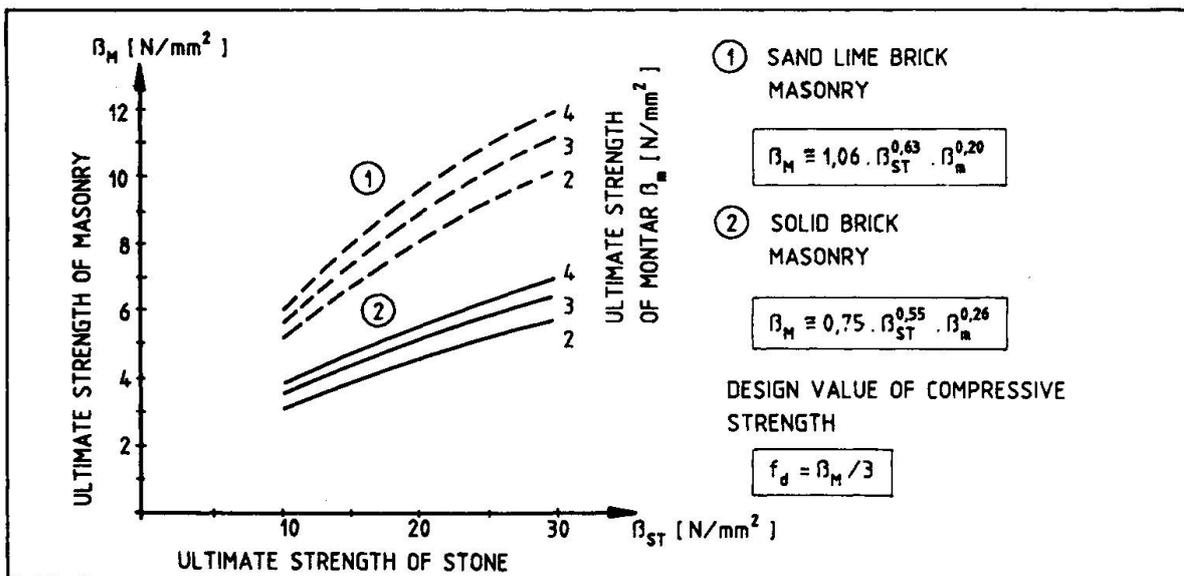
Fig.4 Testing of components - superposition formulas

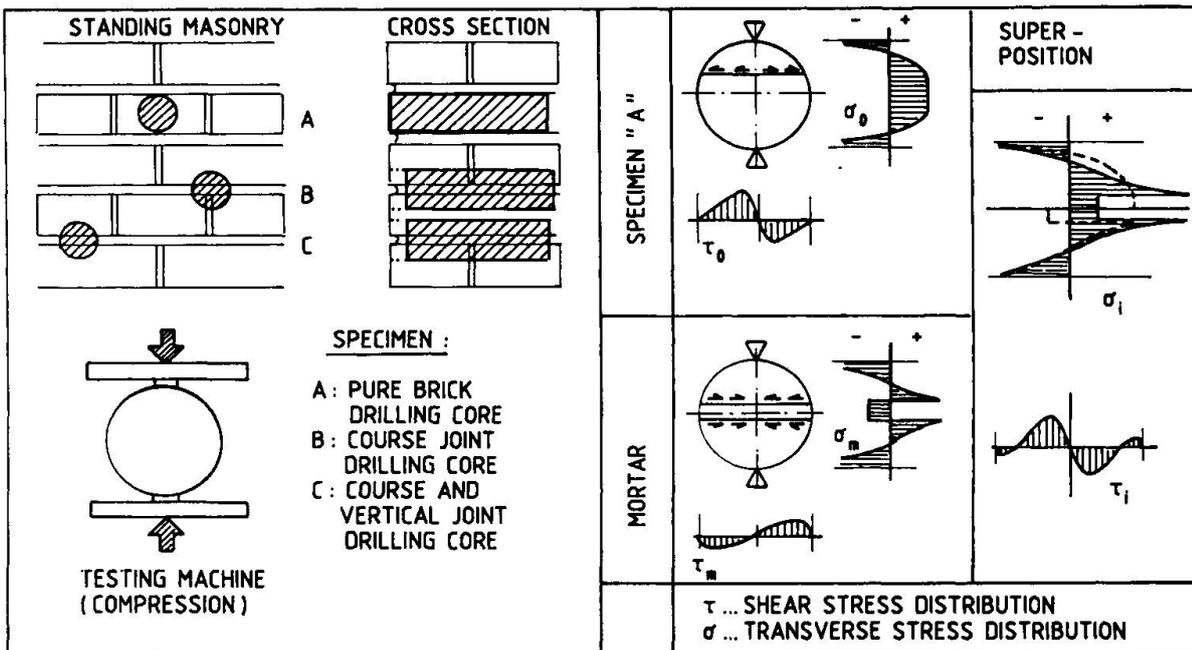
Fig.5 Testing drilling cores

Fig. 5 shows the principles for evaluating compressive strength of pure brick constructions by testing drilling cores (diameter 5 to 6cm). In some cases this method poses problems during the extraction of joint drilling cores. After superposition of the shear stress and transverse stress for pure brick and joint drilling cores the results have to be converted to the compressive strength of the masonry. In order to find acceptable conversion factors, several tests are recently investigated.
