Zeitschrift: IABSE reports = Rapports AIPC = IVBH Berichte
Band: 57/1/57/2 (1989)

Artikel: Assessment of a bow-string bridge 50 years old in Pavia
Autor: Macchi, Giorgio / Nocca, Gaetano
DOI: <https://doi.org/10.5169/seals-44293>

Assessment of a Bow-String Bridge 50 Years Old in Pavia

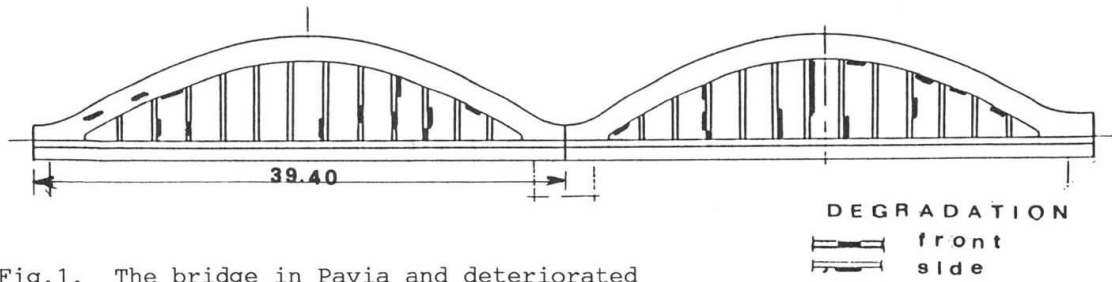
Built in 1932, the bridge (Fig.1) has two spans of 38 m, with a bow-string statical scheme, a popular structure in the 30ies.

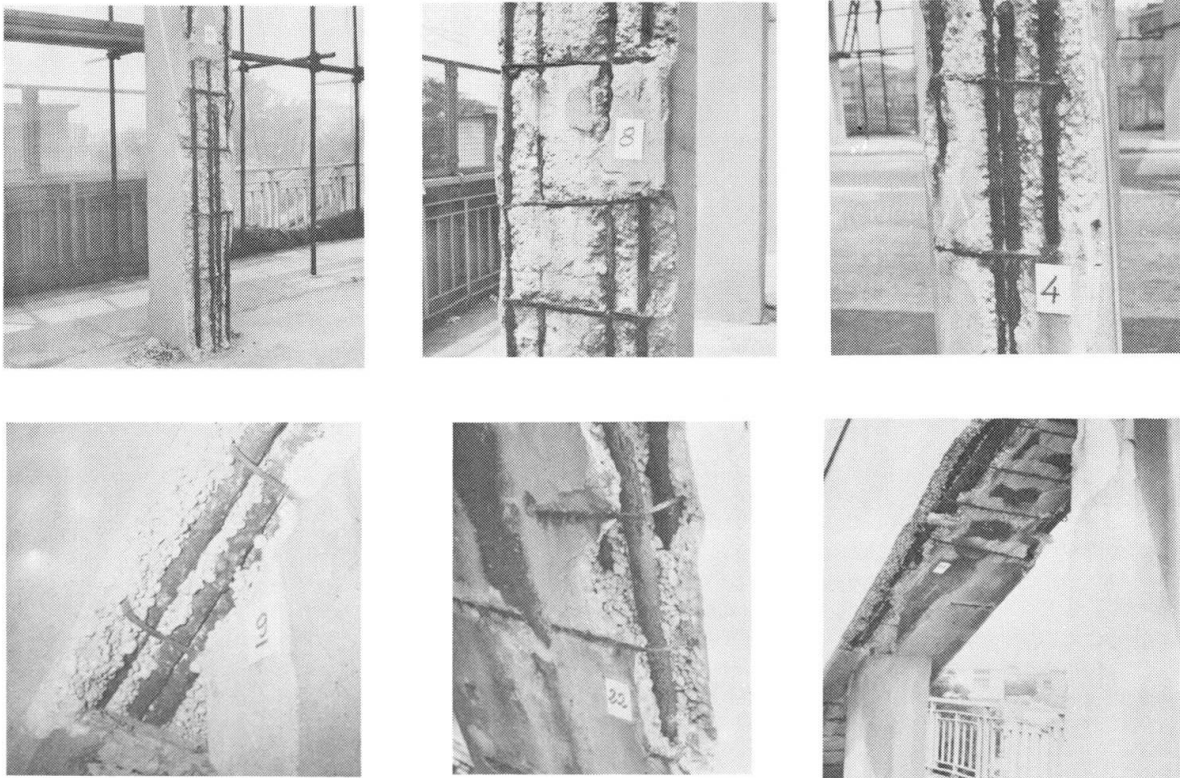
If the deficiencies were obvious in the grid of the superstructure, they were not evident for the main resisting elements of the bridge, because of the great preminence of permanent loads. However, a dramatic spalling of concrete and corrosion of reinforcement (Fig.2) led to the need of a deep diagnosis for the assessment of the residual carrying capacity and for decisions about its possible repair or necessity of replacement.

Fig.2. Corrosion of reinforcement and spalling of concrete on various elements of the bridge

The dramatic spalling of concrete, mainly in vertical elements, as shown by Fig.2, is in complete agreement with the description of the phenomenon given in literature: the expansion of steel due to oxidation creates a pressure causing the spalling of the concrete cover; and oxidation is due to the destruction of the passivation layer caused by the carbonation of concrete.

At the time of the diagnosis the corrosion was already in progress on most reinforcing bars of the vertical tendons (all bars being disposed near to the external surface).

A reduction of 40% of the initial section of one bar has been observed locally; this value cannot obviously be generalized, but it caused a serious concern for the safety of the structure, because the progress of corrosion process in time cannot be estimated at present with reliable models.

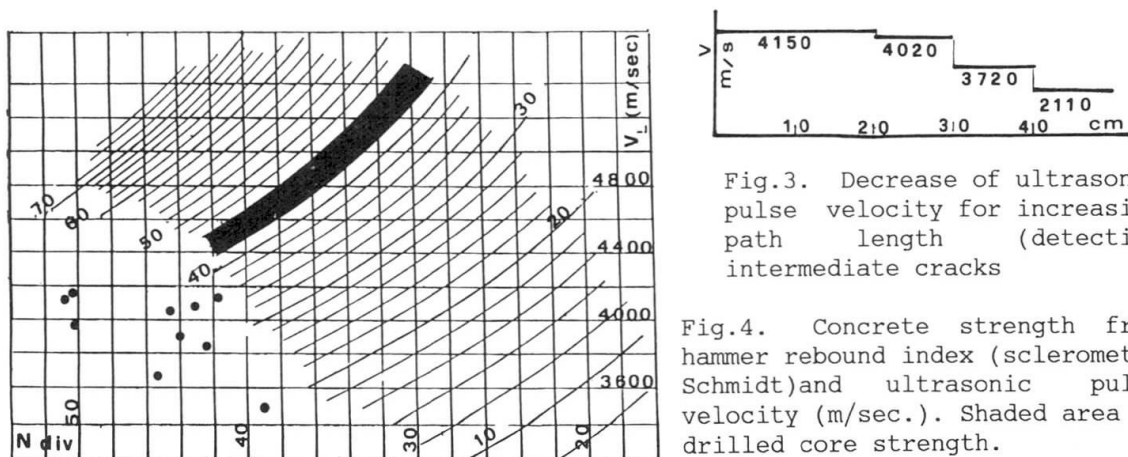
Fig.4. Concrete strength from hammer rebound index (sclerometer Schmidt) and ultrasonic pulse velocity (m/sec.). Shaded area is drilled core strength.

The values of non-destructive tests are compared with the strength obtained on drilled cores, in the diagram SONREB (Fig.4).

The experimental points are plotted on the standard chart (the measurements in the damaged areas have been excluded); the band 42 to 46 MPa of the drilled core strength has been shaded.

It clearly appears that all the experimental points fall out of the area calibrated for new concretes. It means that the hammer rebound is measuring a skin hardness which is not correlated in the usual way with E modulus and strength, and this is due to the carbonation of concrete.

On the other hand, the ultrasonic velocity seems to underestimate the strength, perhaps due to a microstructural damaging of the old concrete. We cannot state anything of this kind at present; nevertheless, a warning is necessary: the use of non-destructive testing requires a special calibration for old structures.

Non-destructive testing shall combine hammer rebound (Schmidt sclerometer) with ultrasonic pulse velocity (the RILEM SONREB method, Fig.4), because the first procedure is sensitive to superficial hardening due to carbonation, and the second one is sensitive to microcracking.

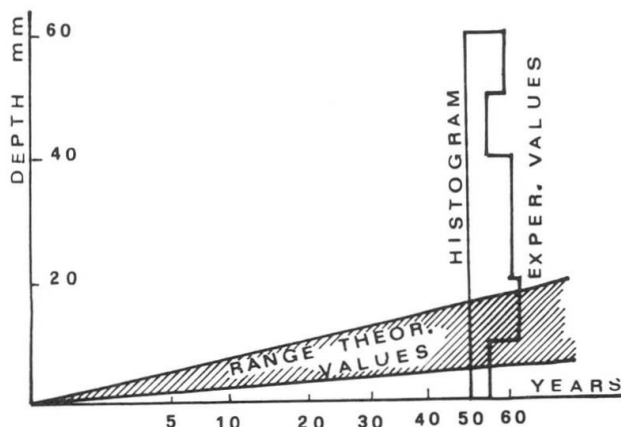
The observed depth of carbonation was variable, but by far larger than expected according to the existing knowledge.

The measured values are plotted in Fig.5, and compared with the curve given in [10] for the development of carbonation with time.

Such unexpected level of the phenomenon cannot be associated with a bad quality of concrete; the strength was in fact exceptionally high for the time.

Fig.5. Carbonation depth vs time; plots indicate measured values.

The decrease of concrete porosity cannot be expected to reduce the carbonation to such an extent to justify the present values of cover; if carbonation depths higher than 40 mm (and locally 60 mm) have been observed in the 52 year old bridge, in spite of an overall good quality of construction, it would be wise to ensure a cover of at least 40 mm to a great percentage of the steel area of the main structural elements. We are perhaps forced to use different criteria for slabs, but envisage other kinds of protection!
