Zeitschrift: IABSE reports = Rapports AIPC = IVBH Berichte
Band: 57/1/57/2 (1989)

Artikel: Assessment of a bow-string bridge 50 years old in Pavia
Autor: Macchi, Giorgio / Nocca, Gaetano
DOI: <https://doi.org/10.5169/seals-44293>

Assessment of a Bow-String Bridge 50 Years Old in Pavia

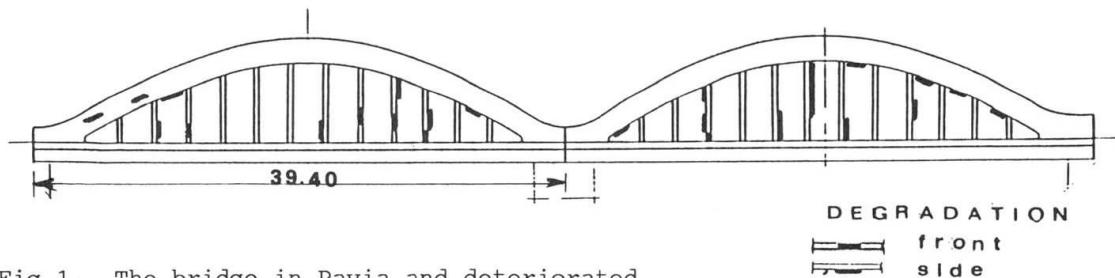
Built in 1932, the bridge (Fig.1) has two spans of 38 m, with a bow-string statical scheme, a popular structure in the 30ies.

Fig.1. The bridge in Pavia and deteriorated parts in elevation

The conclusions of the tests and of the analyses led to establish the loads temporarily admissible on the bridge (100 kN vehicles) and provided the necessary data for a cost/benefit analysis. The data, combined with town planning considerations, led the Authorities to the decision of replacing the bridge with a new one.

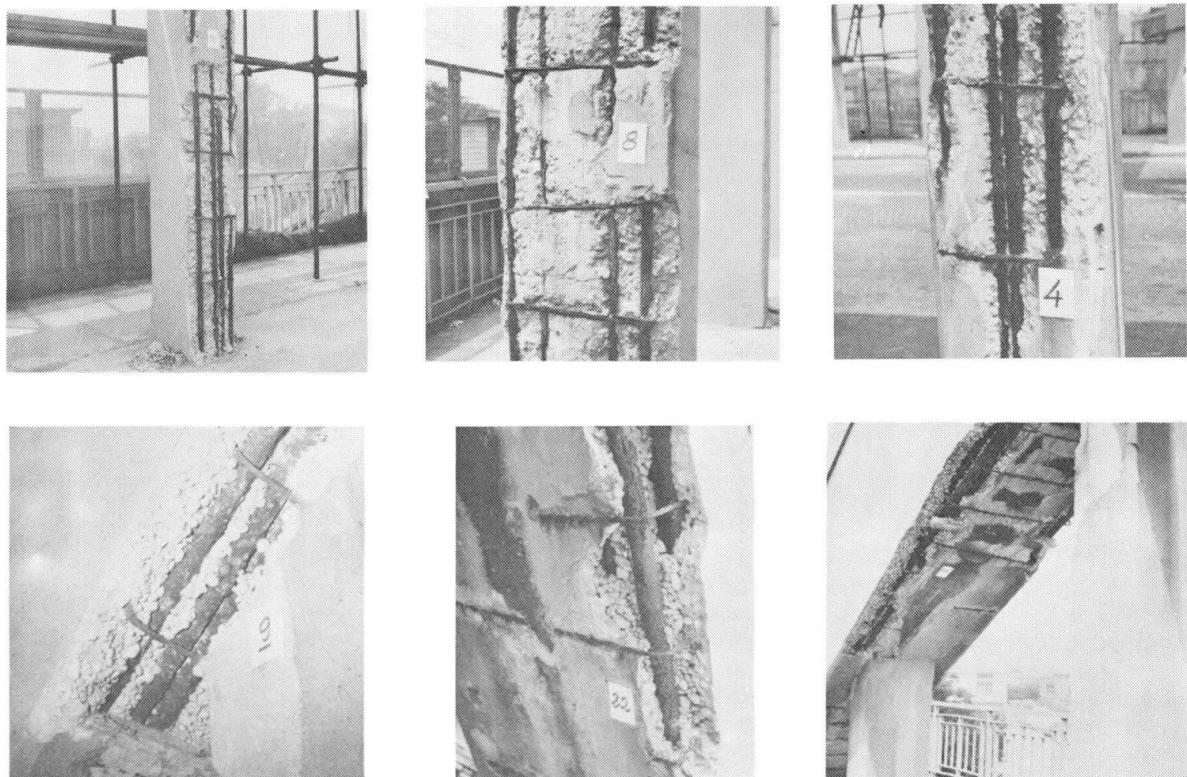
If the deficiencies were obvious in the grid of the superstructure, they were not evident for the main resisting elements of the bridge, because of the great preminence of permanent loads. However, a dramatic spalling of concrete and corrosion of reinforcement (Fig.2) led to the need of a deep diagnosis for the assessment of the residual carrying capacity and for decisions about its possible repair or necessity of replacement.

Fig.2. Corrosion of reinforcement and spalling of concrete on various elements of the bridge

The dramatic spalling of concrete, mainly in vertical elements, as shown by Fig.2, is in complete agreement with the description of the phenomenon given in literature: the expansion of steel due to oxidation creates a pressure causing the spalling of the concrete cover; and oxidation is due to the destruction of the passivation layer caused by the carbonation of concrete.

At the time of the diagnosis the corrosion was already in progress on most reinforcing bars of the vertical tendons (all bars being disposed near to the external surface).

A reduction of 40% of the initial section of one bar has been observed locally; this value cannot obviously be generalized, but it caused a serious concern for the safety of the structure, because the progress of corrosion process in time cannot be estimated at present with reliable models.

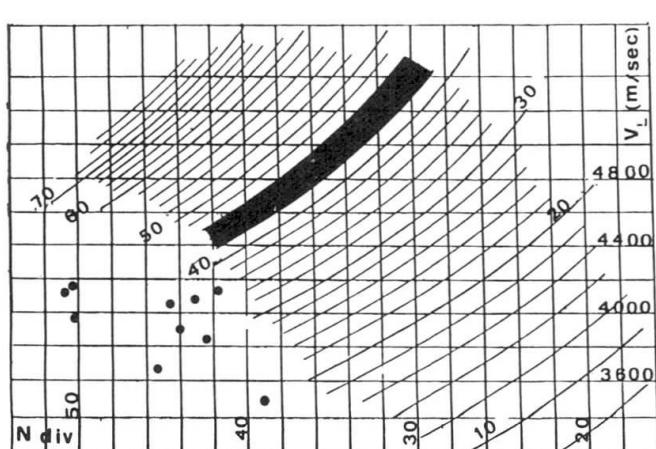
Fig.3. Decrease of ultrasonic pulse velocity for increasing path length (detecting intermediate cracks)

The detection of cracks and the elimination of their effects on measurements has been obtained by measuring the speed on different lengths on the same line (Fig.3); the highest values of speed have been retained as a property of the uncracked material.

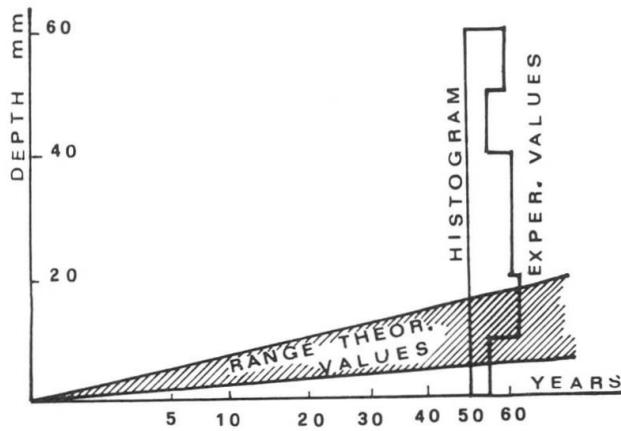
The observed depth of carbonation was variable, but by far larger than expected according to the existing knowledge.

The measured values are plotted in Fig.5, and compared with the curve given in [10] for the development of carbonation with time.

Such unexpected level of the phenomenon cannot be associated with a bad quality of concrete; the strength was in fact exceptionally high for the time.

Fig.5. Carbonation depth vs time;
plots indicate measured values.

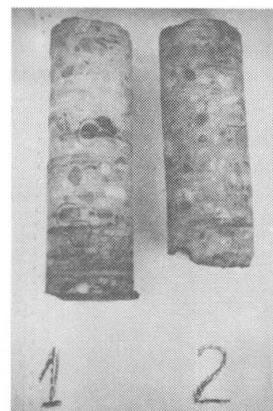
The values of non-destructive tests are compared with the strength obtained on drilled cores, in the diagram SONREB (Fig.4).

Fig.6. Drilled concrete cores.
