Zeitschrift: IABSE reports = Rapports AIPC = IVBH Berichte
Band: 57/1/57/2 (1989)

Artikel: Strengthening of reinforced concrete beams
Autor: Cunha, Albino J.P. da / Andrade, José E. de Q.
DOI: <https://doi.org/10.5169/seals-44300>

Strengthening of Reinforced Concrete Beams

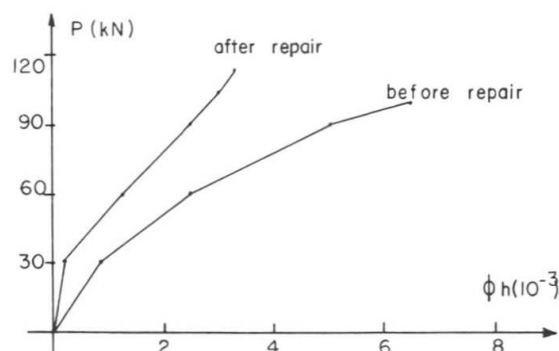
Fig. 7 Load x Curvature diagram

Beams were once more loaded, and fig. 7 shows "load x curvature" diagrams for tests before and after repair. Collapse loads before and after repair are presented at table 2, and a repaired beam before and after failure is showed at figures 8 and 9.

- Two repaired beams, loaded at ages 4 and 8 days, presented increase of collapse loads of 14% and 20%, respectively;
- The other one failed with 83% of initial collapse load, probably because before use, the grout was maintained in an open bag for 40 days, at risk of hydration by the 75% local air humidity; this result was dismissed.
- Although strains measured at the grout (2nd stage of load) were smaller than at the initial concrete (1st stage of load), as displayed at fig. 7, vertical displacements were larger, because a great part of the beam was already cracked.
