Zeitschrift: IABSE reports = Rapports AIPC = IVBH Berichte
Band: 57/1/57/2 (1989)

Artikel: Strengthening of reinforced concrete beams
Autor: Cunha, Albino J.P. da / Andrade, José E. de Q.
DOI: <https://doi.org/10.5169/seals-44300>

Strengthening of Reinforced Concrete Beams

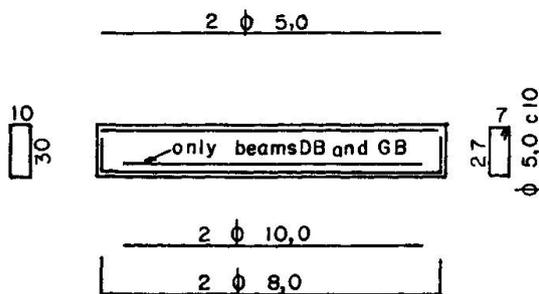
Fig. 1 Beam reinforcement

Twelve equal beams, 2.0 m in length each, were poured (fig. 1). Three of them were not strengthened (beams SB), and were used as a lower-bound limit. Three beams were strengthened with shotcrete (beams SH, fig. 2), and other three with glued mortar (beams MB, fig. 2). The remaining three were strengthened with epoxy-glued steel plates. For the beam in fig. 3.a (beam SP1), only epoxy was used to connect plate to concrete. For beam SP2 in fig. 3.c, U plates were used to connect steel plate to the beam, and for beam SP3 (fig. 3.b) bolts were used to assure a better connection between plate and concrete.

Three other beams received a second reinforcement layer before pouring (beams DB in fig. 1), and were used as an upper-bound limit.

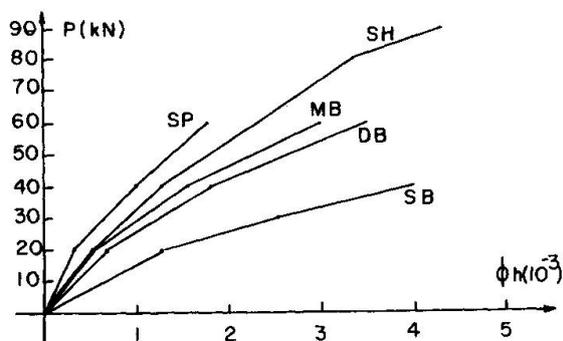
Fig. 4 Load x Curvature diagram

Fig. 4 displays "load x curvature" diagrams, and table 1 shows the design loads (P_d), the theoretical (P_u) and the experimental ($P_{u,exp}$) collapse loads (4). The listed values are total loads applied to the beam (sum of two concentrated loads).

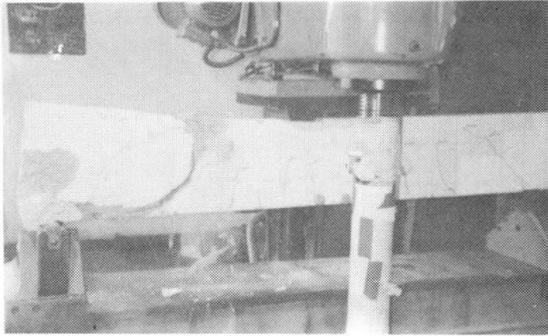
Fig. 5 Steel plate beam

- All tested beams exceeded the design loads;
- Two beams with glued steel plates and special devices to assure connection to the beam, SP2 and SP3, exceeded theoretical collapse load by 9%; collapse load for beam SP1 (fig. 5) was lower than the theoretical one by 10% (5); all beams have collapsed showing a disconnection of the steel plate from the beam (although this was expected only for beam SP1), and none of them have showed rupture of the steel plate.
- Two shotcrete beams surpassed theoretical collapse load by 4%; the other one failed with 88% of expected load, probably because of an old concrete area with

- out rugous surface (fig. 6);
- Beams strengthened with glued mortar failed with 79% of the expected load;
- Beams strengthened with glued steel plates were the stiffest, followed by shotcrete strengthened beams;
- Beams strengthened with glued steel plates showed the best behaviour for crack width, with no cracks in strengthened region until the design loads were reached; nevertheless, beam SP1 collapsed soon after the first horizontal crack in the concrete cover occurred (fig. 5).

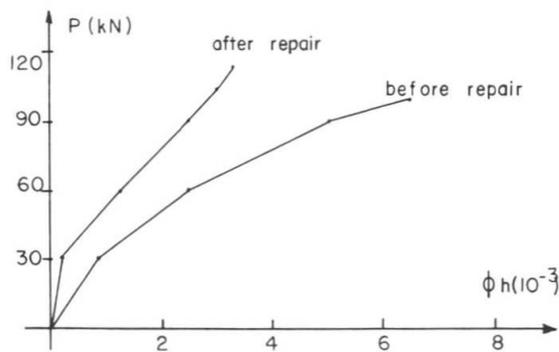
Fig. 7 Load x Curvature diagram

Beams were once more loaded, and fig. 7 shows "load x curvature" diagrams for tests before and after repair. Collapse loads before and after repair are presented at table 2, and a repaired beam before and after failure is showed at figures 8 and 9.

- Two repaired beams, loaded at ages 4 and 8 days, presented increase of collapse loads of 14% and 20%, respectively;
- The other one failed with 83% of initial collapse load, probably because before use, the grout was maintained in an open bag for 40 days, at risk of hydration by the 75% local air humidity; this result was dismissed.
- Although strains measured at the grout (2nd stage of load) were smaller than at the initial concrete (1st stage of load), as displayed at fig. 7, vertical displacements were larger, because a great part of the beam was already cracked.

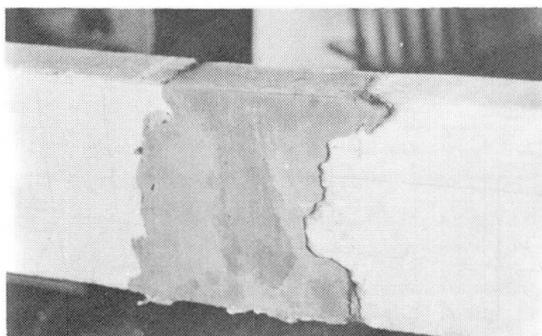
Fig. 8 Grout repaired beam

These beams were repaired, by pouring grout (high strength expansive mortar) to substitute the damaged concrete.
