Artikel: Concrete repair with shotcrete
Autor: Silfwerbrand, Johan
DOI: <https://doi.org/10.5169/seals-44301>

Concrete Repair with Shotcrete
Réparation du béton par béton projeté
Betonreparaturen mit Spritzbeton

Johan SILFWERBRAND
Dr. Tech.
Royal Inst. of Technology
Stockholm, Sweden

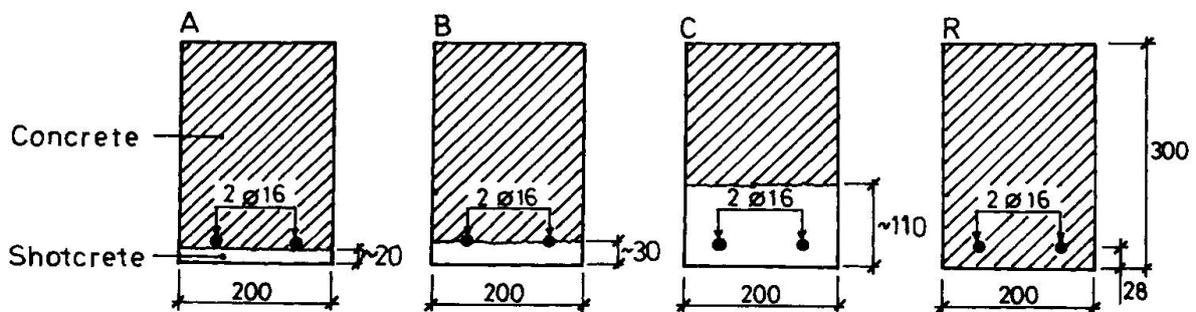
Fig. 1 Cross sections of specimens of type A, B, C and R.

The test programme embraced a total of twelve reinforced concrete beams cut from slabs. Four concrete slabs were cast. Three slabs were water-jetted and the varying parameter was the thickness of the concrete removed. The aim was to precisely reach the reinforcement on the first slab (A), to uncover half of the reinforcement bars on the second one (B), and to completely uncover the reinforcement on the third slab (C). The fourth slab was a reference slab (R) which was not water-jetted.

In a second phase of test specimen preparation, the removed concrete was replaced by shotcrete to the level of the original slab thickness. The slabs were finally sawn into strips, resulting in beam specimens. The test specimens were designated A1, A2, A3 etc. The cross-sections are shown in Fig. 1 and material properties are listed in Table 1.

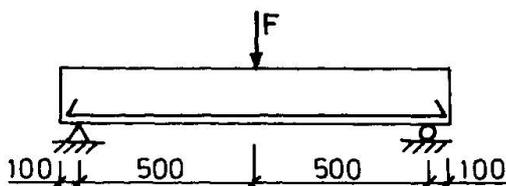
One beam specimen of each type was statically loaded to failure and two of each type were loaded by fatigue. All beams were simply supported on two supports and loaded by a central single load according to Fig. 2.

Fig. 2 Loading of the beam specimens

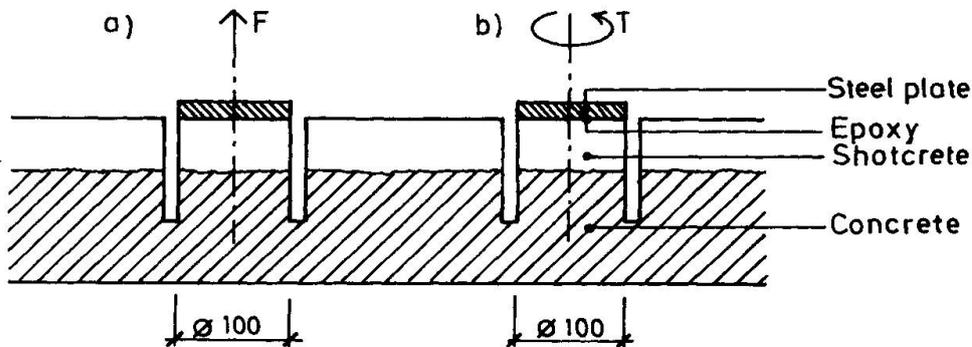
The tests were terminated with pull-off tests and torsional tests of cores according to Fig. 3. The results are shown in Table 5. Since no pure interface failure occurred it can only be stated that the tensile and shear strength of the interface cannot have been less than the failure values obtained. The failure stress was 1-2 MPa at tension (pull-off tests) and 3-4 MPa at shear (torsional tests). No differences dependent on the location of the interface in relation to the reinforcement plane could be determined according to these tests.

Fig. 3 Pull-off tests (a) and torsional tests (b) of cores
