**Zeitschrift:** IABSE reports = Rapports AIPC = IVBH Berichte

**Band:** 59 (1990)

**Rubrik:** Theme B: Behaviour of materials

# **Experimental and Theoretical Investigations of Existing Railway Bridges**

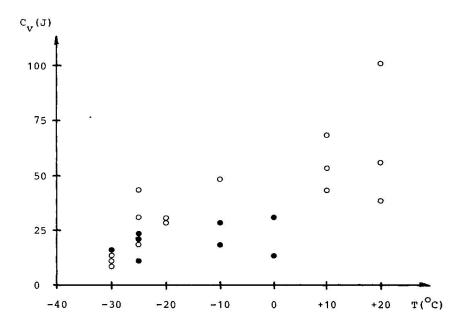
Fig 1. Charpy-V notch toughness for two specimen series of a given material. o Ser no 1. • Ser no 2.

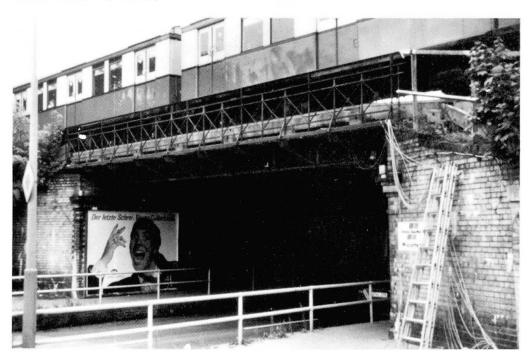
Figure 1.
Steel bridge
of the
Berlin
Metropolitan, built
in 1898,
replaced
1988

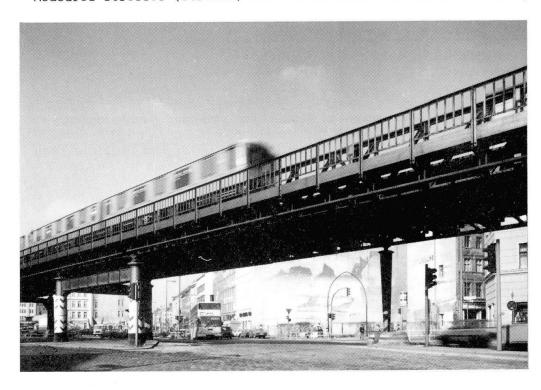
Figure 2.
Truss girder bridge of the Berlin Underground, built in 1902, replaced in 1989
