Zeitschrift: IABSE reports = Rapports AIPC = IVBH Berichte
Band: 59 (1990)

Rubrik: Theme B: Behaviour of materials

Experimental and Theoretical Investigations of Existing Railway Bridges

Remaining Fatigue Strength of Corroded Steel Beams

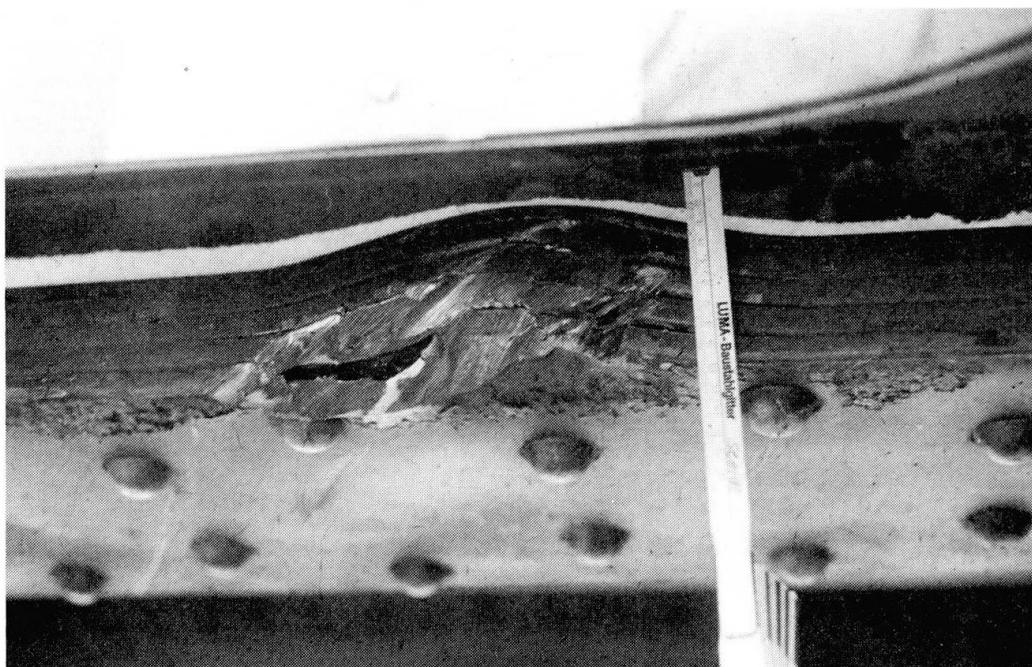
Defective structural components (damaged e.g. by corrosion, by accident (see Fig. 1) or by bullets) may cause a considerable reduction of the life of a construction depending on the situation of the defect and on the stress level. We therefore recommend to attach special importance to these points when visiting a construction.

Fig. 1 Bridge damaged by impact

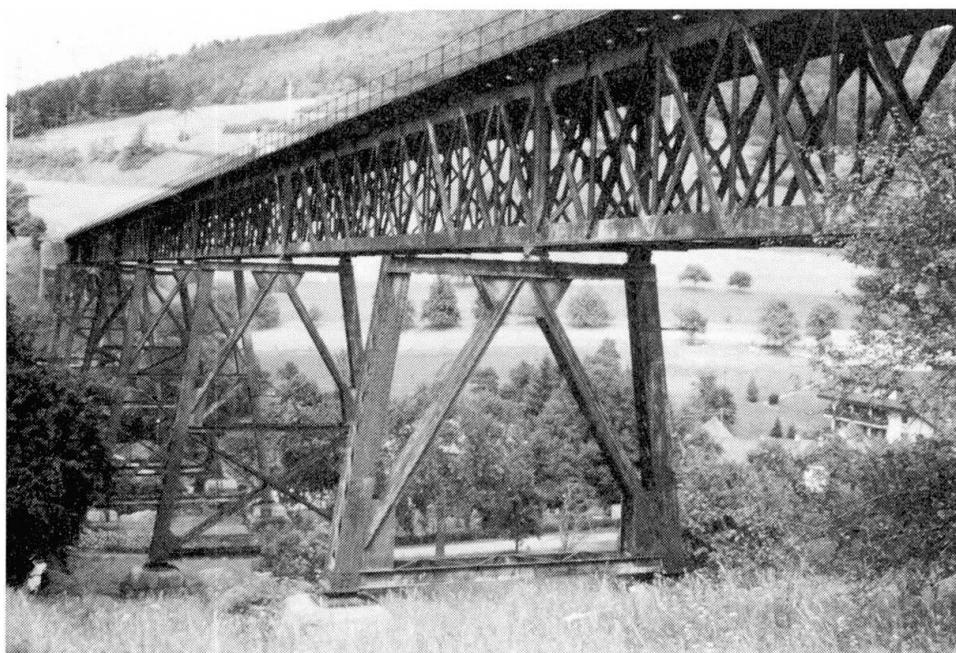
At the "Versuchsanstalt für Stahl, Holz und Steine" tests were carried out on a whole bridge built in 1887 which had been chosen from different bridge systems of the "Museumsbahn" (Fig. 2).

Fig. 2 Bridge of the "Museumsbahn"

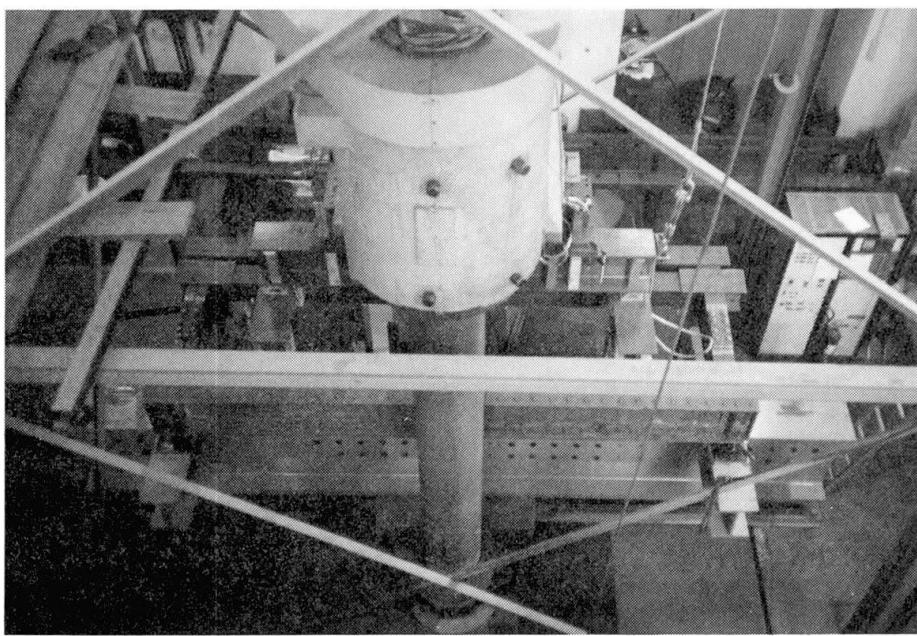
The whole bridge was built in the 50 MN power press of the institute. Fig. 3 shows the bridge built in according to load configuration LF 1.

Fig. 3 Bridge of the "Museumsbahn" in the 50 MN power press

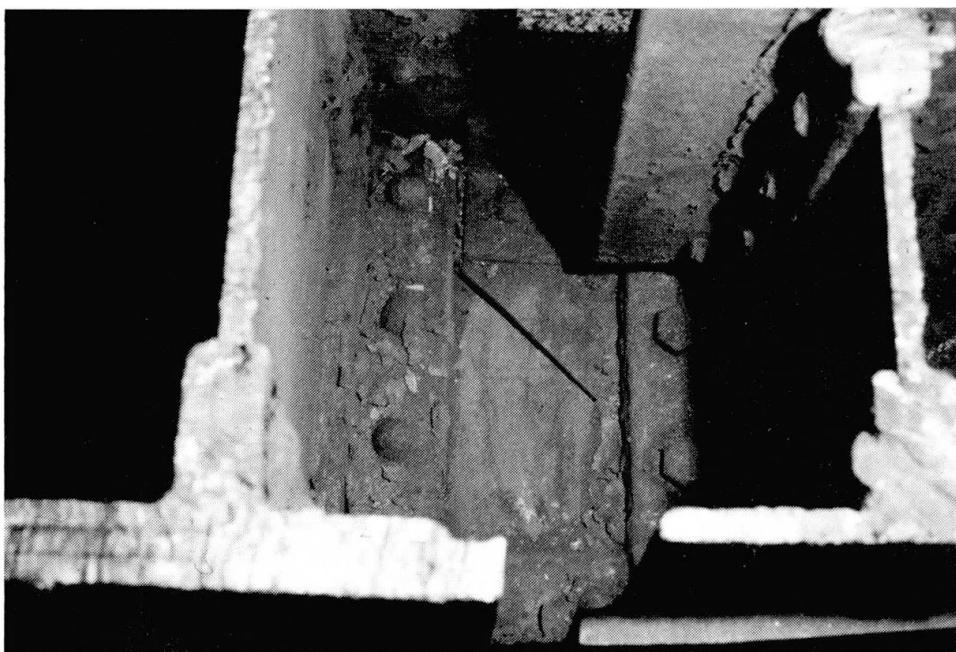
The test was interrupted at 108 070 stress cycles as a correct load application was no longer possible due to a large crack in the connection between transverse girder and main girder. Fig. 4 shows the point of failure.

Fig. 4 Connection between transverse girder and main girder, crack in web plate

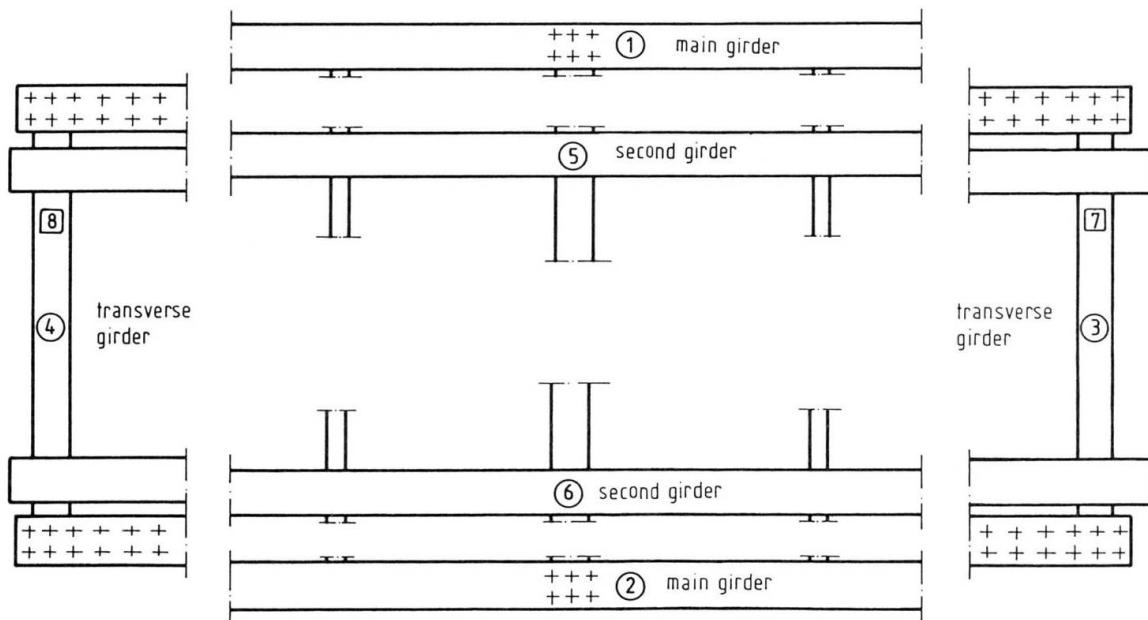
Afterwards, the bridge was sawed up (see Fig. 5) to carry out separate tests on components (main girder, longitudinal girder) and connections (transverse girder, main girder).

Fig. 5 Blumberg bridge - designation of specimens

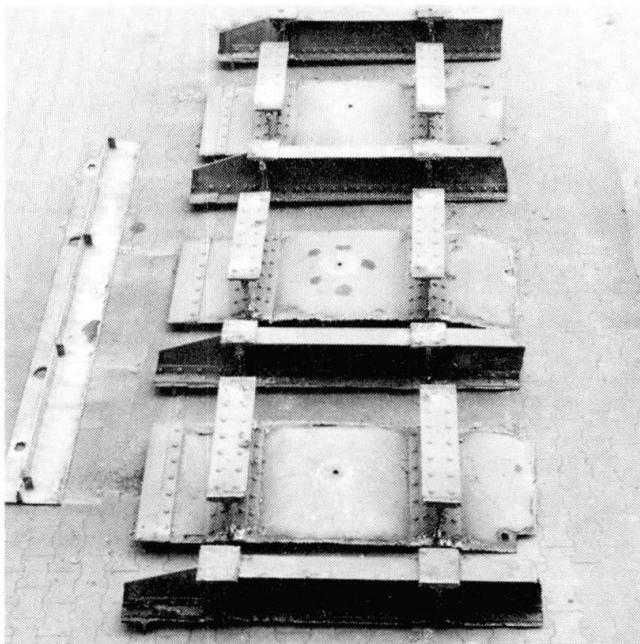
Analogously, the Stahringen bridge dating from 1895 was sawed up to investigate the two main girders and the connections between main girder and transverse girder. Fig. 6 shows the components of one half of the bridge. Punched specimens, riveted specimens as well as specimens of the plain web plate material were taken from the remaining bridge parts.

Fig. 6 Stahringen bridge - structural components

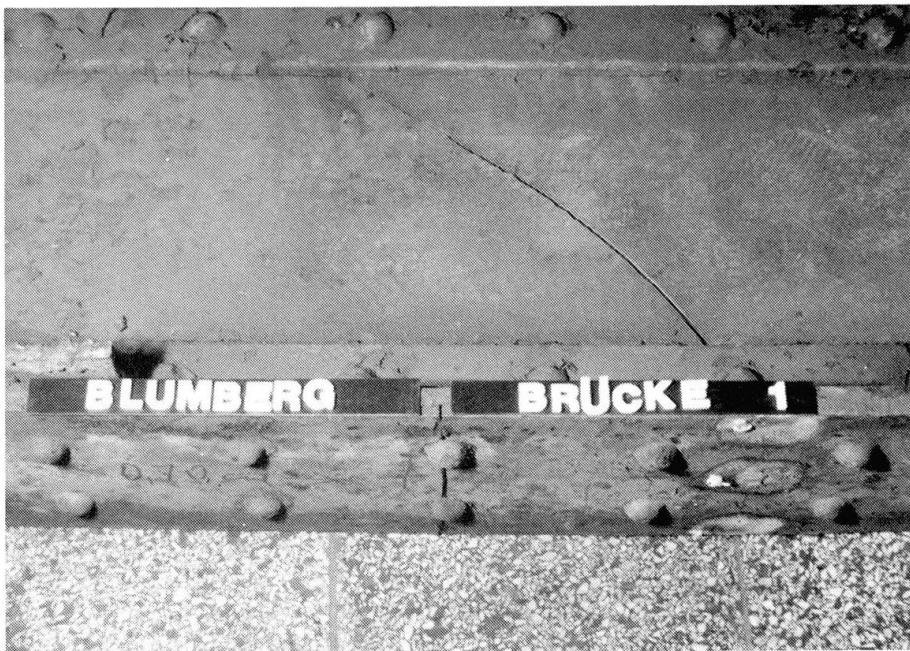
Under a maximum stress of 165 N/mm^2 and at 1 534 000 stress cycles the crack occurred in the web of main girder I of the Blumberg bridge. Despite the crack, the main girder carried the full load and the test was continued until the two angles and the cover plate of the main girder tensile chord failed at a total number of stress cycles of 1 572 600. This means that the minimum number of stress cycles between crack appearance and total failure of the main girder was 38 600 (see Fig. 7).

Fracture first occurred in the web, then in the angle section and finally in the cover plate. The cracks were not situated on one level.

Fig. 7 Points of fracture of main girder I

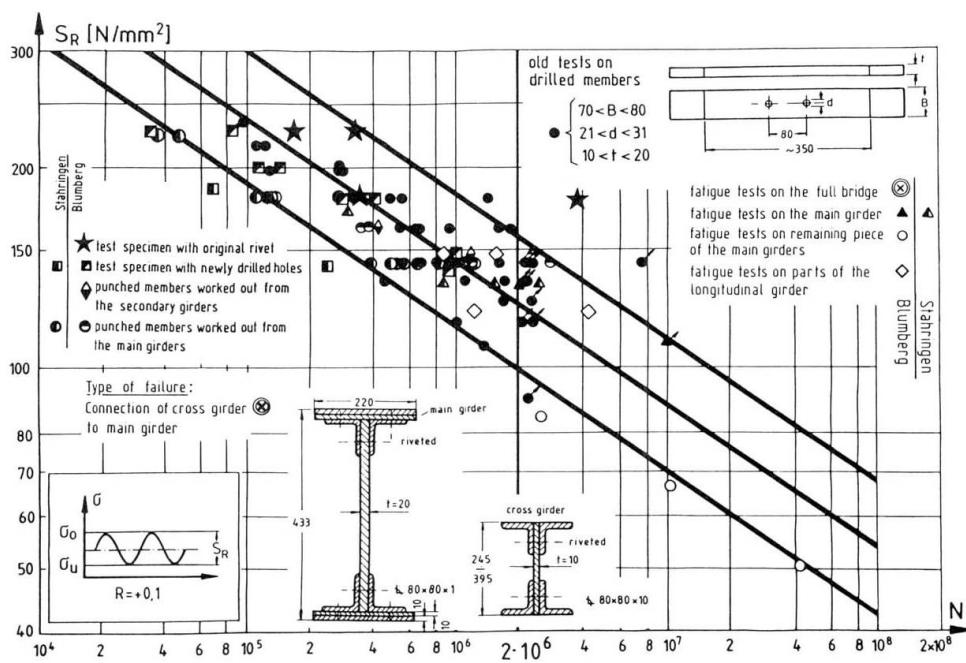
Fig. 8 shows the test results in comparison with earlier data obtained by tests on punched specimens of puddled iron. The diagram shows that the results of the main girder and transverse girder tests are within the range of scattering of results for small-scale specimens.

Fig. 8 Results of tests on components of the Blumberg bridge compared to earlier test results of punched specimens

The results of the specimens taken from the remaining parts of the main girder are slightly beyond the $P_{\bar{u}} = 97.5\%$ line which is due to previous fatigue loads endured during service and during the girder tests (1.6 to $2.0 \cdot 10^6$ stress cycles).

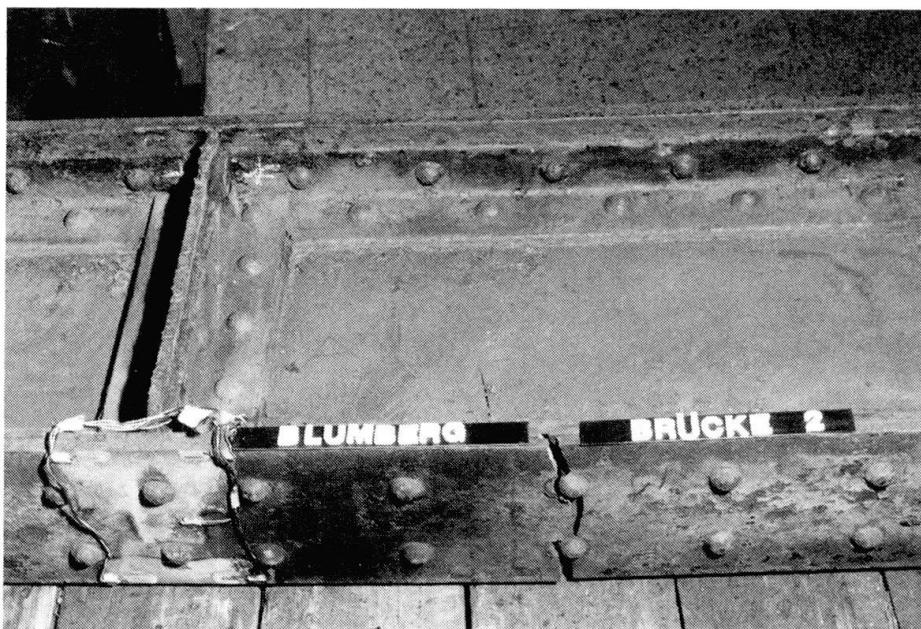
Four specimens were taken from the longitudinal girders of the Museumsbahn bridge and subjected to three-point-bending tests with a span of 1500 mm. For two specimens the maximum stress was 165 N/mm², for the other ones 135 N/mm². The ultimate stress ratio was $R = + 0.1$. The test results are shown in Fig. 8 in comparison with earlier data for flat plate specimens of similar age. The cracks usually started at a distance of about 600 mm from the point of support and proceeded diagonally through the web. In some specimens further cracks occurred in the angle sections. Fig. 9 gives an example of the failure mode.

Fig. 9 Failure mode for the longitudinal girder of the Blumberg bridge

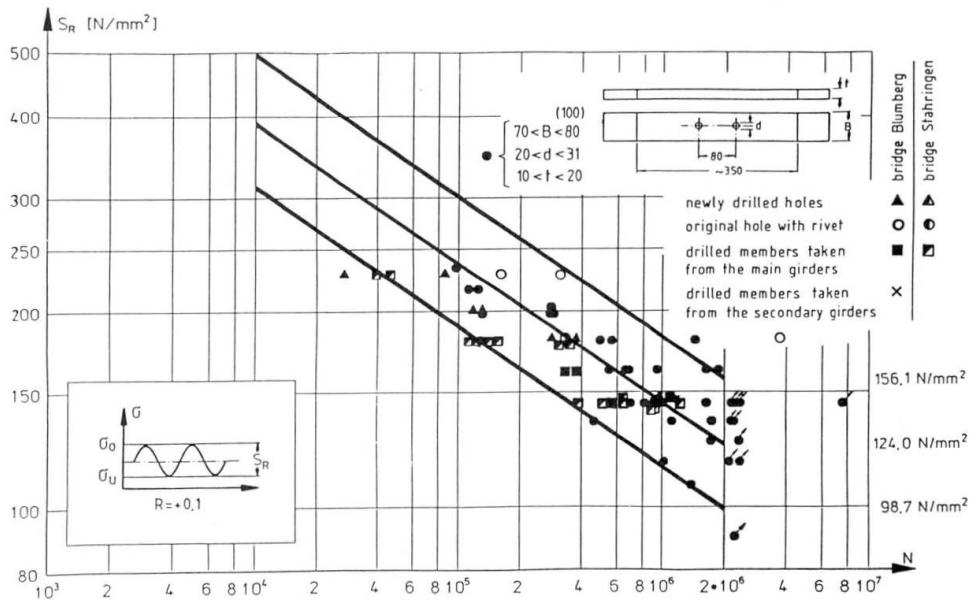
It is evident that the test results are in good agreement with earlier data, although the data of the Stahringen bridge are comparatively low. The scattering of the results is comparatively large, as is the rule with old constructions.

Fig. 10 Results of tests on punched specimens and specimens with original rivets

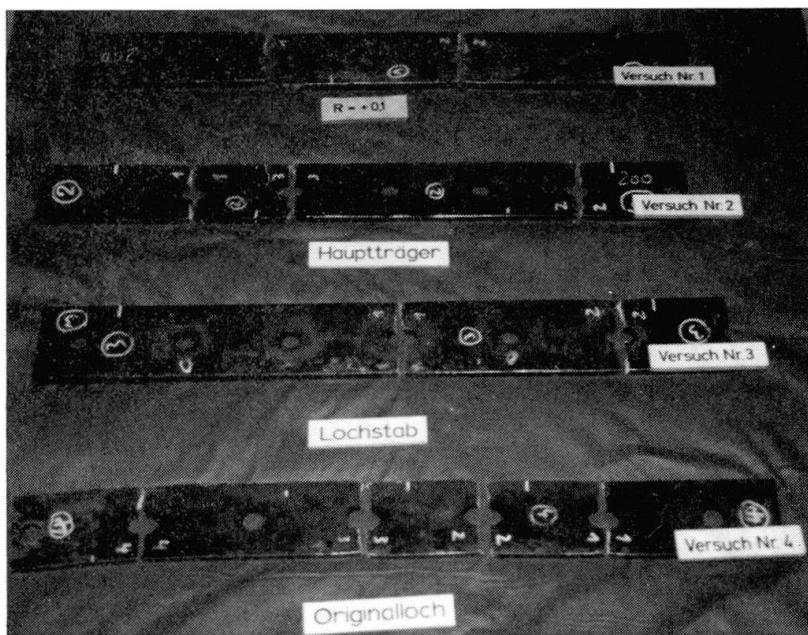
Two specimens taken from the web area are also in good agreement with earlier test data. As expected, the fatigue cracks started from rivet holes. Fig. 11 shows the specimens taken from the main girder of the Stahringen bridge after failure. After the first crack had occurred the specimens were re-fixed until a second or a third crack started from another rivet hole.

Fig. 11 Specimen after failure (punched specimen from Stahringen bridge)

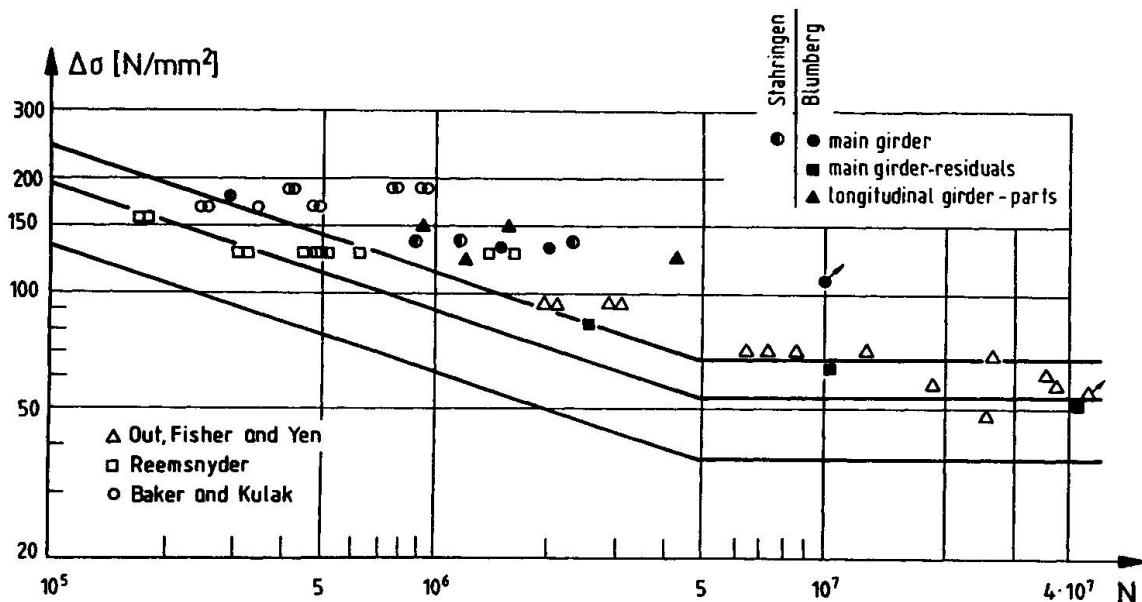
As mentioned before, information on the fatigue behaviour of old steels, particularly from the 19th century is very scarce. Hirt and Brühwiler [3] were the first researchers to carry out a methodical evaluation for two old bridge components. They compared their results to those of three other reports. For comparison the test results of the Blumberg bridge and the Stahringen bridge were entered into the diagrams of Figs. 12 and 13.

Fig. 12 Test results and data from [3]

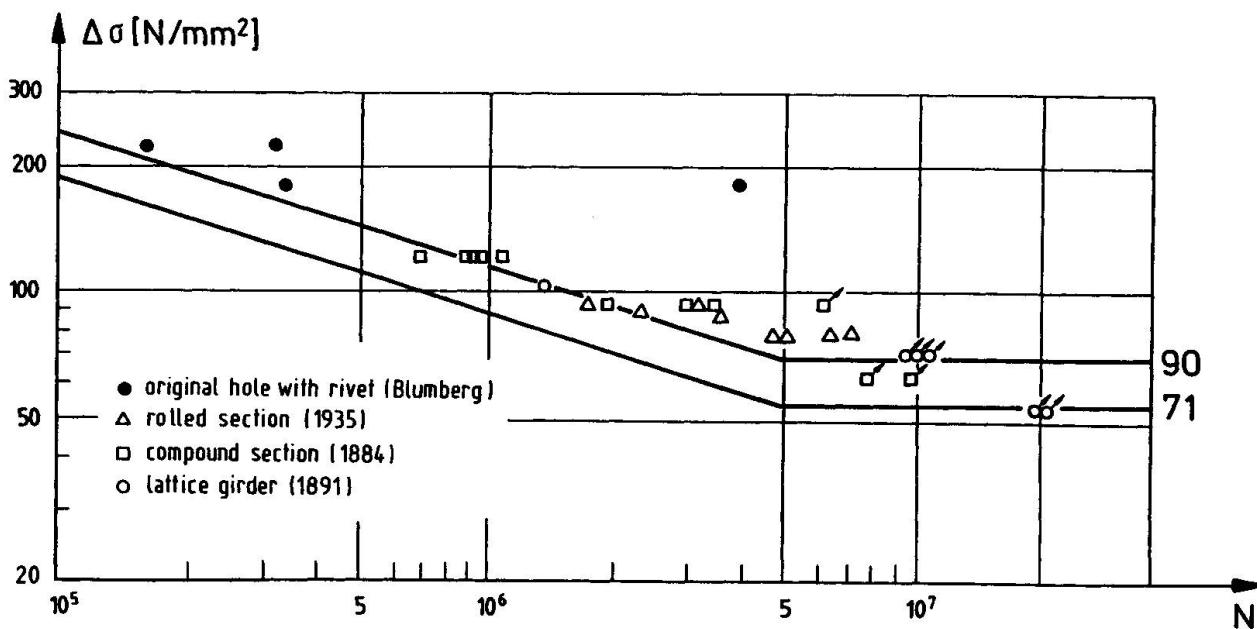
Fig. 13 Test results and data from [3]

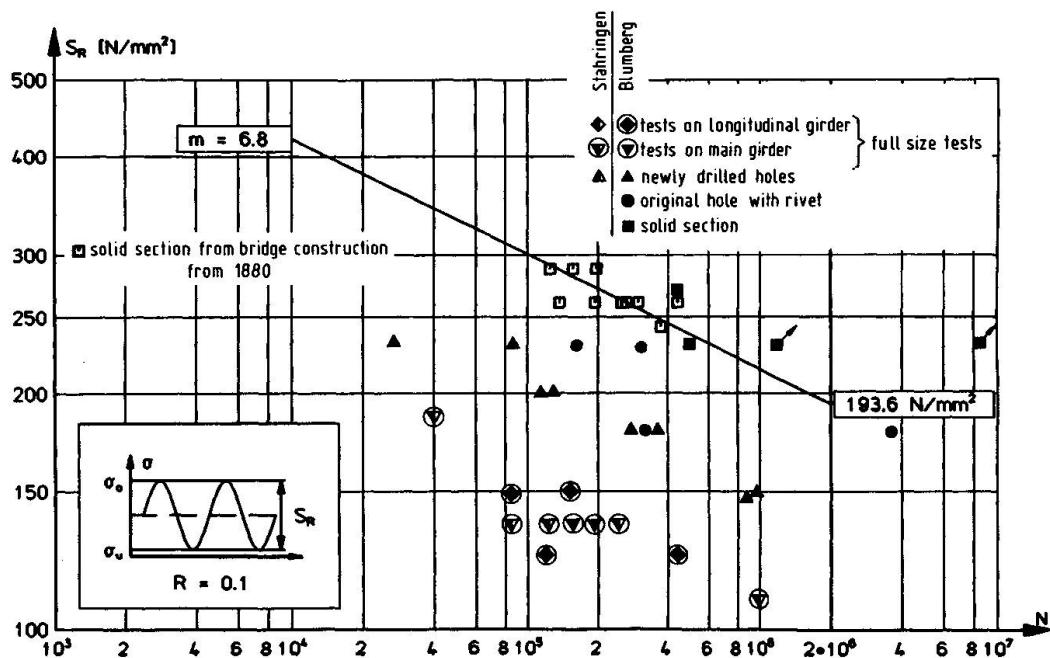
Fig. 14 Test results and data from [5], bridges dating from 1880, plain material

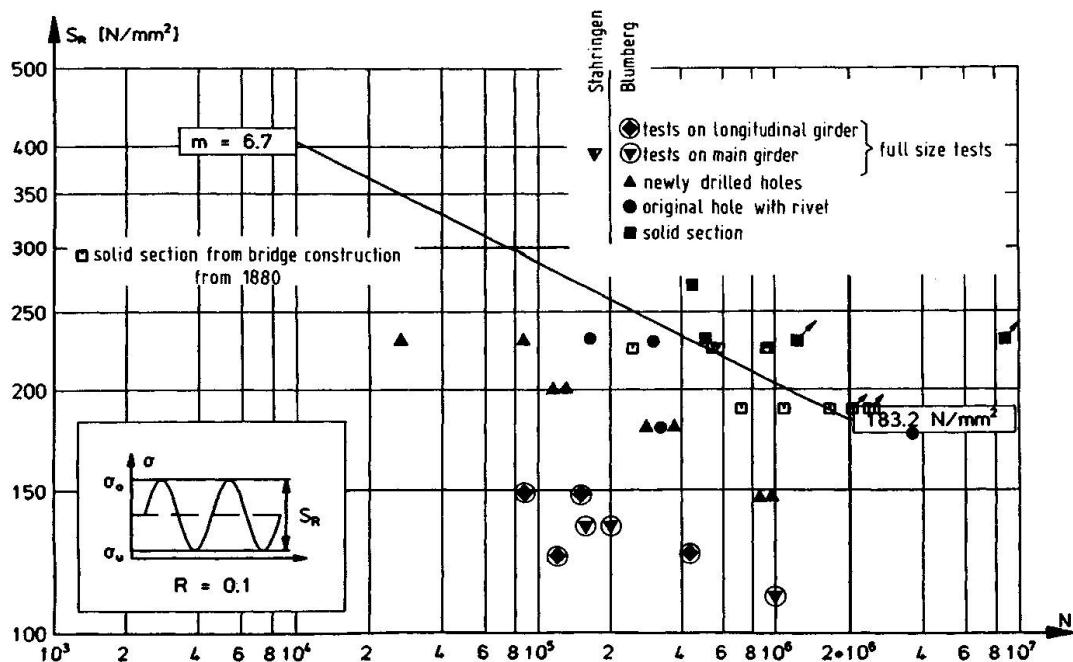
Fig. 15 Test results and data from [5], bridges dating from 1880, plain material prestressed by 290 N/mm² and 10⁵ stress cycles

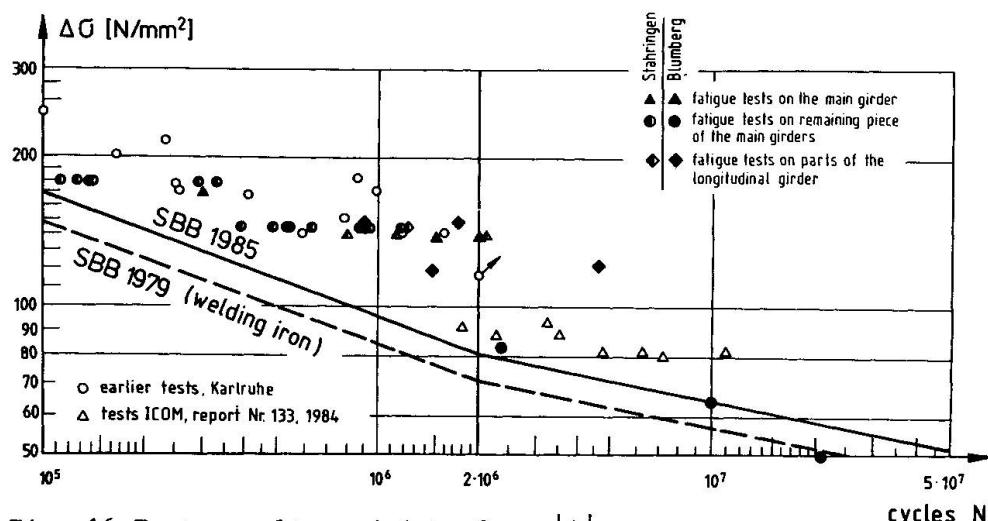
Fig. 16 Test results and data from [4]

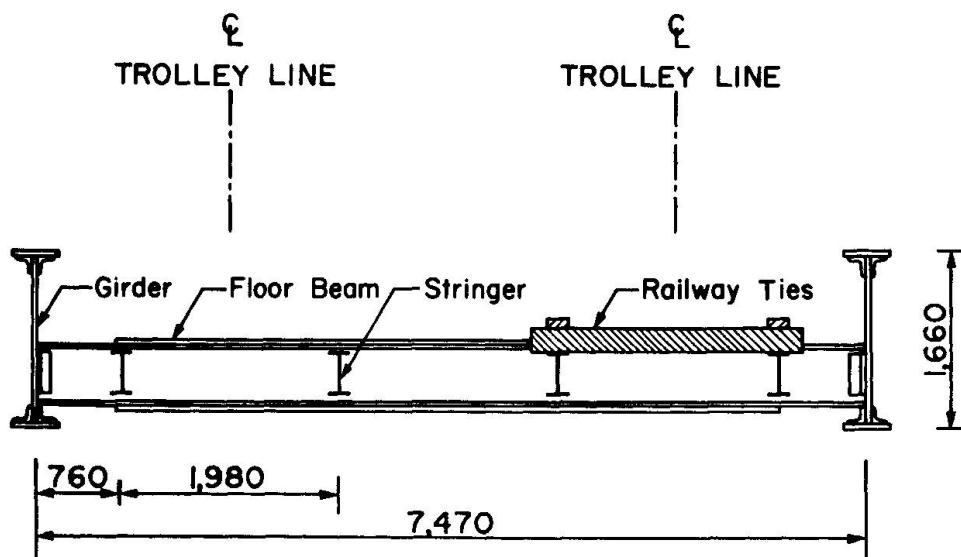
The remaining fatigue strength of the A7 rolled steel beams was determined with tests of trolley bridge stringers that were exposed to the environment for long periods of time. These stringers consisted of 4.72 m long standard beams of W 15x42 (380 mm deep and weighing 62.4 kg/m) cross section. They were removed in 1985 from a bridge carrying the Maryland Line over the Paint Branch in College Park, Maryland. The bridge was built in 1900 and abandoned in 1985. Figure 1 shows a cross section of the bridge.

Fig. 1 Cross Section of Trolley Bridge

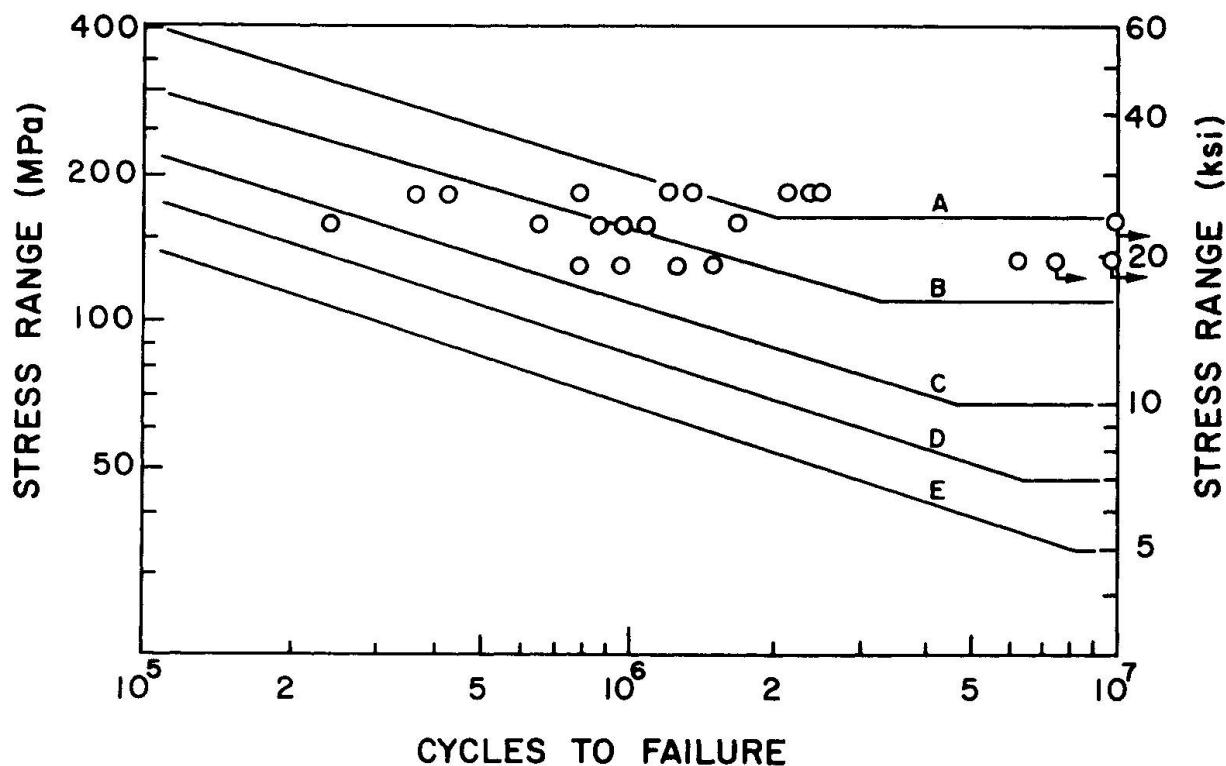
The fatigue test data for the trolley bridge stringers are compared in Fig. 2 with the allowable S-N lines for the AASHTO Category A through E details. The aforesighted defects reduced the fatigue strength of the standard rolled beams from Category A for base metal to Category C for transverse stiffeners and 50 mm long attachments. The reduction in fatigue strength was greatest for rust pits at railway ties, followed by rust pits away from railway ties, and smallest for rolled-in seams and indentations.

Fig. 2 Fatigue Test Data for Carbon Steel Beams

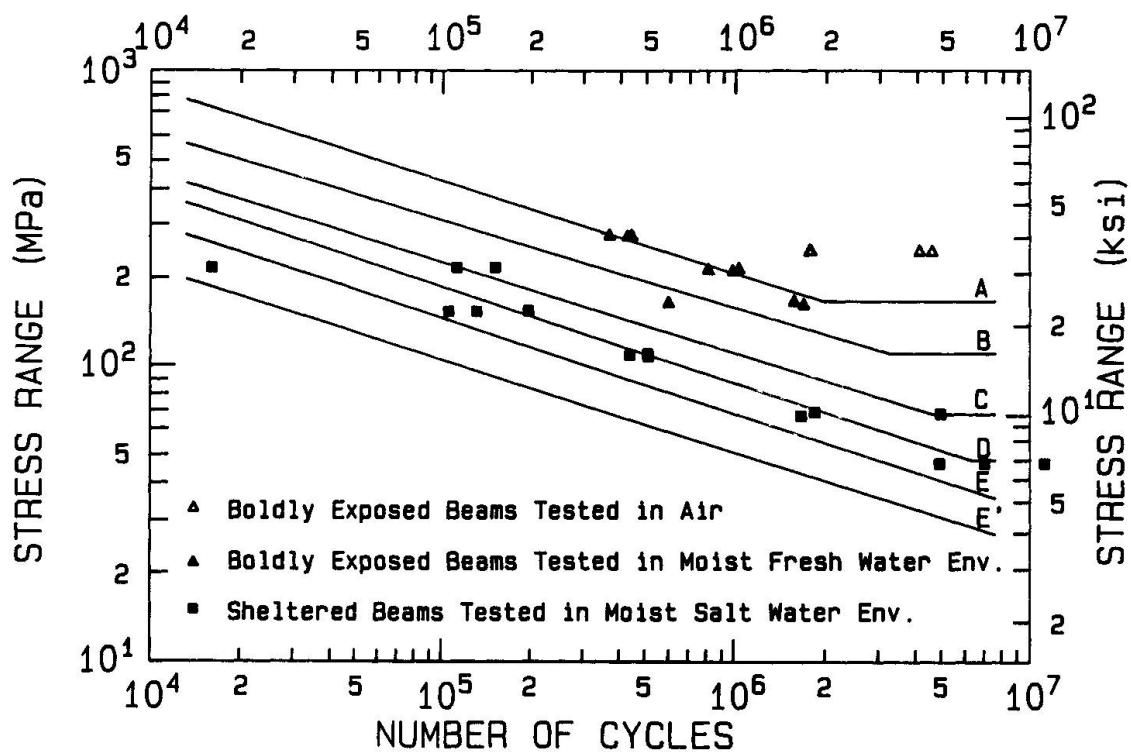
Fig. 3 Fatigue Test Data for Weathering Steel Beams

The fatigue test data for the weathering steel beams are compared in Fig. 3 with the allowable S-N lines for the AASHTO Category A through E' details. As can be seen, the boldly exposed beams had Category A fatigue strength when tested in air, and B when tested in a moist fresh water environment. The sheltered beams tested in a moist salt water environment had Category E fatigue strength, with one beam failing below Category E. The loss in fatigue strength was 31 percent for the boldly exposed beams and 69 percent for the sheltered beams. The total reduction in fatigue strength exhibited by the beams tested in the aqueous environments is attributed to (a) the loss in cross-sectional area due to corrosion in plane of crack, (b) the aqueous test environment, and (c) the stress concentration effect of the rust pits. Accordingly, the fatigue notch factor of a bare exposed weathering steel beam can be expressed as the product of the corrosion, environment, and pitting factors.

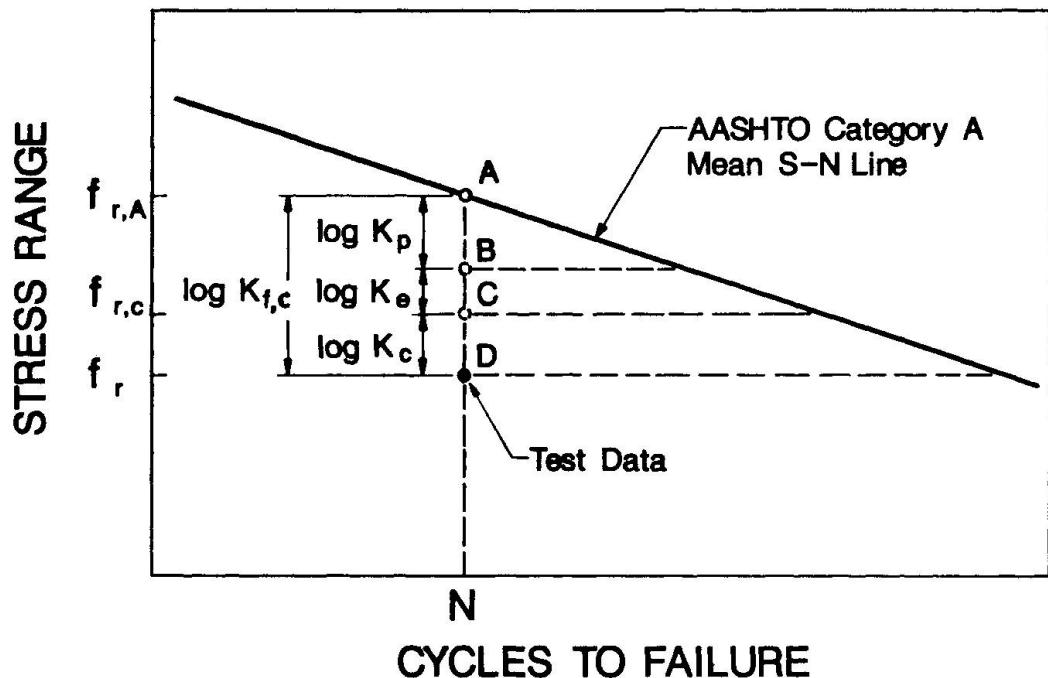
The total reduction in fatigue strength of a corroded beam is the vertical distance in Fig. 4 between the solid data point D for that beam and point A on the mean S-N line for Category A rolled beams given by

The terms K_c , K_e , and K_p are hereafter referred to as the corrosion factor, environment, and pitting factors, respectively. Their logarithms are equal to the distances CD, BC, and AB shown in Fig. 4. The corrosion factor is calculated from

Fig. 4 Illustration of Fatigue Strength Reduction Factors

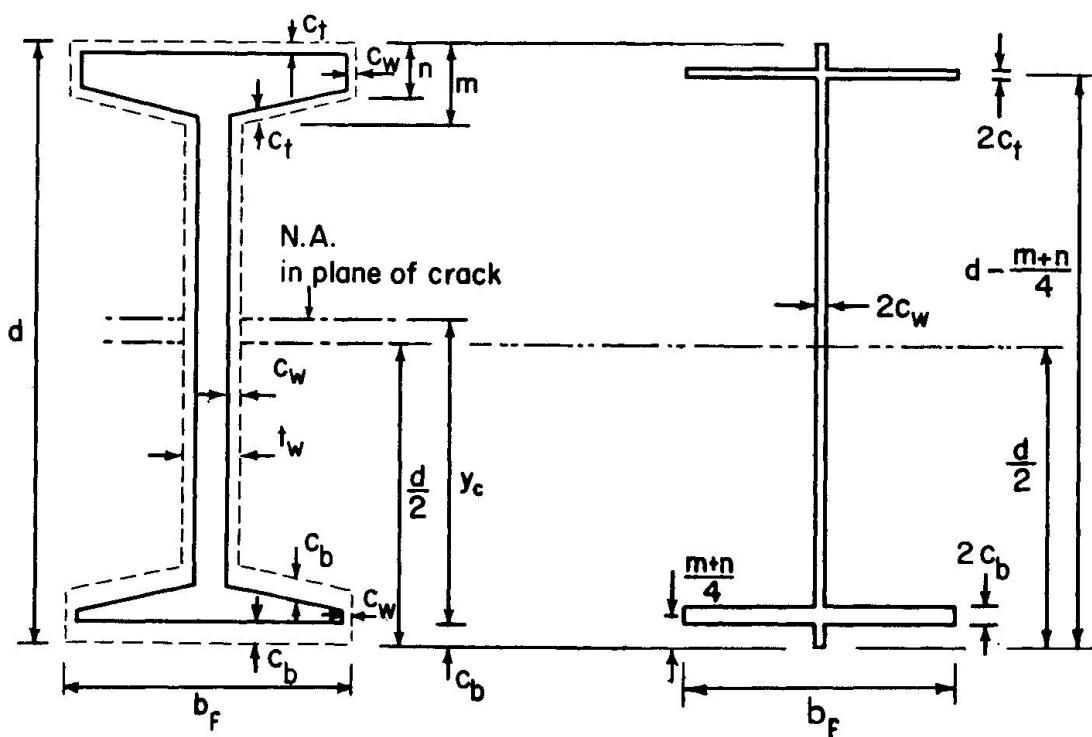
Fig. 5 Standard Beam with Noncorroded and Corroded Sections on left, Section Loss on Right

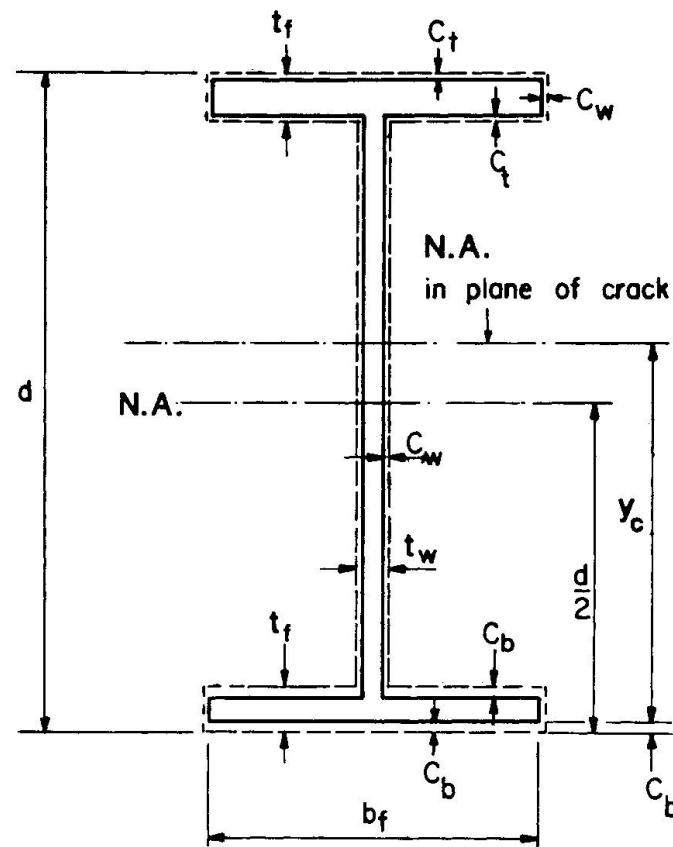
Fig. 6 Wide Flange Beam with Noncorroded and Corroded Sections

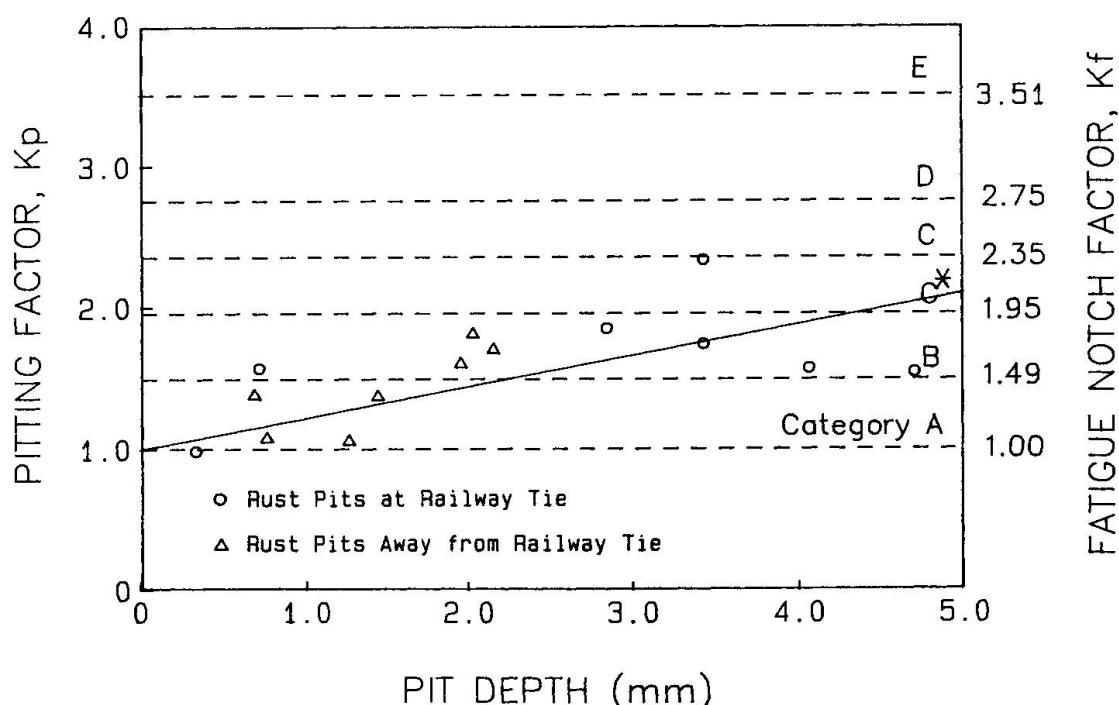
Fig. 7 Pitting Factor for Carbon Steel Beams

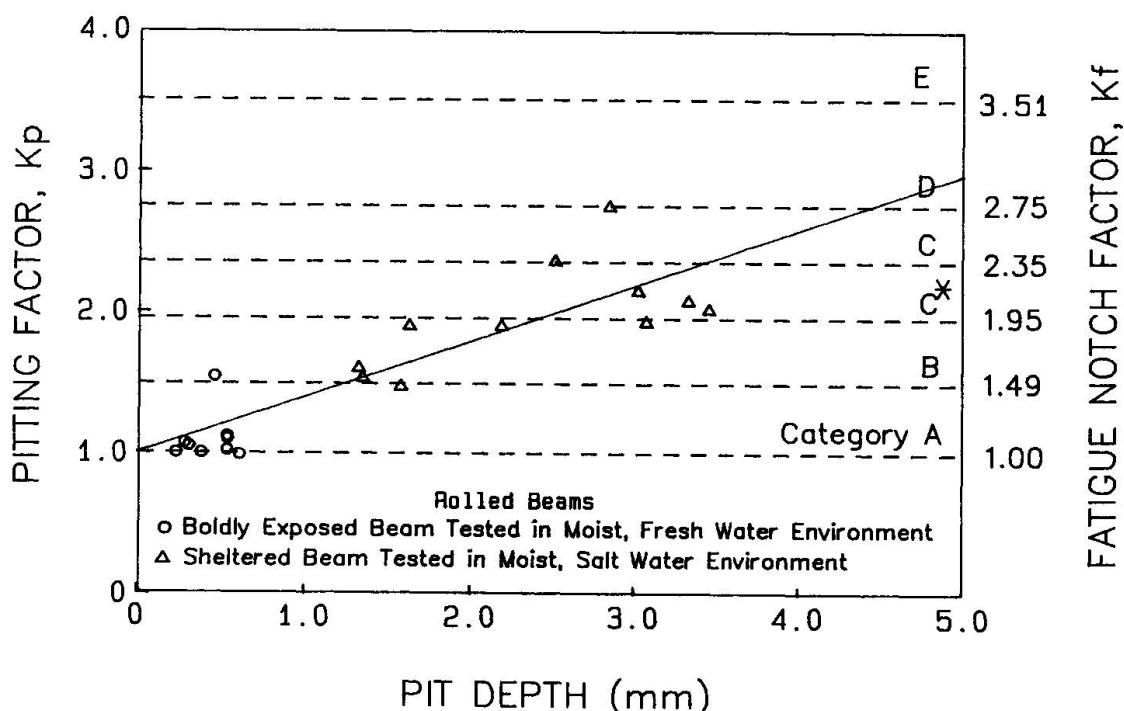
As an example of the severity of the rust pits in weathering steel beams, substituting the fatigue notch factors listed on the right vertical axis of Fig. 8 into Eq. 17 in place of K_p and solving for d_p , one finds that pit depths of $d_p = 1.2, 2.4, 3.4$, and 4.4 mm, respectively, reduced the fatigue strength of the weathering steel beams on the average to the mean fatigue strength of Category B welded beams, Category C* transverse stiffeners, Category C 50-mm attachments, and Category D 100-mm attachments.

Fig. 8 Pitting Factor for A588 Weathering Steel Beam

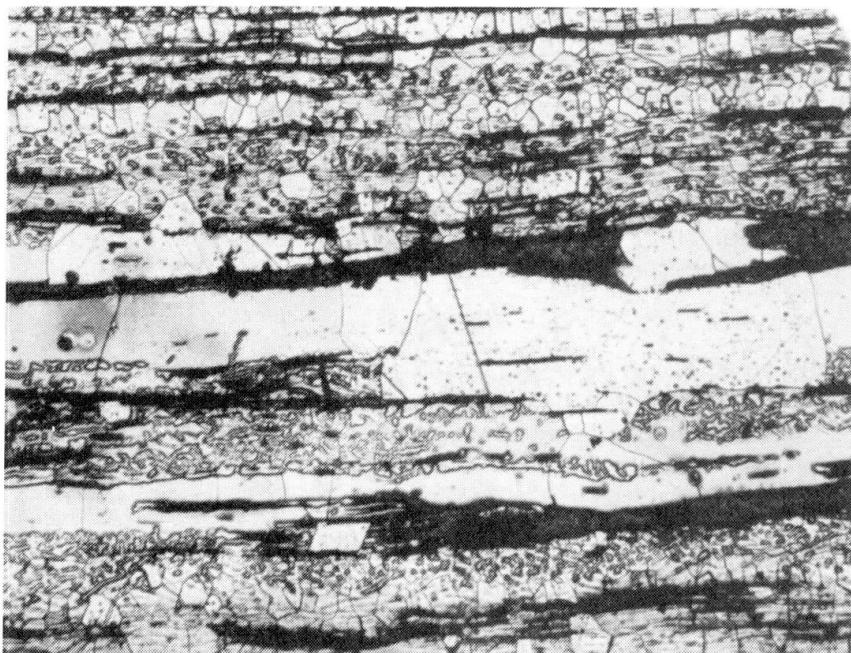
Fig. 1: Microstructure of wrought iron (magn. 50x)

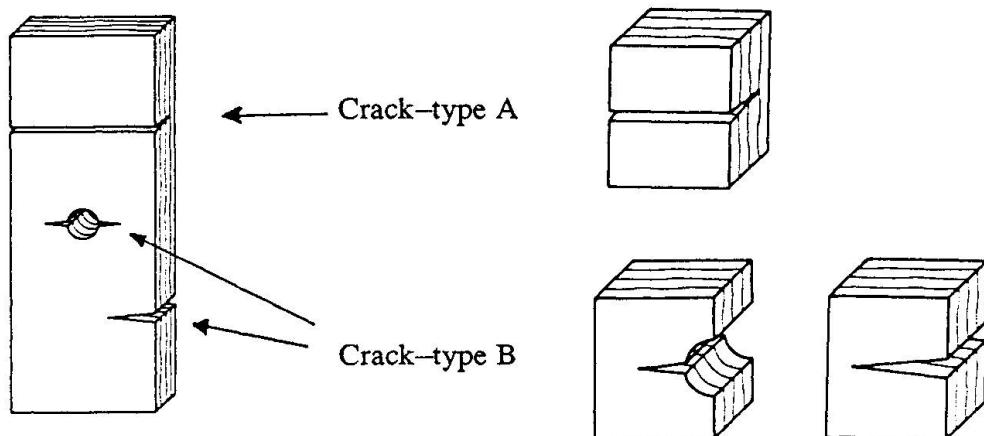
Fig. 2: Definition of crack-type A resp. B.

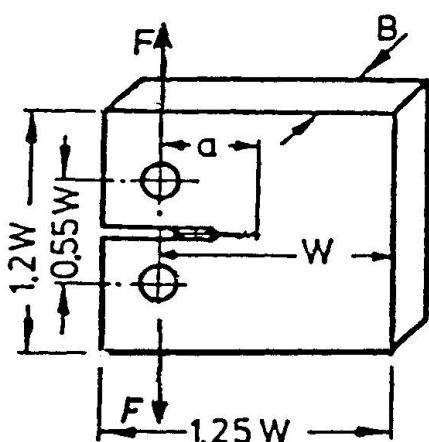
Fig. 3: Geometry of compact tension (CT-) specimen used. For dimensions see Tab. 2.

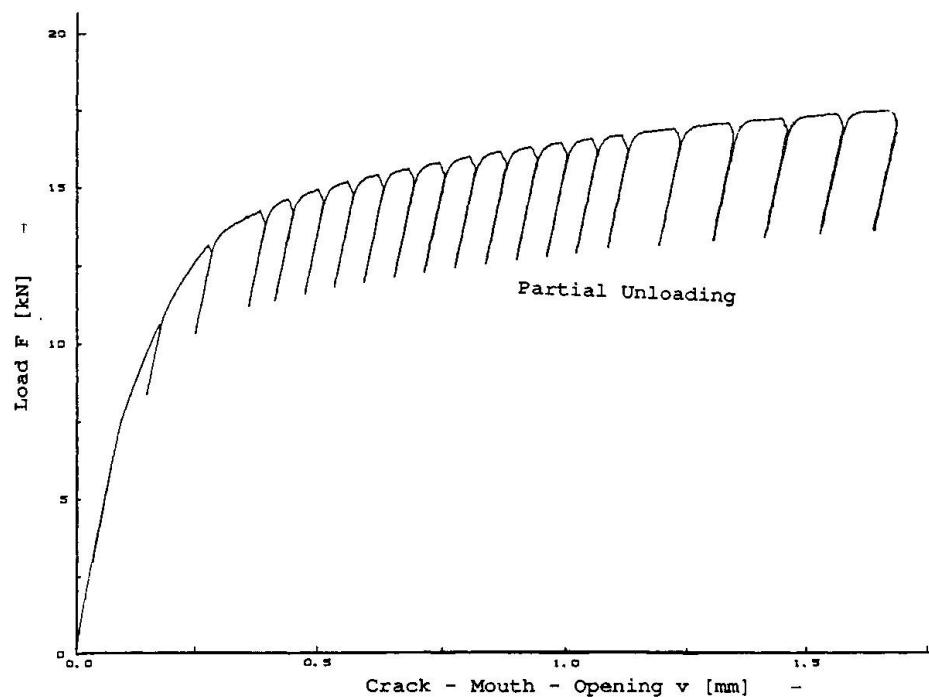
Fig. 4: Example of load vs. crack-mouth opening at load-line as measured on specimen W4

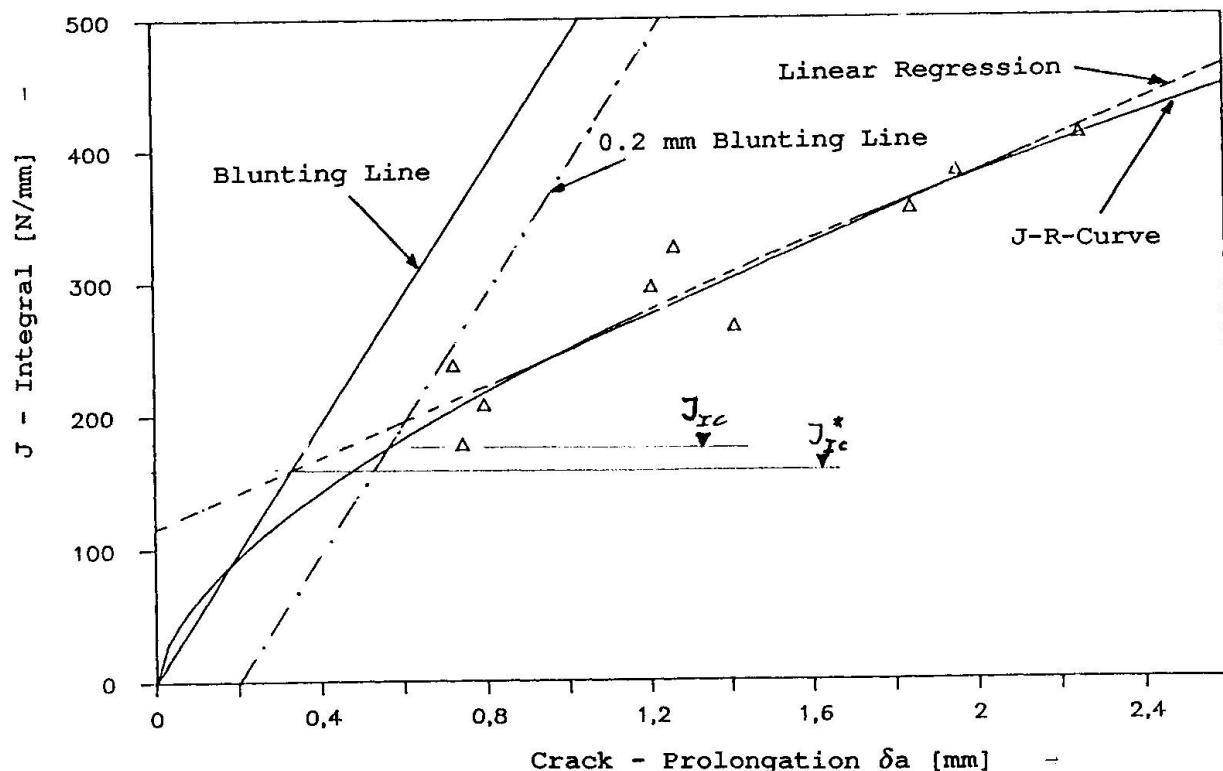
Fig. 5: Example of J-Integral vs. crack-prolongation δa (J-resistance-curve) calculated from load-displacement-curve (Fig. 4) and definition of J_{Ic} . For comparison J_{Ic} according to ASTM E813-81 (issue 1981 of [7]), denoted by J_{Ic}^* , is also shown.

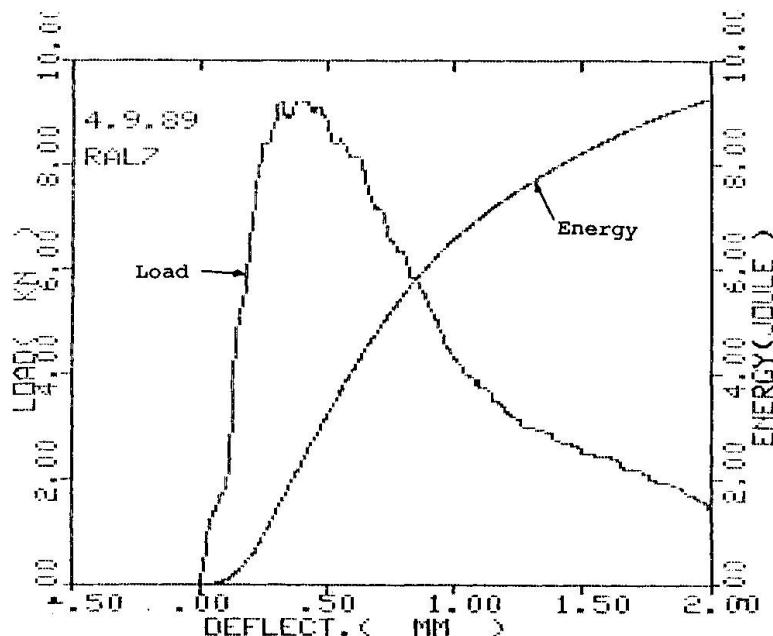
Fig. 6: Example of a load vs. deflection curve and transmitted energy vs. deflection curve of a 3-point-bend impact test with precracked Charpy-specimen. This curve is calculated from the load vs. time curve.

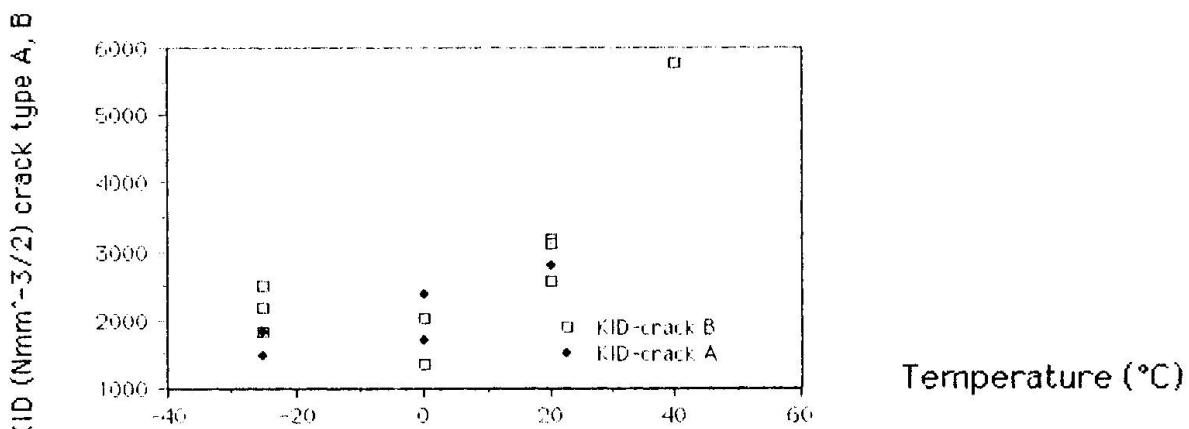
Whereas the Charpy test exhibited no clear transition behaviour the dynamic fracture toughness measured on precracked Charpy-specimens show a remarkable increase in the temperature range between approximately 0 and 40°C. According to [11] the shift in the transition temperature between static loading and impact loading is about 90°C (for steel with yield-stress of 240 N/mm²). Thus one can conclude, that fracture toughness is at the upper shelf (i.e. approximately 5000 N/mm^{3/2}) for all in-service conditions.

Fig. 7: Dynamic fracture toughness vs. temperature

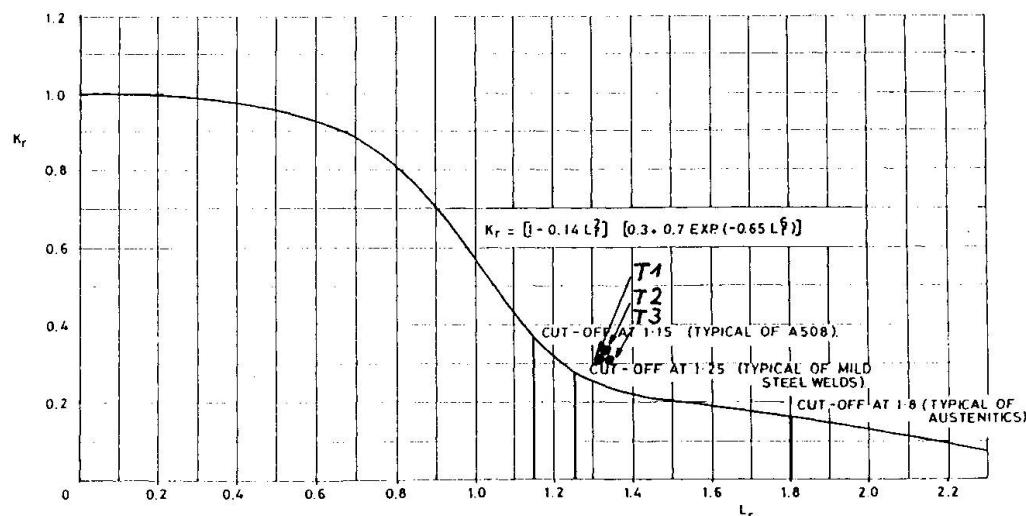
Fig. 8: Failure assessment diagram according to [12]. The points T1, T2 and T3 correspond to fracture tests on precracked component-like specimens
