Zeitschrift: IABSE reports = Rapports AIPC = IVBH Berichte
Band: 59 (1990)

Rubrik: Theme B: Behaviour of materials

Experimental and Theoretical Investigations of Existing Railway Bridges

Remaining Fatigue Strength of Corroded Steel Beams

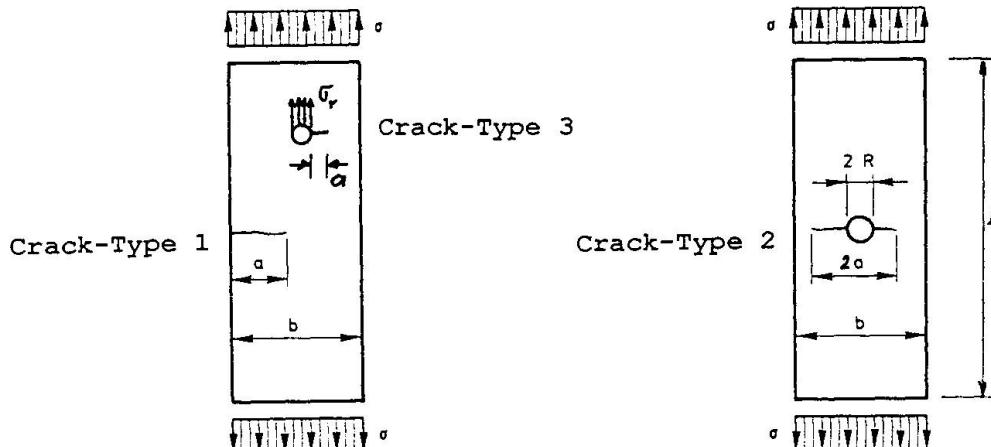
Fig. 9: Definition of crack-types 1, 2 and 3 considered in Tab.3.

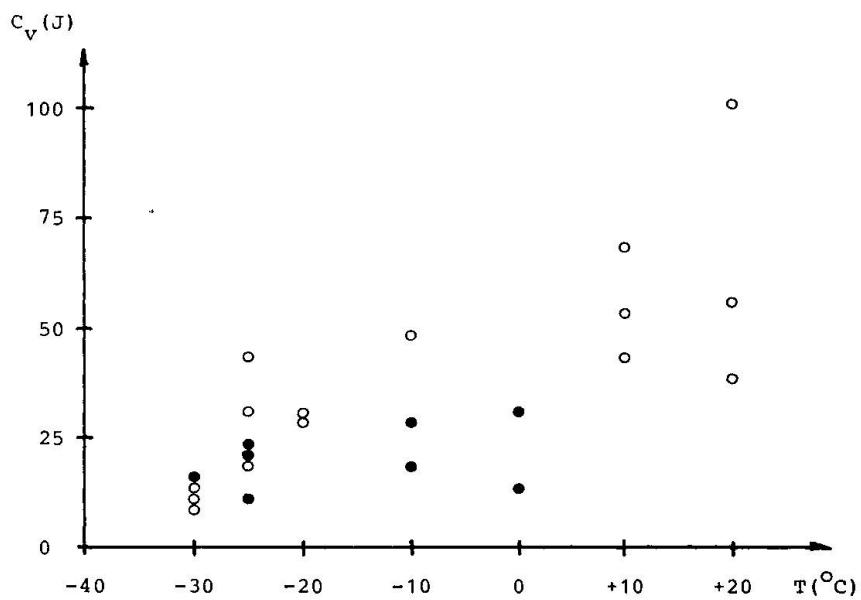
Fig 1. Charpy-V notch toughness for two specimen series of a given material. o Ser no 1. ● Ser no 2.

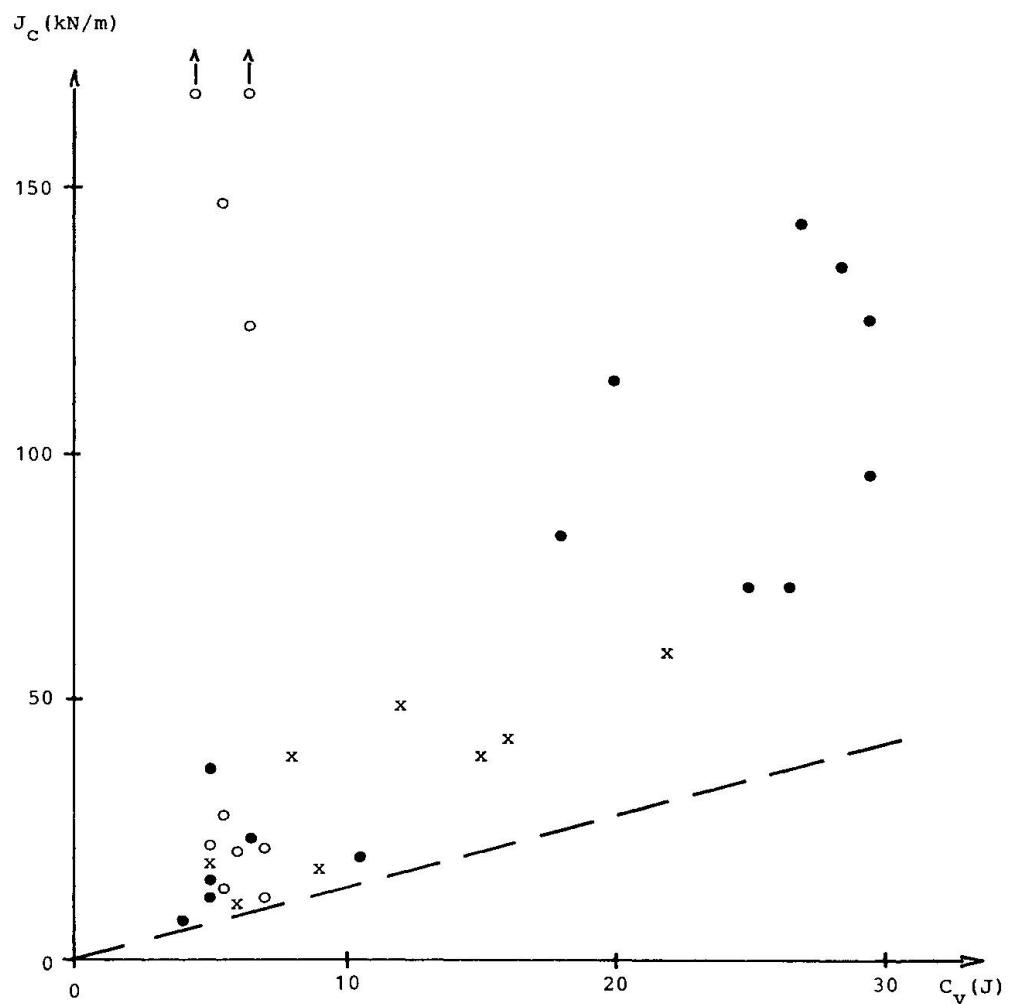
Fig 2. Fracture toughness J_C and Charpy-V notch toughness C_V .
o This investigation, x Ref (4), ● Ref (5).
- - - Ref (6).

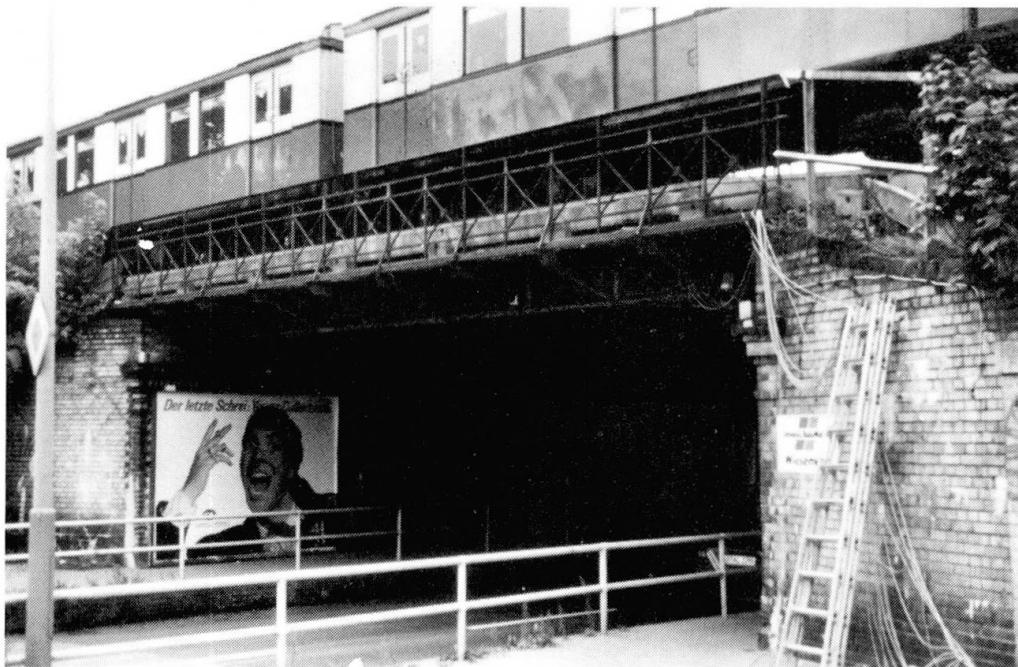
Figure 1.
Steel bridge
of the
Berlin
Metropoli-
tan, built
in 1898,
replaced
1988

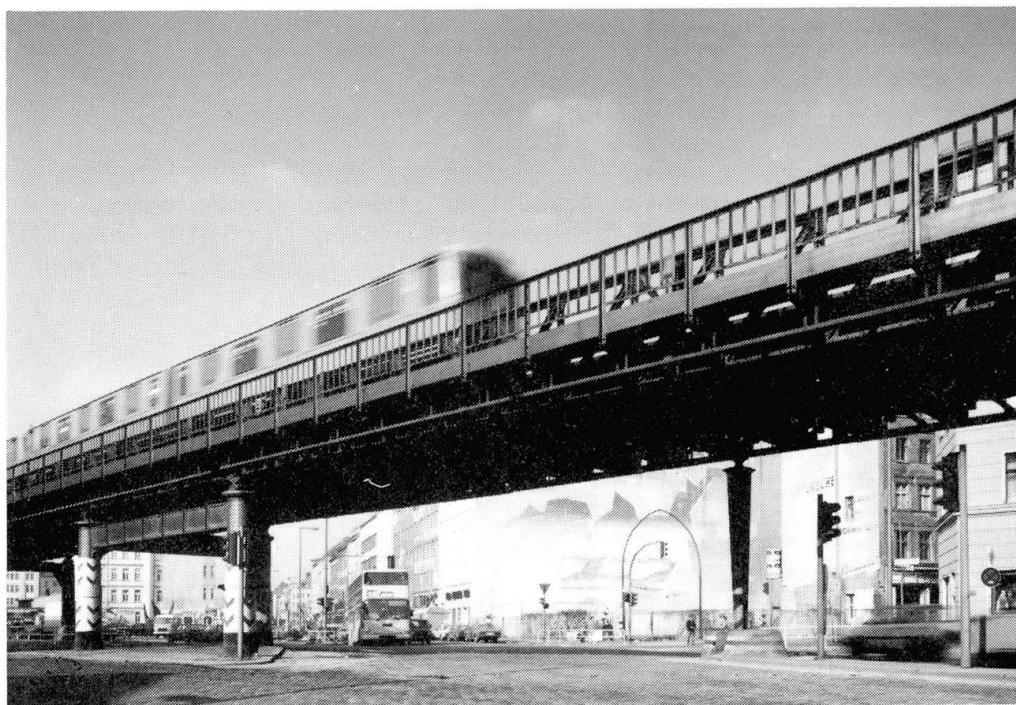
Figure 2.
Truss gir-
der bridge
of the
Berlin
Underground,
built in
1902, re-
placed in
1989

Today, we perform cyclic loading tests on parts of the Berlin Underground Bridge shown in fig. 2, which was built in 1902.

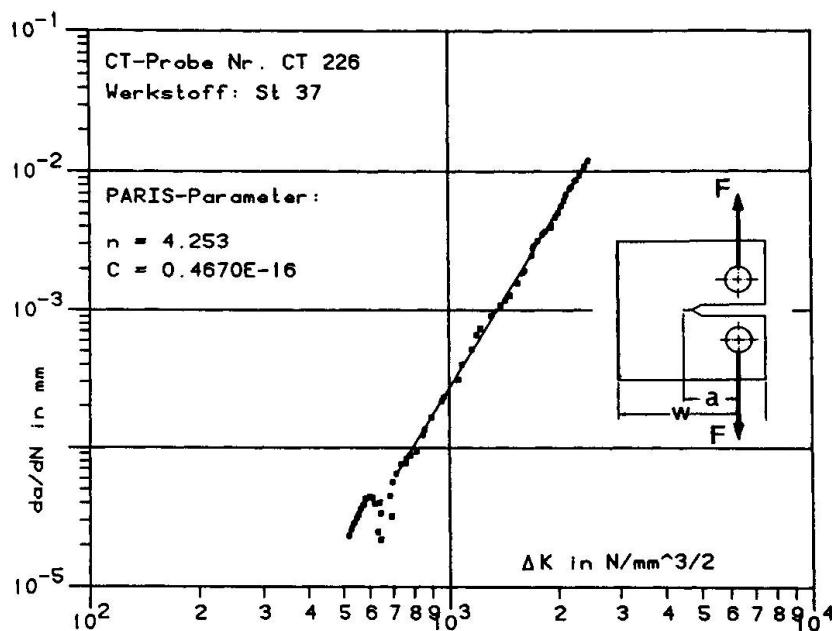
Figure 3.
Result of
one of the
crack
growth
tests (ASTM
E 647-83)
with re-
gression
line re-
garding the
Paris equa-
tion (1)

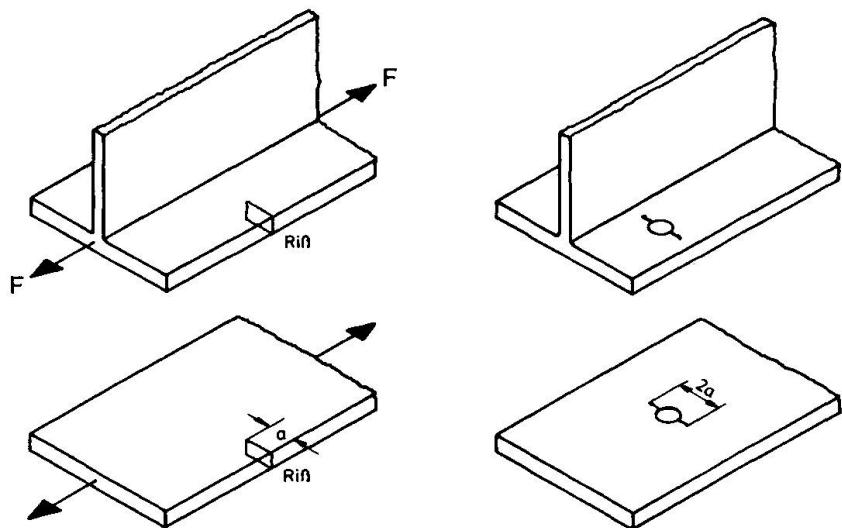
The application of fracture mechanics in the evaluation of remaining fatigue life implies the modelling of cracks in structural members, which can presumably appear, fig 4. The propagation of cracks then is only governed by the stress intensity at the crack's tip as expressed by the Paris equation. On this basis, it is possible to predict how far a certain crack can grow within the period of time between two inspections.

Figure 4.
Crack patterns in riveted members for evaluating stress intensity factors and crack growth

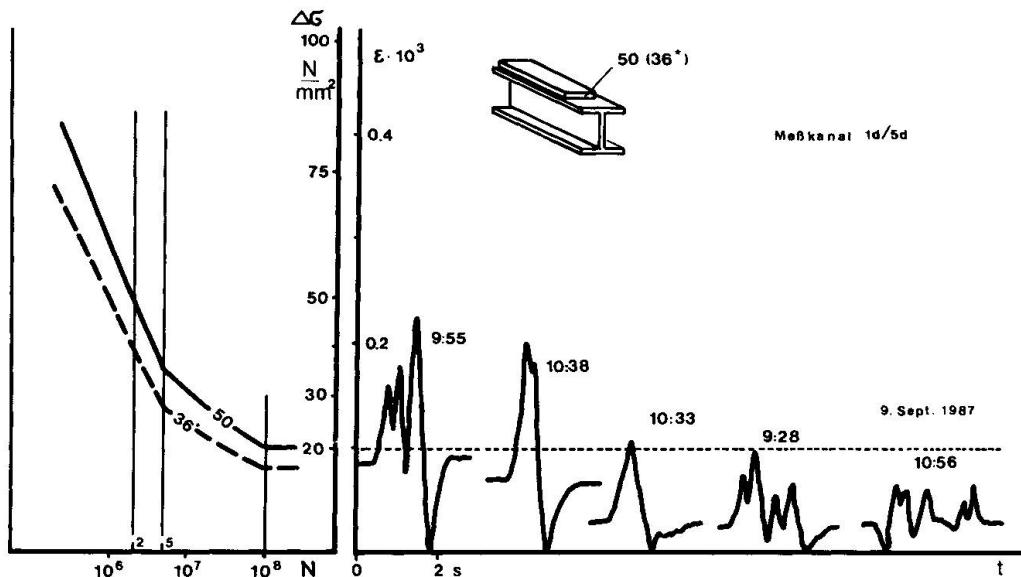
Figure 5. Measured strains/stresses during about 3 hours of observation at one measuring point.
