**Zeitschrift:** IABSE reports = Rapports AIPC = IVBH Berichte  
**Band:** 59 (1990)

**Rubrik:** Theme B: Behaviour of materials

## Experimental and Theoretical Investigations of Existing Railway Bridges

## Remaining Fatigue Strength of Corroded Steel Beams

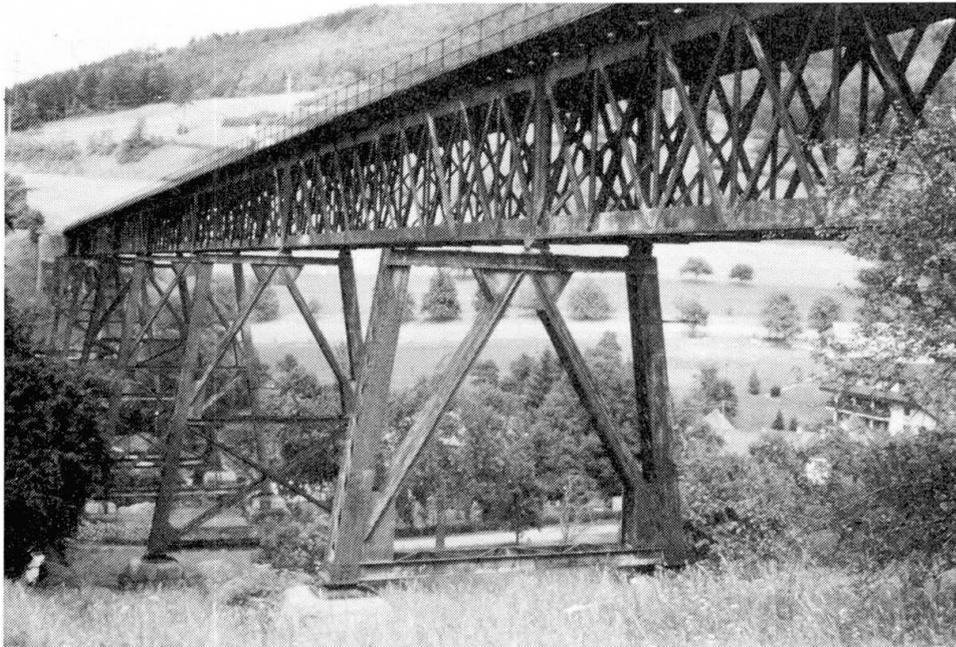
At the "Versuchsanstalt für Stahl, Holz und Steine" tests were carried out on a whole bridge built in 1887 which had been chosen from different bridge systems of the "Museumsbahn" (Fig. 2).

Fig. 2 Bridge of the "Museumsbahn"

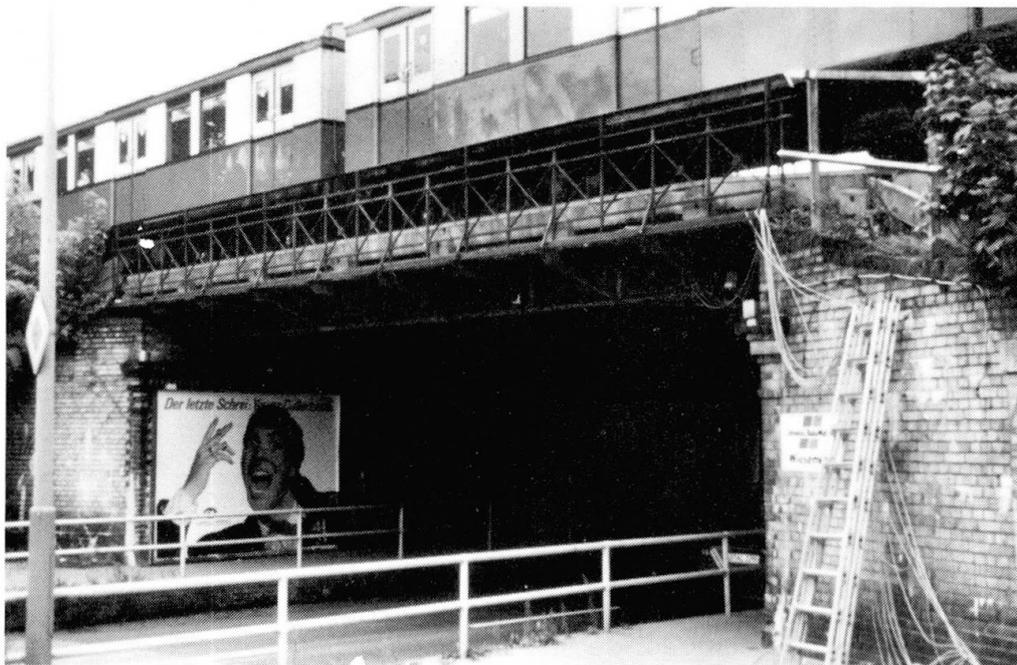
Figure 1.  
Steel bridge  
of the  
Berlin  
Metropoli-  
tan, built  
in 1898,  
replaced  
1988
