**Zeitschrift:** IABSE reports = Rapports AIPC = IVBH Berichte  
**Band:** 59 (1990)

**Rubrik:** Theme B: Behaviour of materials

## Experimental and Theoretical Investigations of Existing Railway Bridges

## **Remaining Fatigue Strength of Corroded Steel Beams**

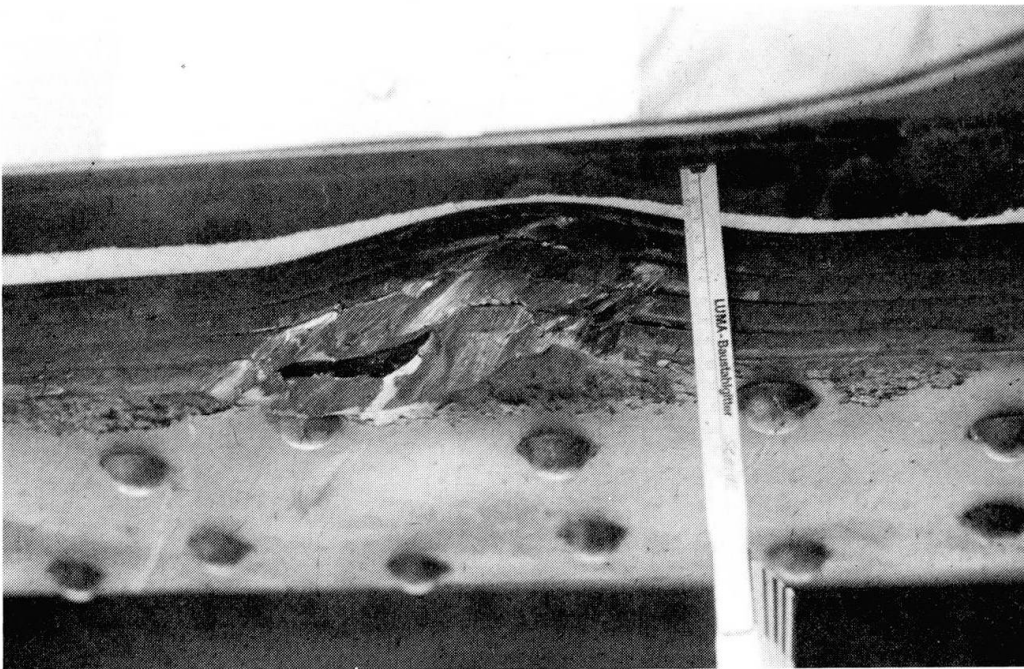
Fig. 1 Bridge damaged by impact

Defective structural components (damaged e.g. by corrosion, by accident (see Fig. 1) or by bullets) may cause a considerable reduction of the life of a construction depending on the situation of the defect and on the stress level. We therefore recommend to attach special importance to these points when visiting a construction.

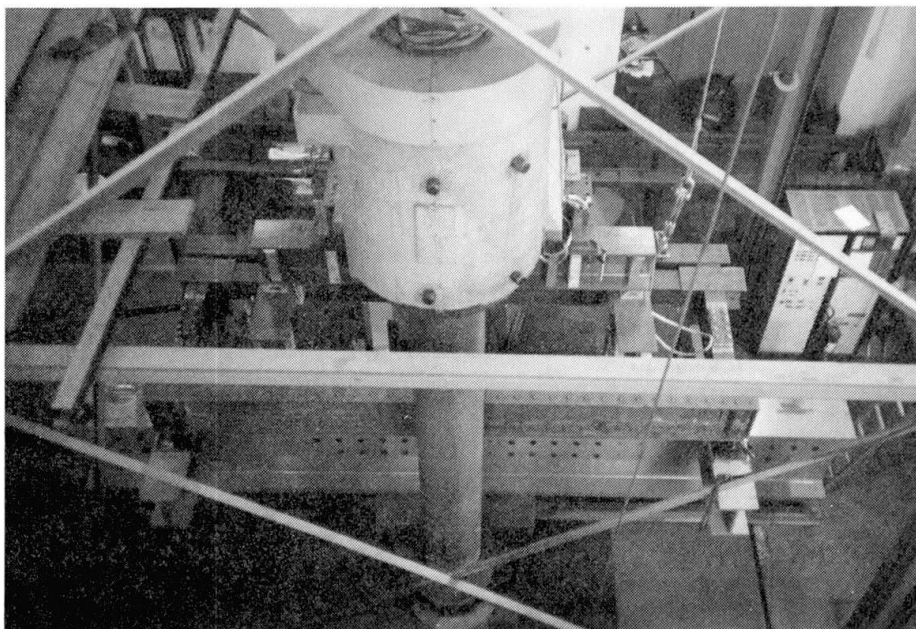
Fig. 3 Bridge of the "Museumsbahn" in the 50 MN power press

The whole bridge was built in the 50 MN power press of the institute. Fig. 3 shows the bridge built in according to load configuration LF 1.

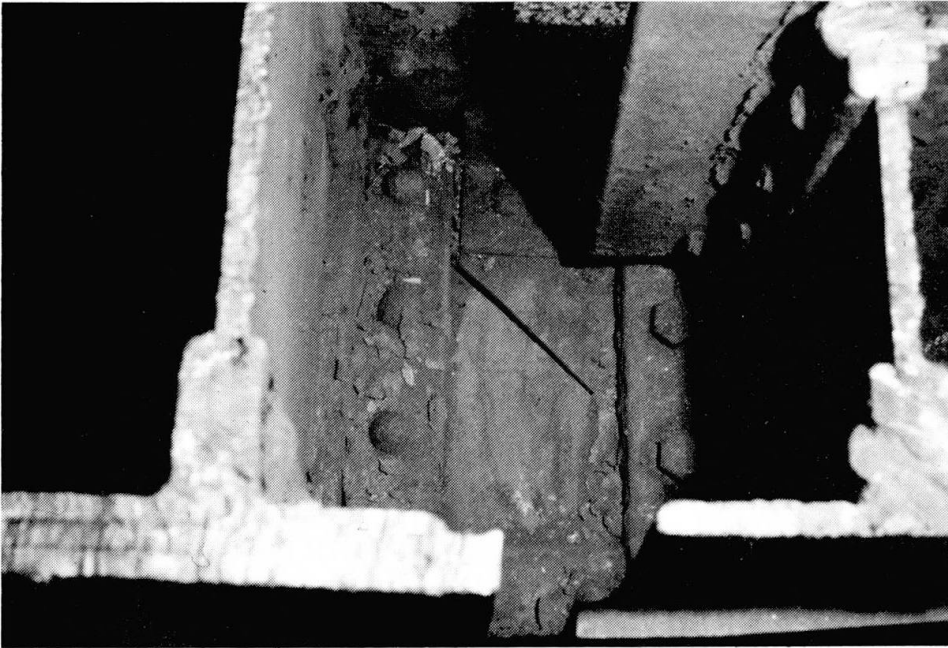
Fig. 4 Connection between transverse girder and main girder, crack in web plate

The test was interrupted at 108 070 stress cycles as a correct load application was no longer possible due to a large crack in the connection between transverse girder and main girder. Fig. 4 shows the point of failure.

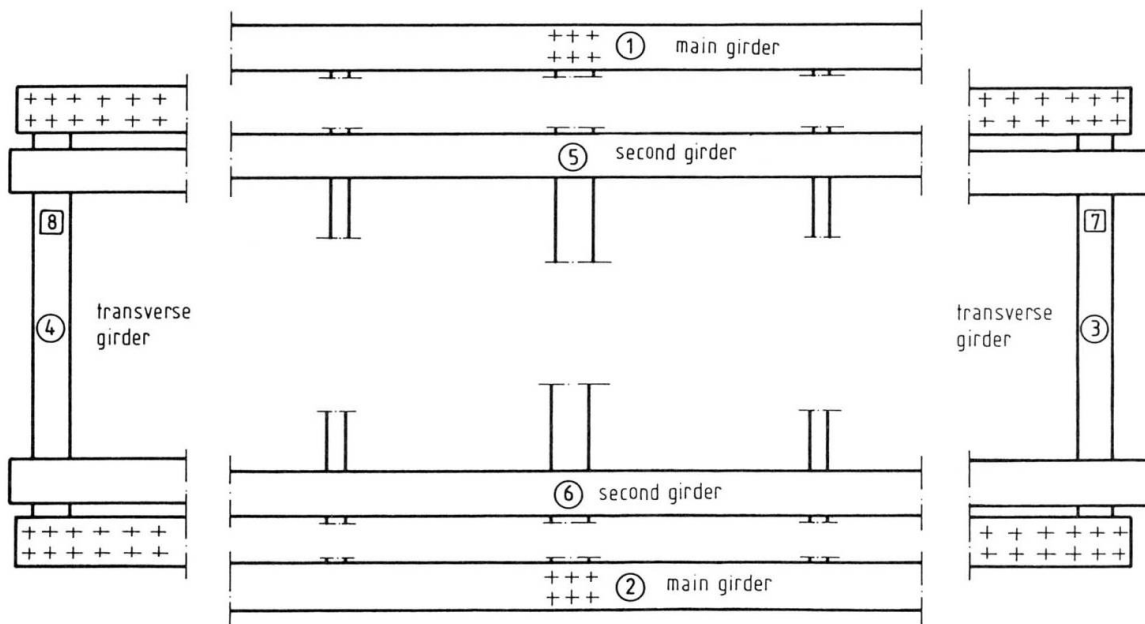
Fig. 5 Blumberg bridge - designation of specimens

Afterwards, the bridge was sawed up (see Fig. 5) to carry out separate tests on components (main girder, longitudinal girder) and connections (transverse girder, main girder).

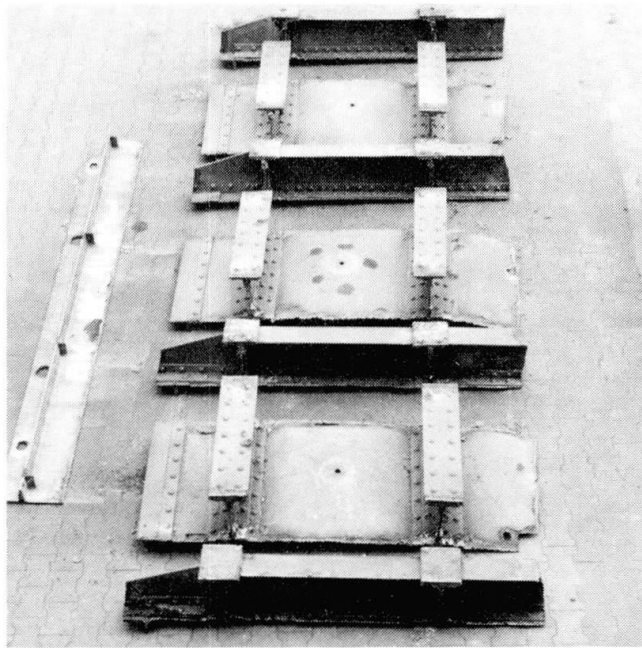
Fig. 6 Stahringen bridge - structural components

Analogously, the Stahringen bridge dating from 1895 was sawed up to investigate the two main girders and the connections between main girder and transverse girder. Fig. 6 shows the components of one half of the bridge. Punched specimens, riveted specimens as well as specimens of the plain web plate material were taken from the remaining bridge parts.

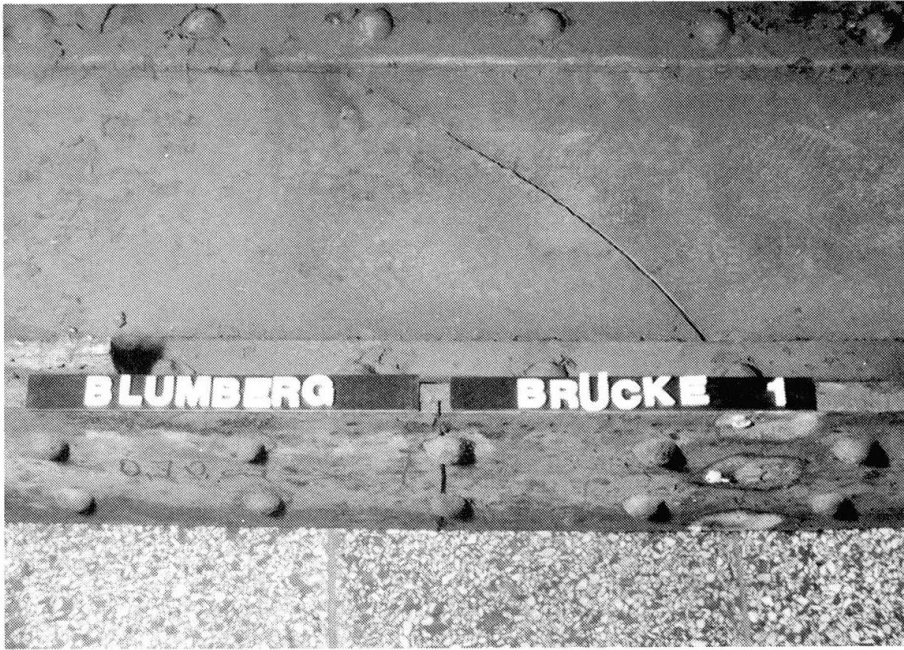
Fig. 7 Points of fracture of main girder I

Under a maximum stress of  $165 \text{ N/mm}^2$  and at 1 534 000 stress cycles the crack occurred in the web of main girder I of the Blumberg bridge. Despite the crack, the main girder carried the full load and the test was continued until the two angles and the cover plate of the main girder tensile chord failed at a total number of stress cycles of 1 572 600. This means that the minimum number of stress cycles between crack appearance and total failure of the main girder was 38 600 (see Fig. 7).

Fracture first occurred in the web, then in the angle section and finally in the cover plate. The cracks were not situated on one level.

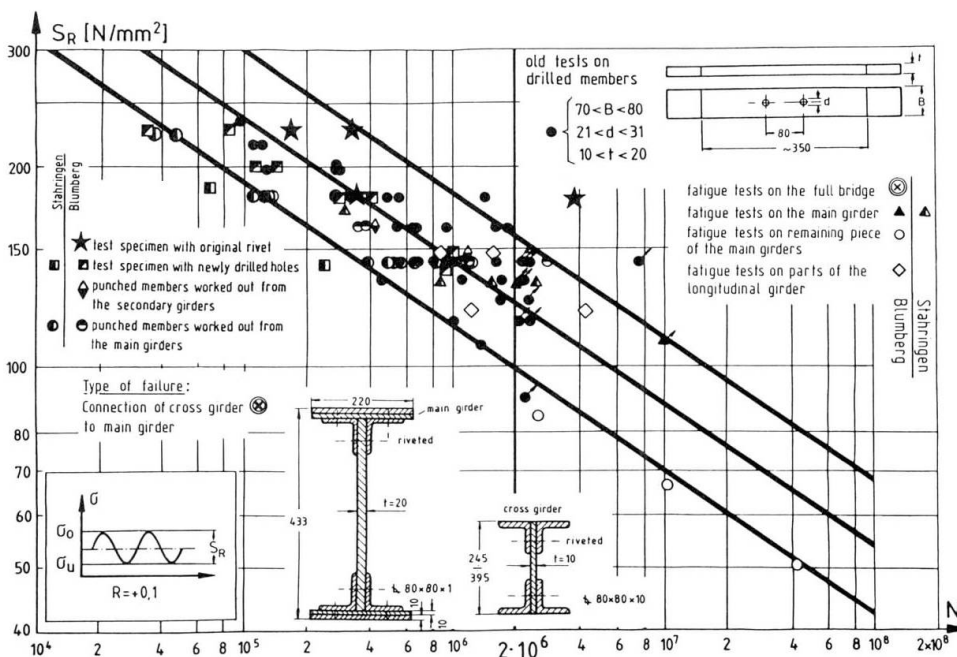
Fig. 8 Results of tests on components of the Blumberg bridge compared to earlier test results of punched specimens

Fig. 8 shows the test results in comparison with earlier data obtained by tests on punched specimens of puddled iron. The diagram shows that the results of the main girder and transverse girder tests are within the range of scattering of results for small-scale specimens.

The results of the specimens taken from the remaining parts of the main girder are slightly beyond the  $P_{\dot{u}} = 97.5\%$  line which is due to previous fatigue loads endured during service and during the girder tests ( $1.6$  to  $2.0 \cdot 10^6$  stress cycles).

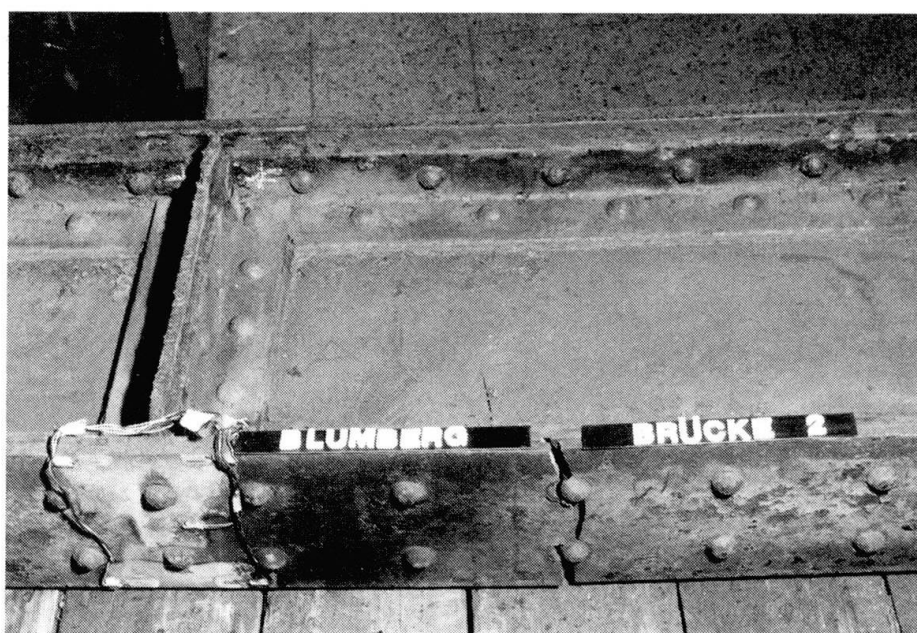
Fig. 9 Failure mode for the longitudinal girder of the Blumberg bridge

Four specimens were taken from the longitudinal girders of the Museumsbahn bridge and subjected to three-point-bending tests with a span of 1500 mm. For two specimens the maximum stress was  $165 \text{ N/mm}^2$ , for the other ones  $135 \text{ N/mm}^2$ . The ultimate stress ratio was  $R = + 0.1$ . The test results are shown in Fig. 8 in comparison with earlier data for flat plate specimens of similar age. The cracks usually started at a distance of about 600 mm from the point of support and proceeded diagonally through the web. In some specimens further cracks occurred in the angle sections. Fig. 9 gives an example of the failure mode.

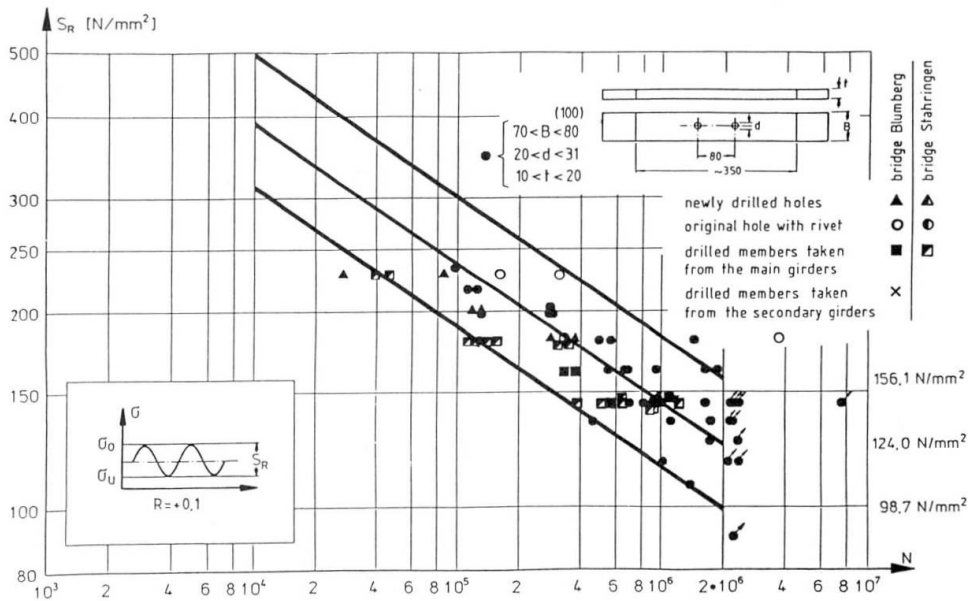
Fig. 10 Results of tests on punched specimens and specimens with original rivets

It is evident that the test results are in good agreement with earlier data, although the data of the Stahringen bridge are comparatively low. The scattering of the results is comparatively large, as is the rule with old constructions.

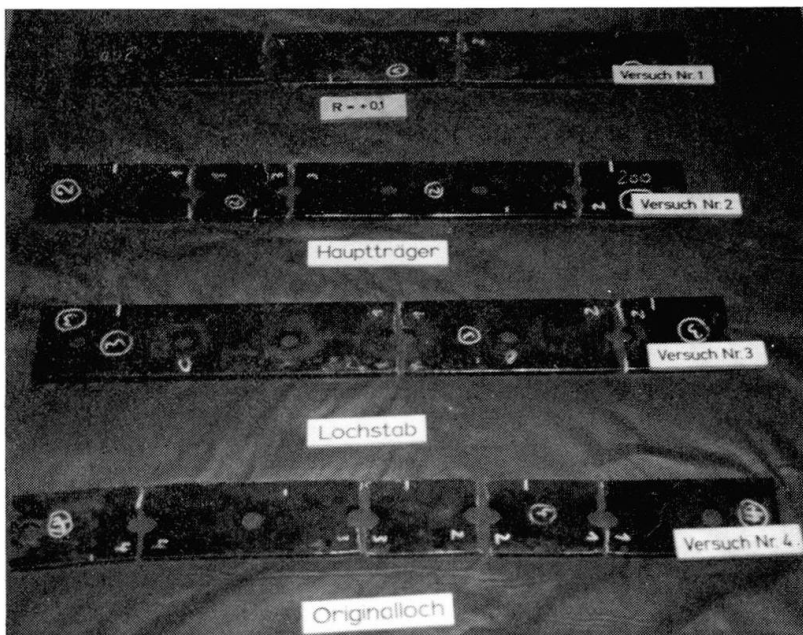
Fig. 11 Specimen after failure (punched specimen from Stahringen bridge)

Two specimens taken from the web area are also in good agreement with earlier test data. As expected, the fatigue cracks started from rivet holes. Fig. 11 shows the specimens taken from the main girder of the Stahringen bridge after failure. After the first crack had occurred the specimens were re-fixed until a second or a third crack started from another rivet hole.

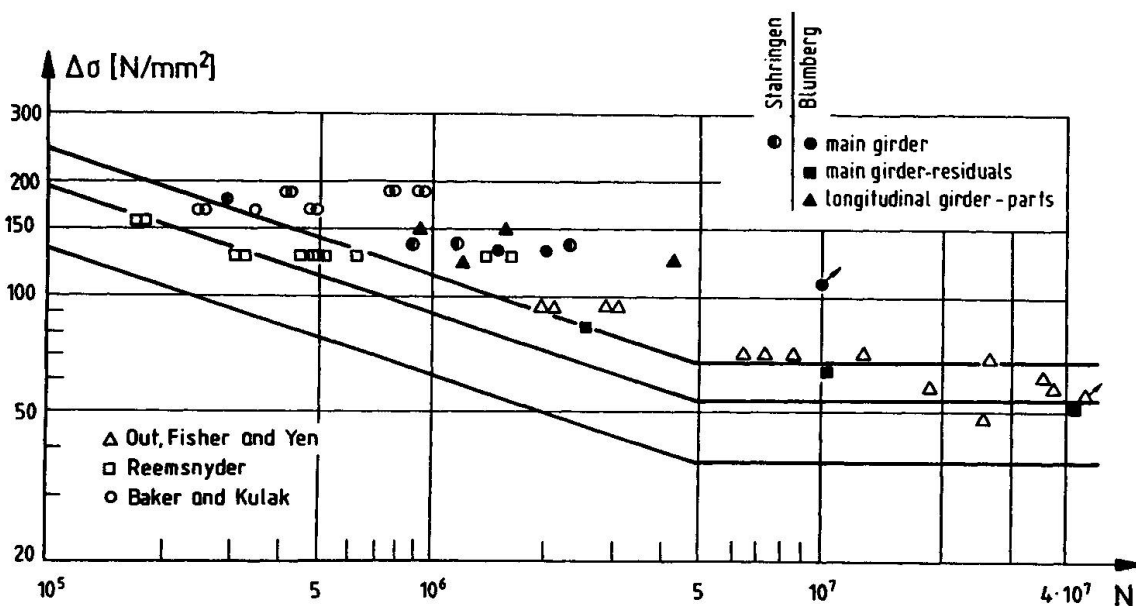
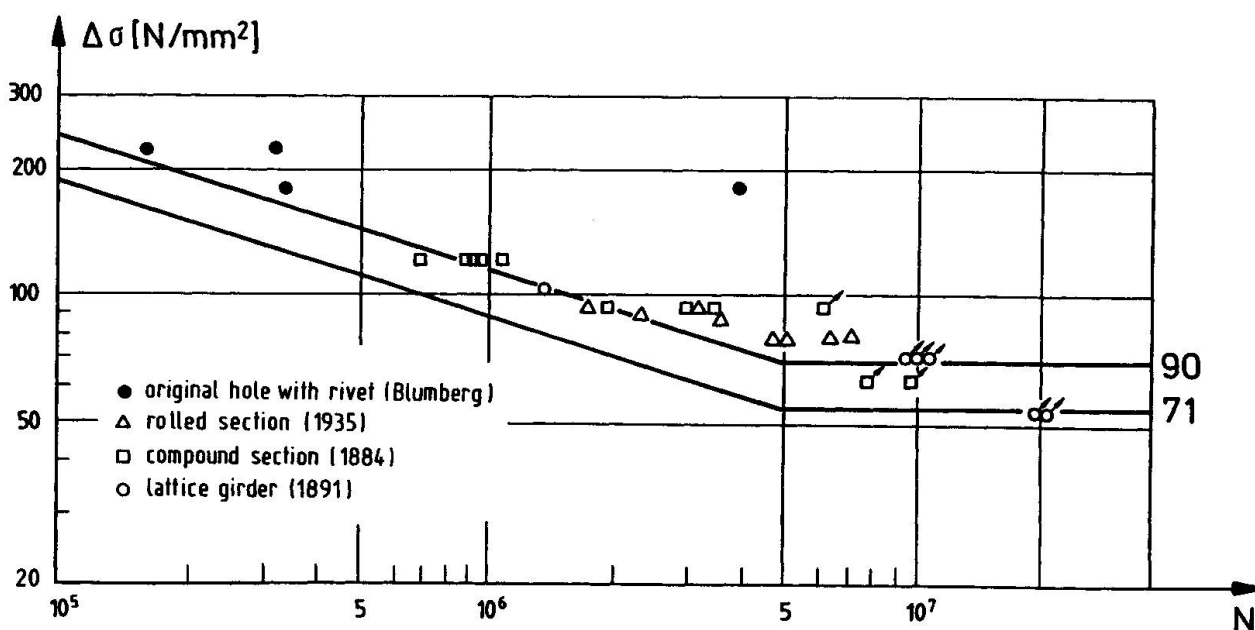
As mentioned before, information on the fatigue behaviour of old steels, particularly from the 19th century is very scarce. Hirt and Brühwiler [3] were the first researchers to carry out a methodical evaluation for two old bridge components. They compared their results to those of three other reports. For comparison the test results of the Blumberg bridge and the Stahringen bridge were entered into the diagrams of Figs. 12 and 13.

Fig. 12 Test results and data from [3]

Fig. 13 Test results and data from [3]

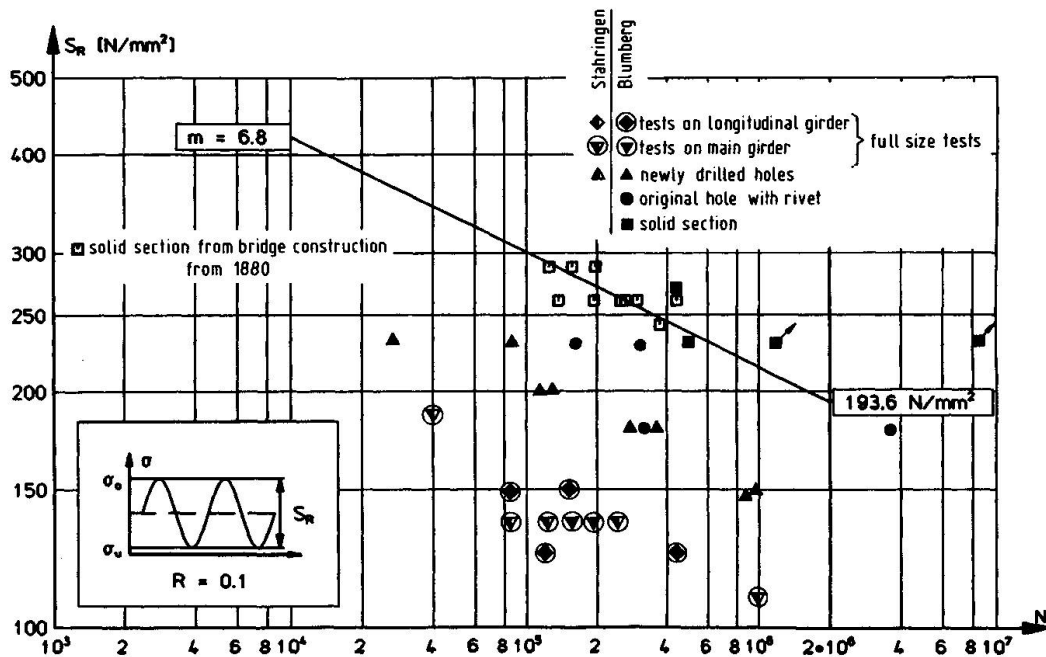
Fig. 14 Test results and data from [5], bridges dating from 1880, plain material

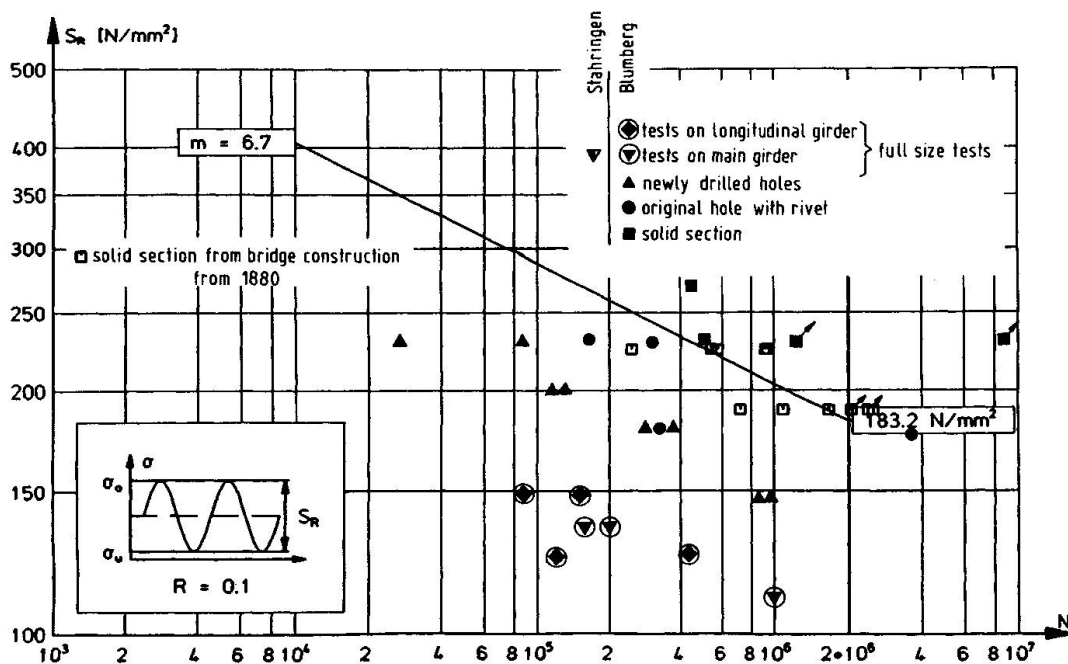
Fig. 15 Test results and data from [5], bridges dating from 1880, plain material prestressed by 290  $\text{N/mm}^2$  and  $10^5$  stress cycles

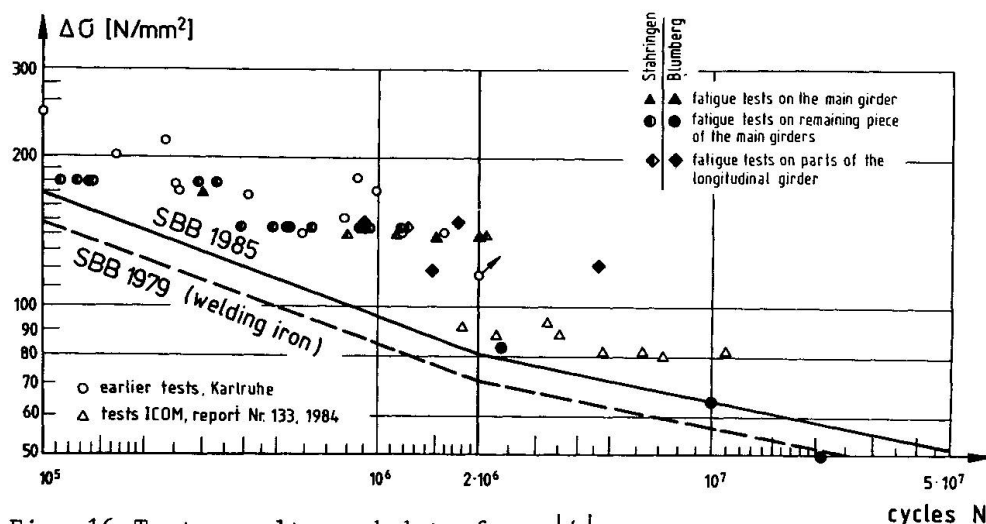
Fig. 16 Test results and data from [4]

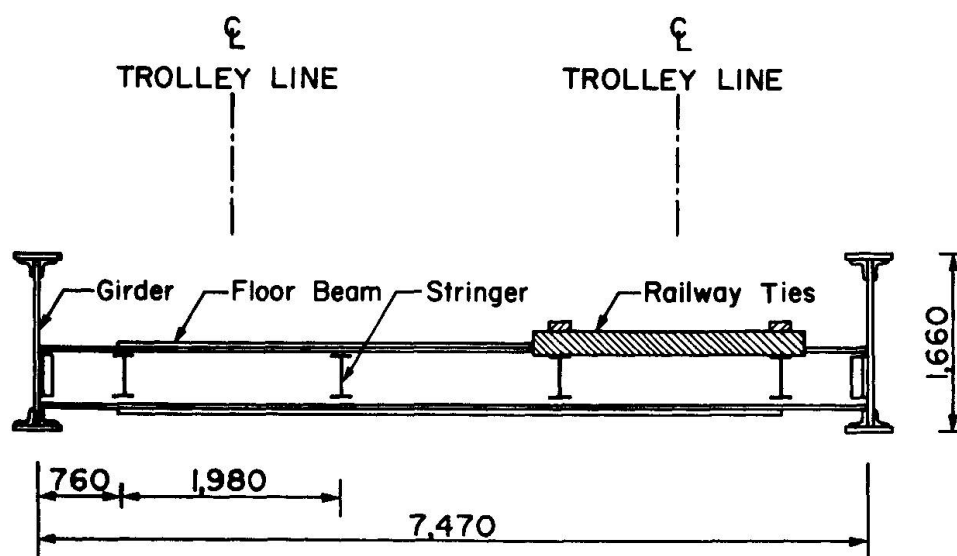
The remaining fatigue strength of the A7 rolled steel beams was determined with tests of trolley bridge stringers that were exposed to the environment for long periods of time. These stringers consisted of 4.72 m long standard beams of W 15x42 (380 mm deep and weighing 62.4 kg/m) cross section. They were removed in 1985 from a bridge carrying the Maryland Line over the Paint Branch in College Park, Maryland. The bridge was built in 1900 and abandoned in 1985. Figure 1 shows a cross section of the bridge.

Fig. 1 Cross Section of Trolley Bridge

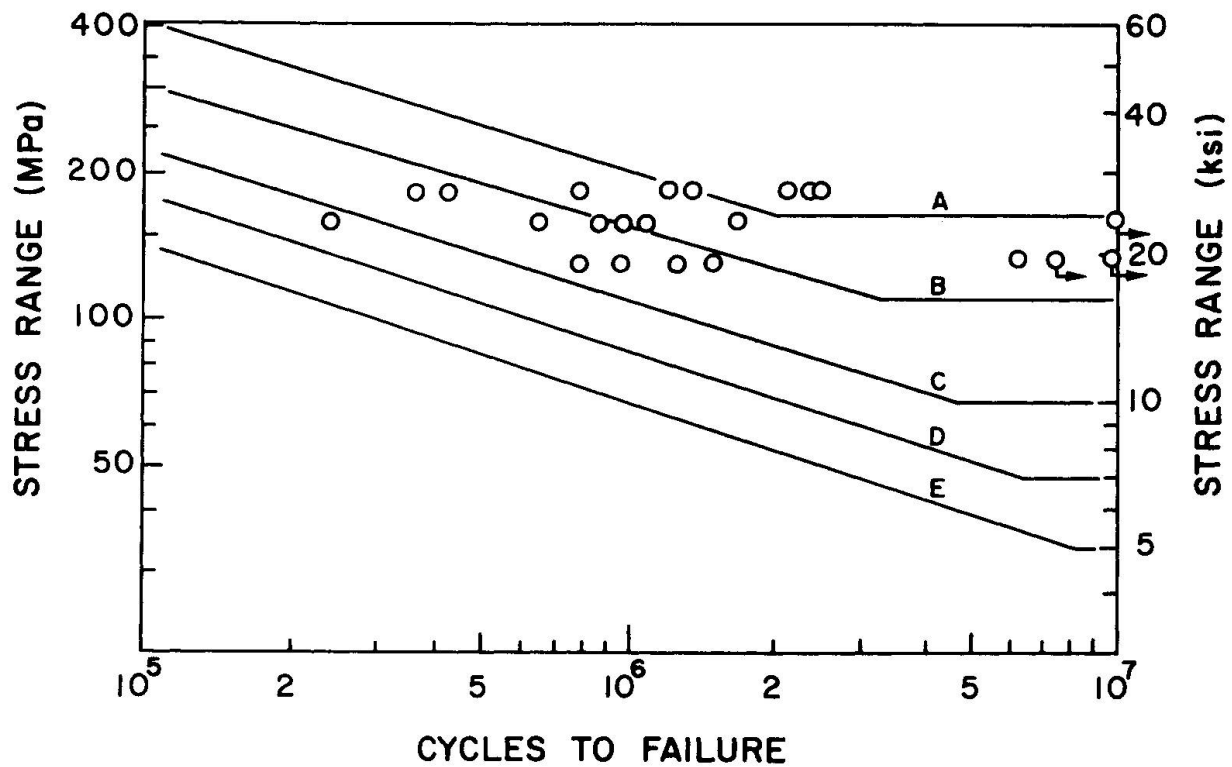
The fatigue test data for the trolley bridge stringers are compared in Fig. 2 with the allowable S-N lines for the AASHTO Category A through E details. The aforementioned defects reduced the fatigue strength of the standard rolled beams from Category A for base metal to Category C for transverse stiffeners and 50 mm long attachments. The reduction in fatigue strength was greatest for rust pits at railway ties, followed by rust pits away from railway ties, and smallest for rolled-in seams and indentations.

Fig. 2 Fatigue Test Data for Carbon Steel Beams

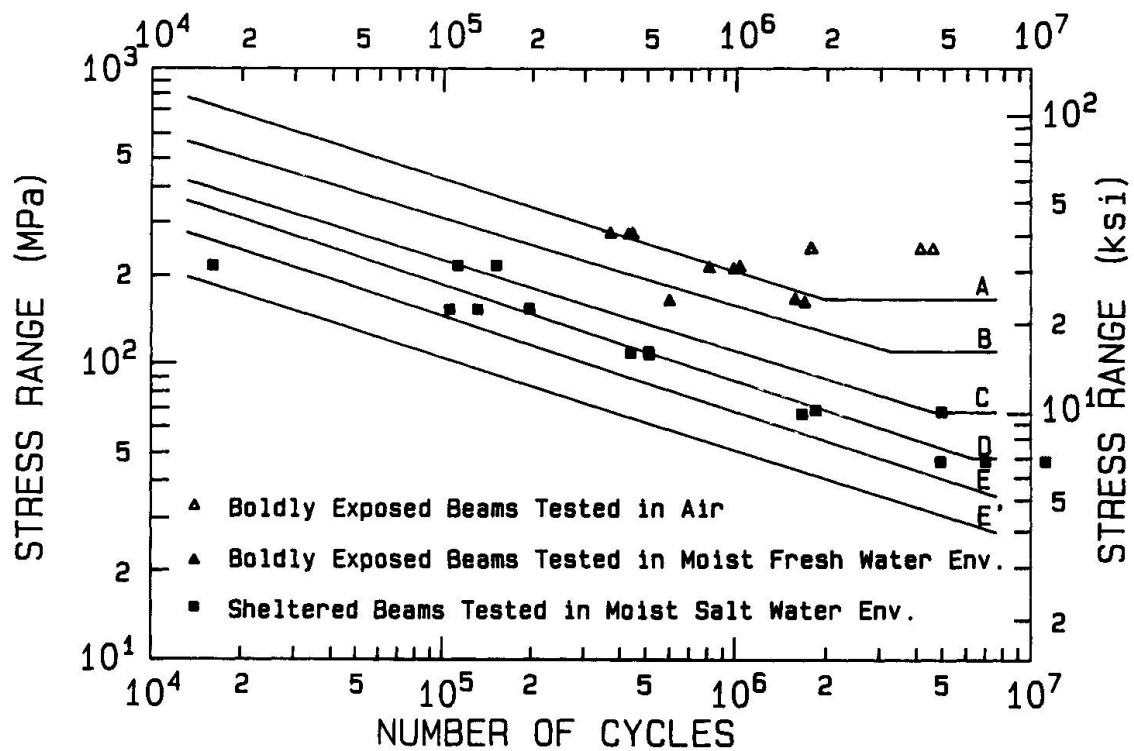
Fig. 3 Fatigue Test Data for Weathering Steel Beams

The fatigue test data for the weathering steel beams are compared in Fig. 3 with the allowable S-N lines for the AASHTO Category A through E' details. As can be seen, the boldly exposed beams had Category A fatigue strength when tested in air, and B when tested in a moist fresh water environment. The sheltered beams tested in a moist salt water environment had Category E fatigue strength, with one beam failing below Category E. The loss in fatigue strength was 31 percent for the boldly exposed beams and 69 percent for the sheltered beams. The total reduction in fatigue strength exhibited by the beams tested in the aqueous environments is attributed to (a) the loss in cross-sectional area due to corrosion in plane of crack, (b) the aqueous test environment, and (c) the stress concentration effect of the rust pits. Accordingly, the fatigue notch factor of a bare exposed weathering steel beam can be expressed as the product of the corrosion, environment, and pitting factors.

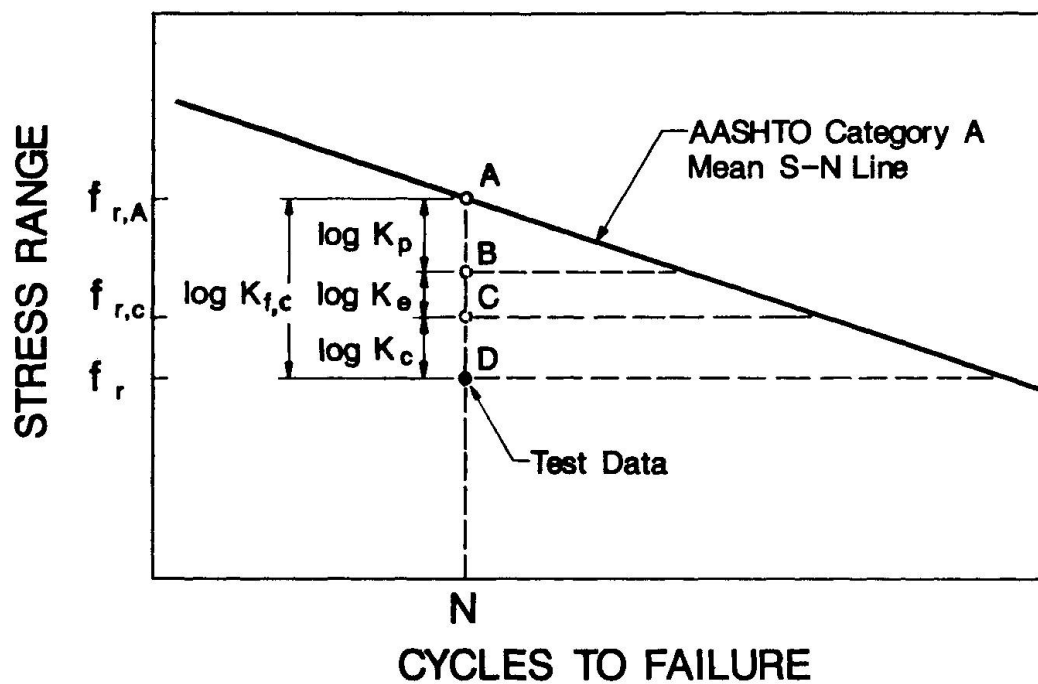
The total reduction in fatigue strength of a corroded beam is the vertical distance in Fig. 4 between the solid data point D for that beam and point A on the mean S-N line for Category A rolled beams given by

The terms  $K_c$ ,  $K_e$ , and  $K_p$  are hereafter referred to as the corrosion factor, environment, and pitting factors, respectively. Their logarithms are equal to the distances CD, BC, and AB shown in Fig. 4. The corrosion factor is calculated from

Fig. 4 Illustration of Fatigue Strength Reduction Factors

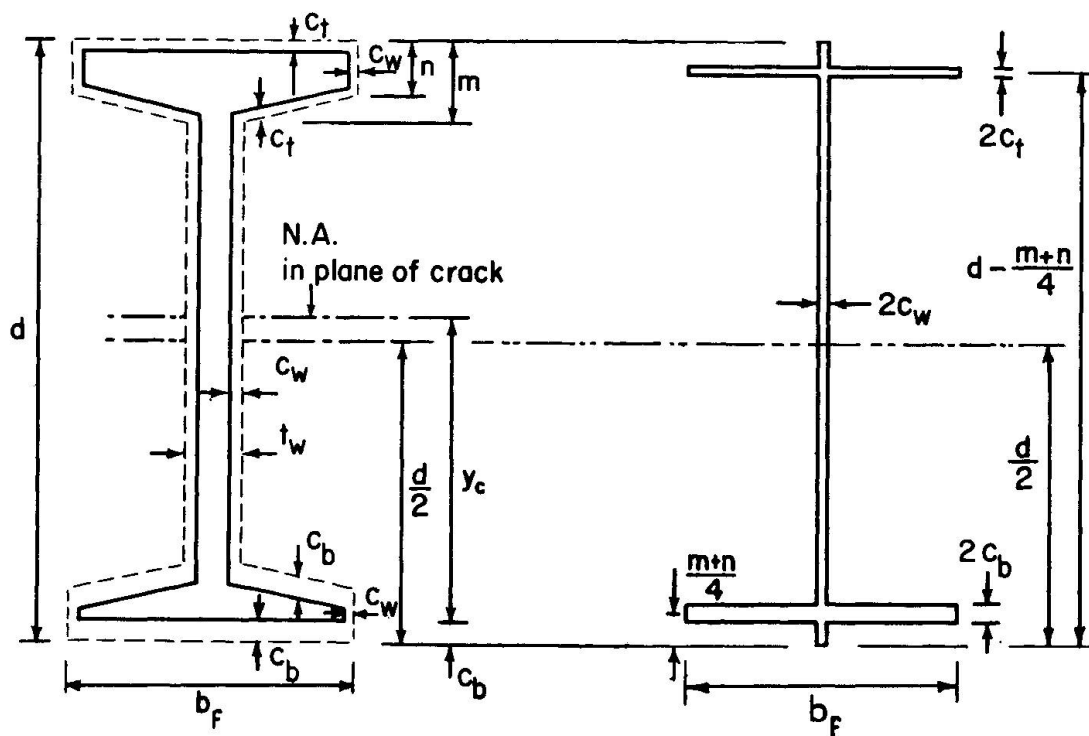
Fig. 5 Standard Beam with Noncorroded and Corroded Sections on left, Section Loss on Right

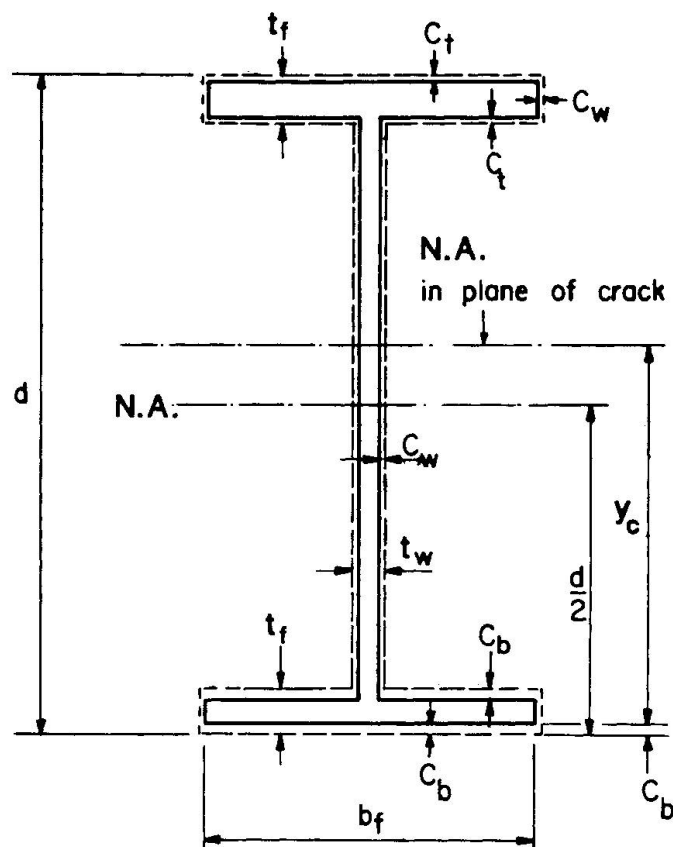
Fig. 6 Wide Flange Beam with Noncorroded and Corroded Sections

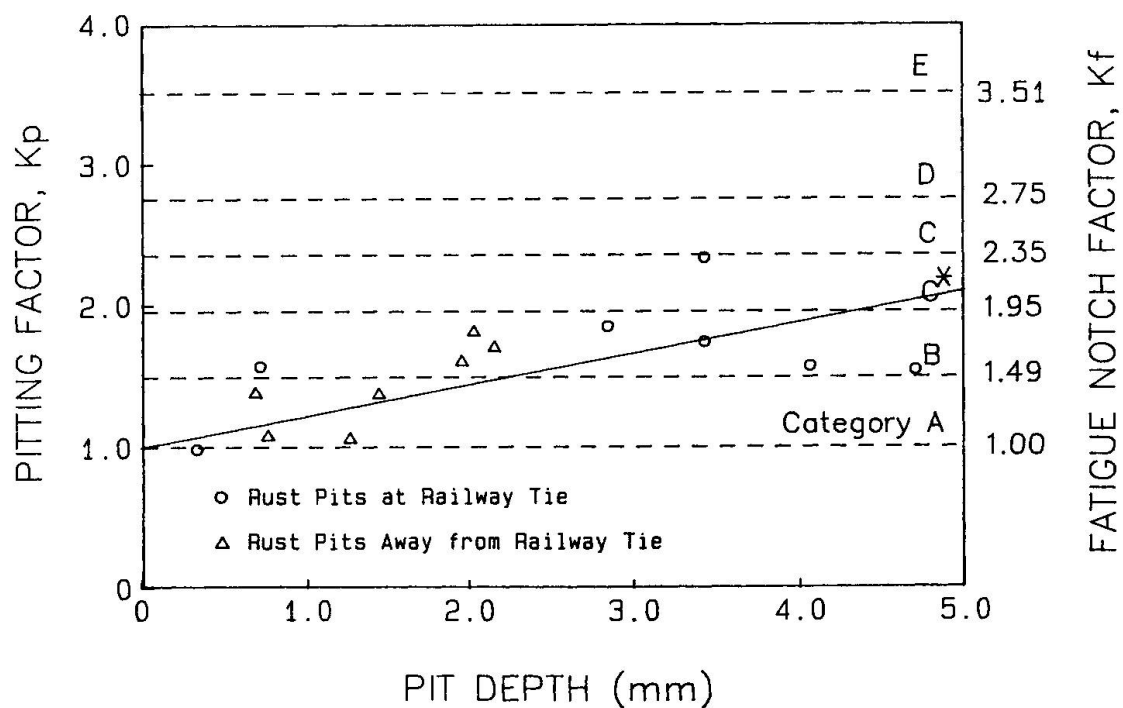
Fig. 7 Pitting Factor for Carbon Steel Beams

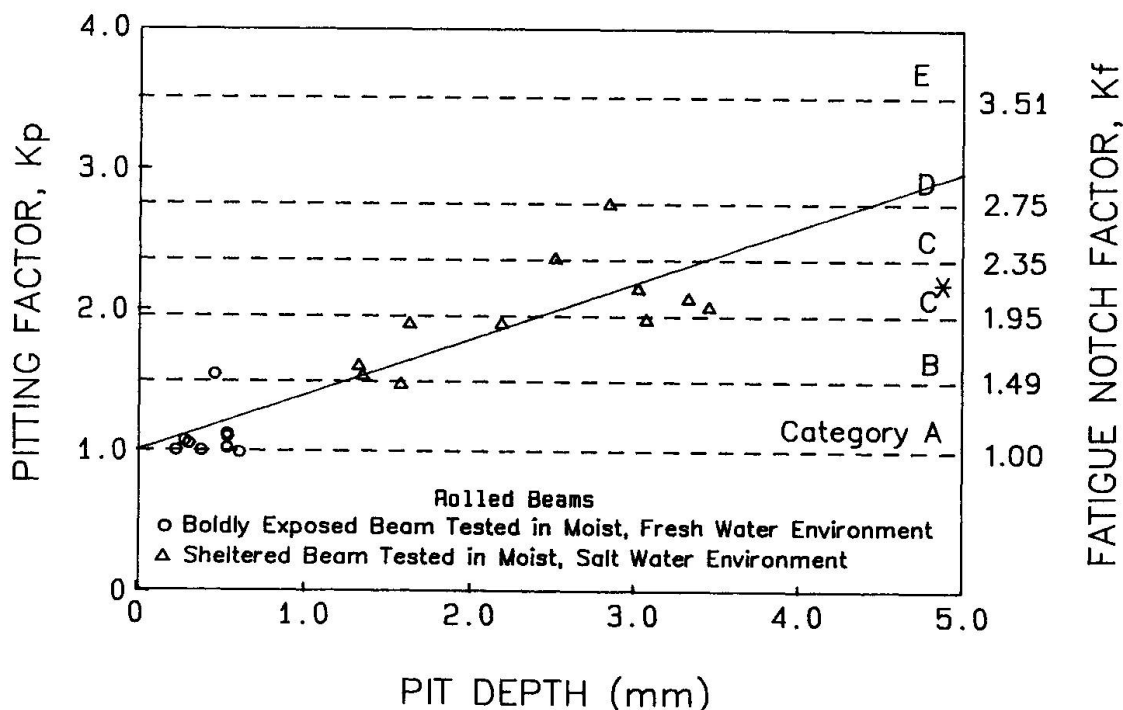
As an example of the severity of the rust pits in weathering steel beams, substituting the fatigue notch factors listed on the right vertical axis of Fig. 8 into Eq. 17 in place of  $K_p$  and solving for  $d_p$ , one finds that pit depths of  $d_p = 1.2, 2.4, 3.4$ , and  $4.4$  mm, respectively, reduced the fatigue strength of the weathering steel beams on the average to the mean fatigue strength of Category B welded beams, Category C\* transverse stiffeners, Category C 50-mm attachments, and Category D 100-mm attachments.

Fig. 8 Pitting Factor for A588 Weathering Steel Beam

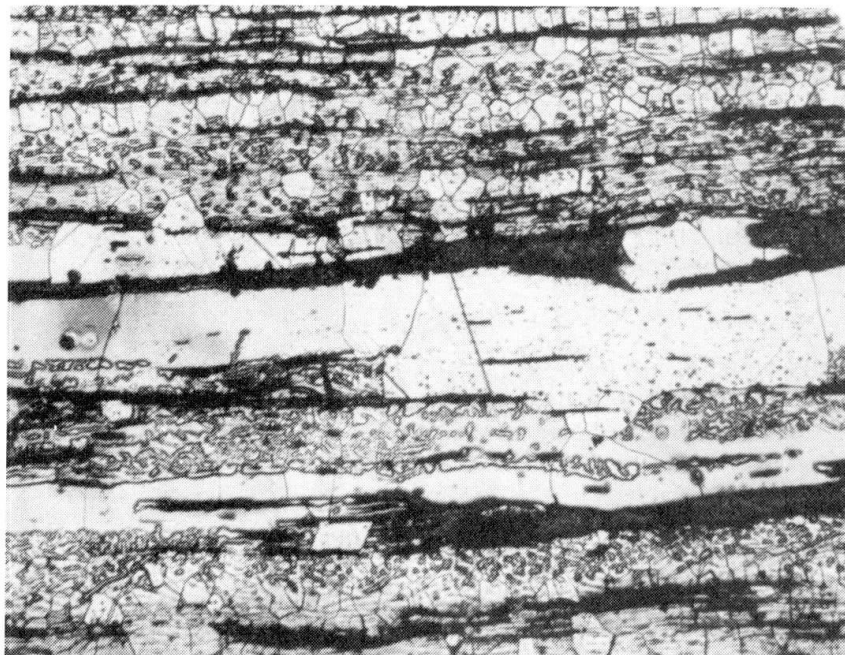
Fig. 1: Microstructure of wrought iron (magn. 50x)

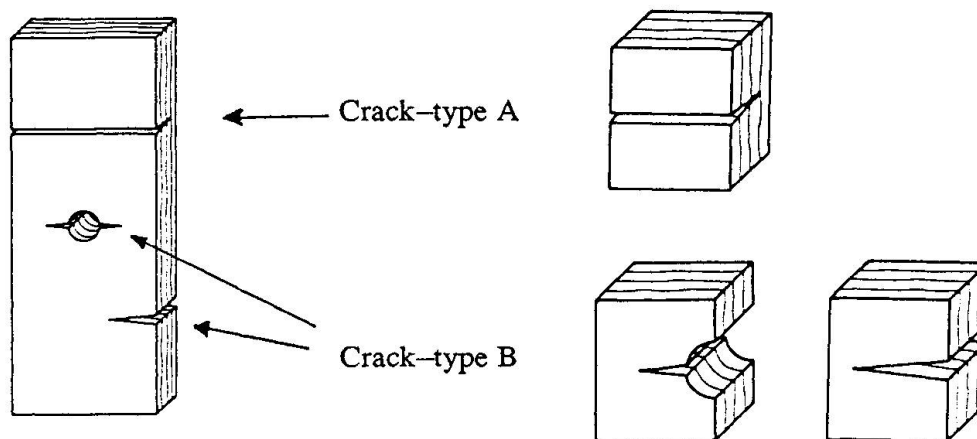
Fig. 2: Definition of crack-type A resp. B.

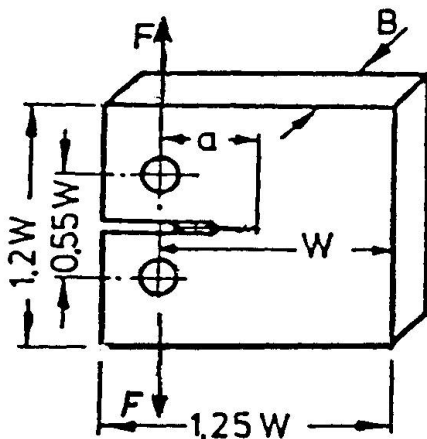
Fig. 3: Geometry of compact tension (CT-) specimen used. For dimensions see Tab. 2.

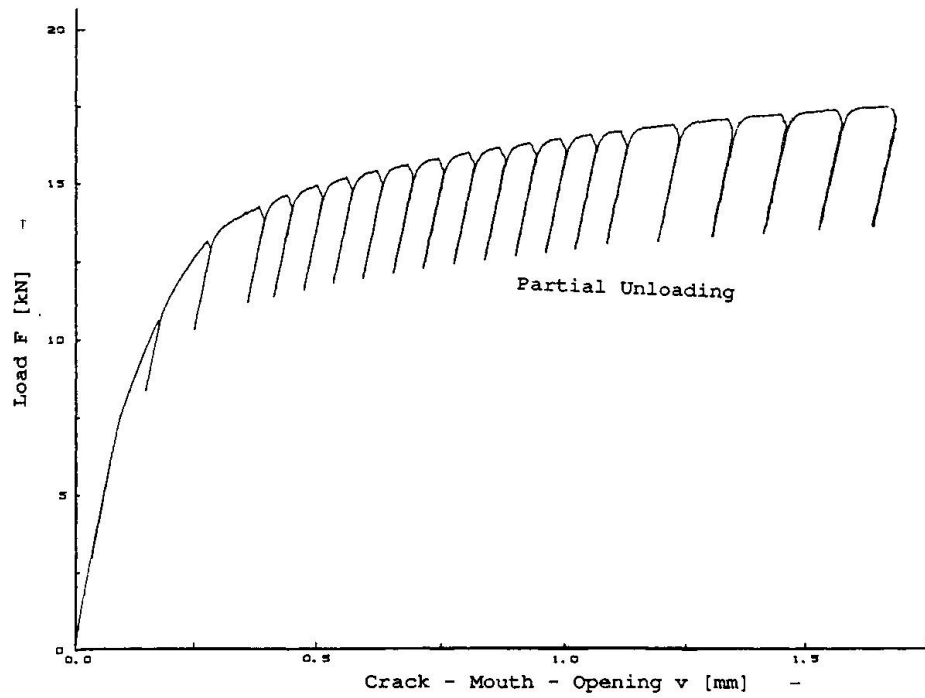
Fig. 4: Example of load vs. crack-mouth opening at load-line as measured on specimen W4

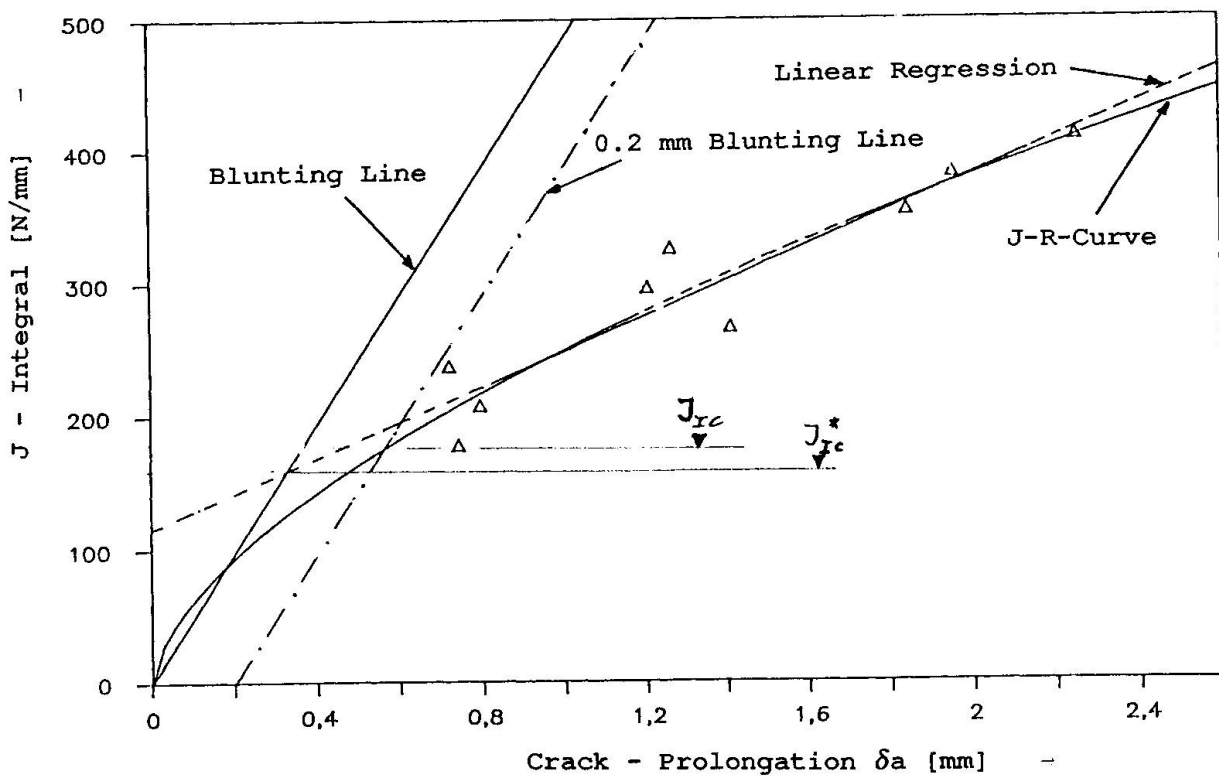
Fig. 5: Example of J-Integral vs. crack-prolongation  $\delta a$  (J-resistance-curve) calculated from load-displacement-curve (Fig. 4) and definition of  $J_{Ic}$ . For comparison  $J_{Ic}$  according to ASTM E813-81 (issue 1981 of [7]), denoted by  $J_{Ic}^*$ , is also shown.

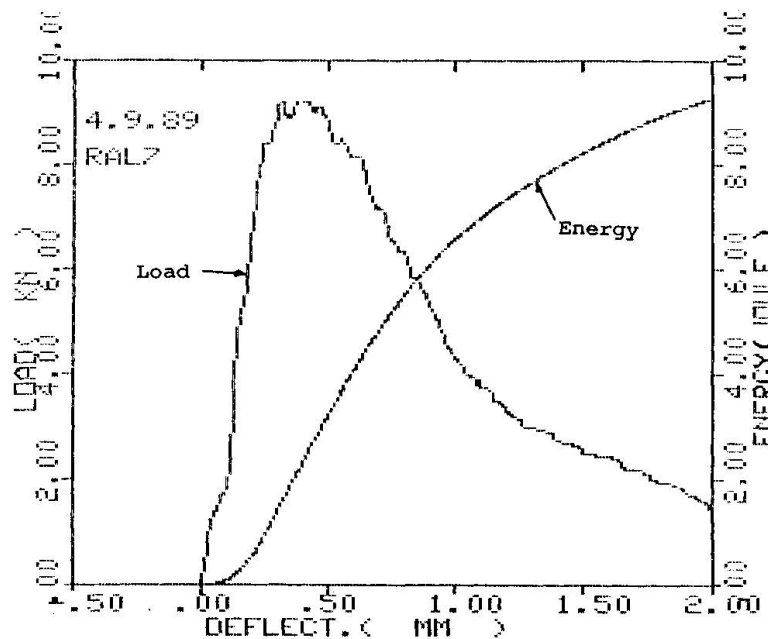
Fig. 6: Example of a load vs. deflection curve and transmitted energy vs. deflection curve of a 3-point-bend impact test with precracked Charpy-specimen. This curve is calculated from the load vs. time curve.

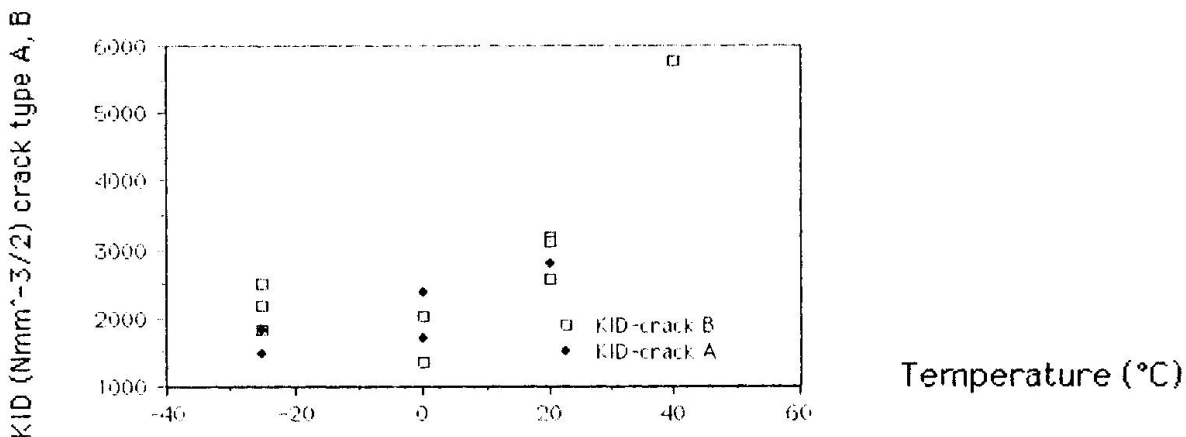
Whereas the Charpy test exhibited no clear transition behaviour the dynamic fracture toughness measured on precracked Charpy-specimens show a remarkable increase in the temperature range between approximately 0 and 40°C. According to [11] the shift in the transition temperature between static loading and impact loading is about 90°C (for steel with yield-stress of 240 N/mm<sup>2</sup>). Thus one can conclude, that fracture toughness is at the upper shelf (i.e. approximately 5000 N/mm<sup>3/2</sup>) for all in-service conditions.

Fig. 7: Dynamic fracture toughness vs. temperature

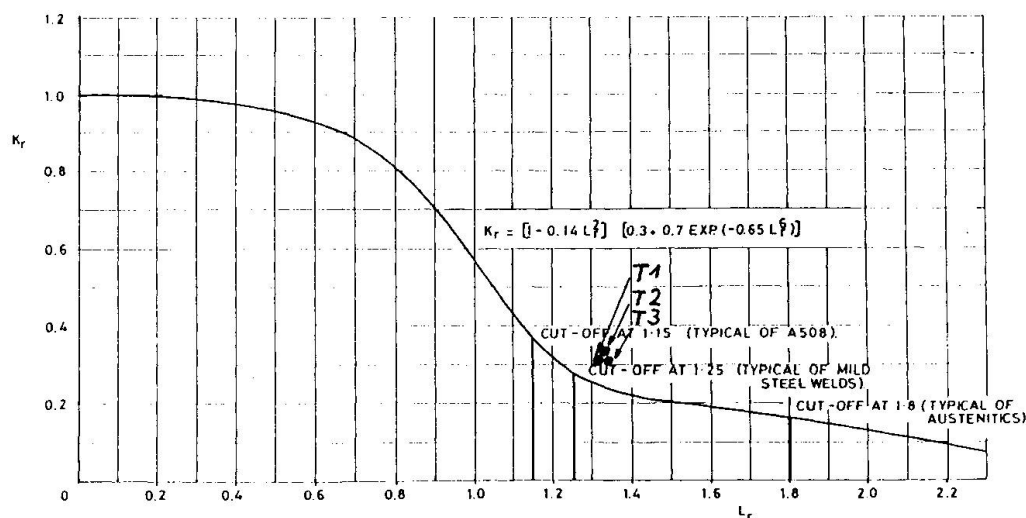
Fig. 8: Failure assessment diagram according to [12]. The points T1, T2 and T3 correspond to fracture tests on precracked component-like specimens

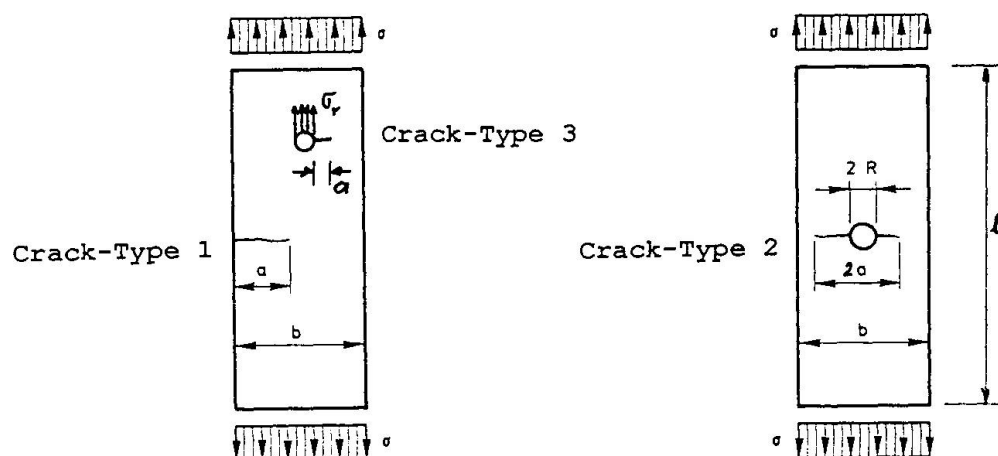
Fig. 9: Definition of crack-types 1, 2 and 3 considered in Tab.3.
