**Zeitschrift:** IABSE reports = Rapports AIPC = IVBH Berichte  
**Band:** 59 (1990)

**Rubrik:** Theme B: Behaviour of materials

## Experimental and Theoretical Investigations of Existing Railway Bridges

## **Remaining Fatigue Strength of Corroded Steel Beams**

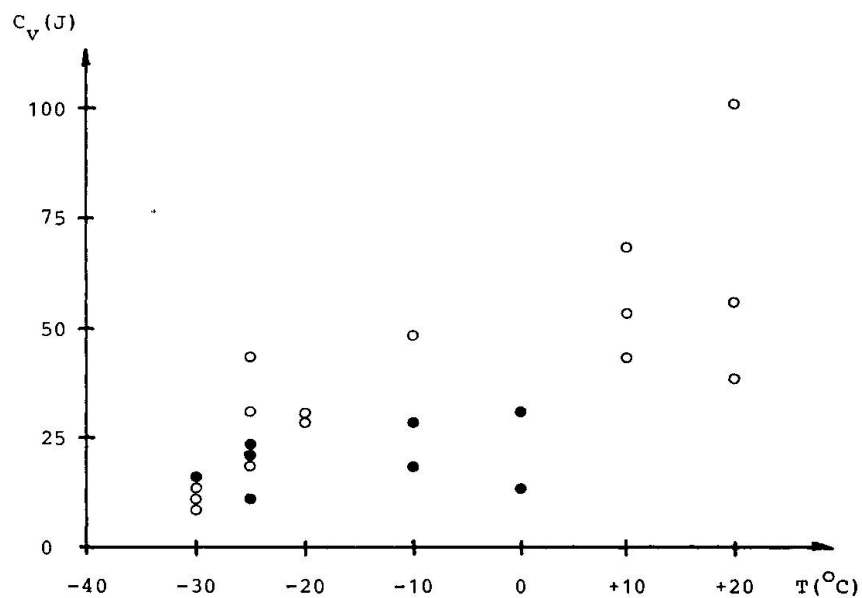
Fig 1. Charpy-V notch toughness for two specimen series of a given material. o Ser no 1. • Ser no 2.

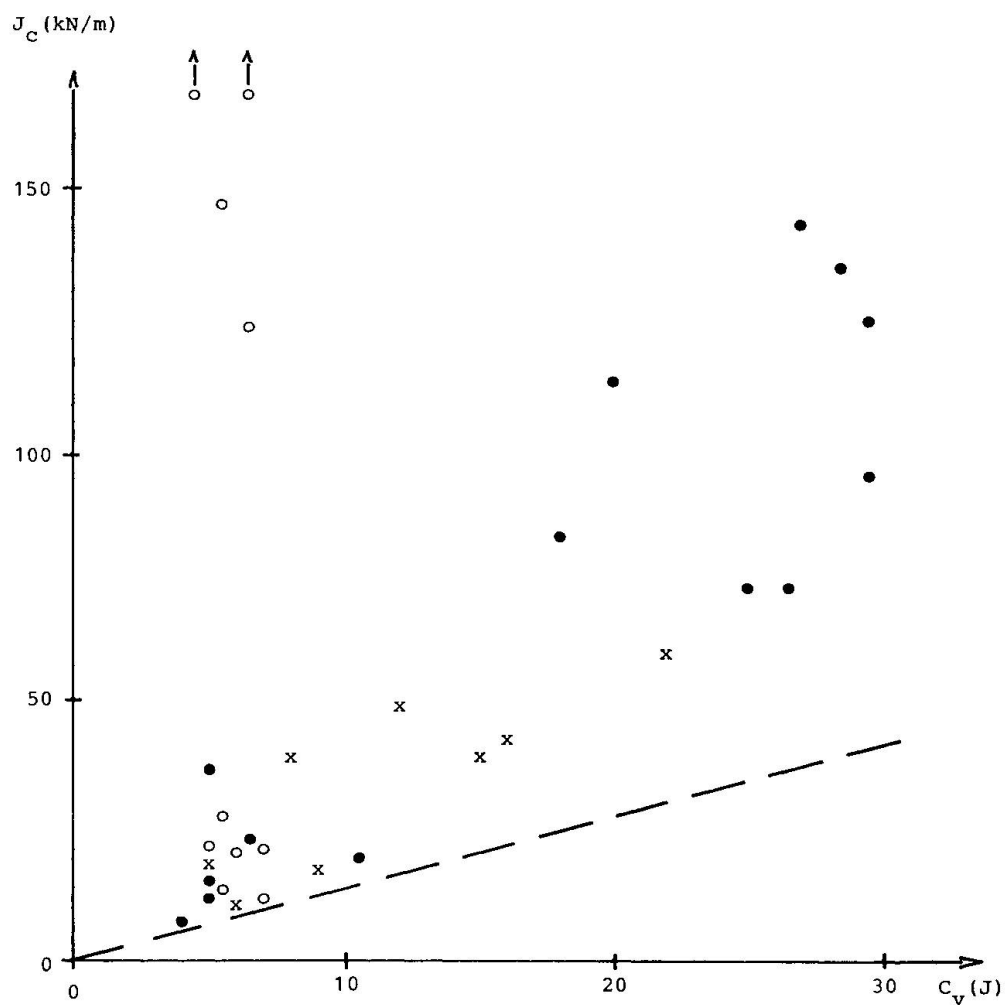
Fig 2. Fracture toughness  $J_C$  and Charpy-V notch toughness  $C_V$ .  
o This investigation, x Ref (4), • Ref (5).  
- - - Ref (6).

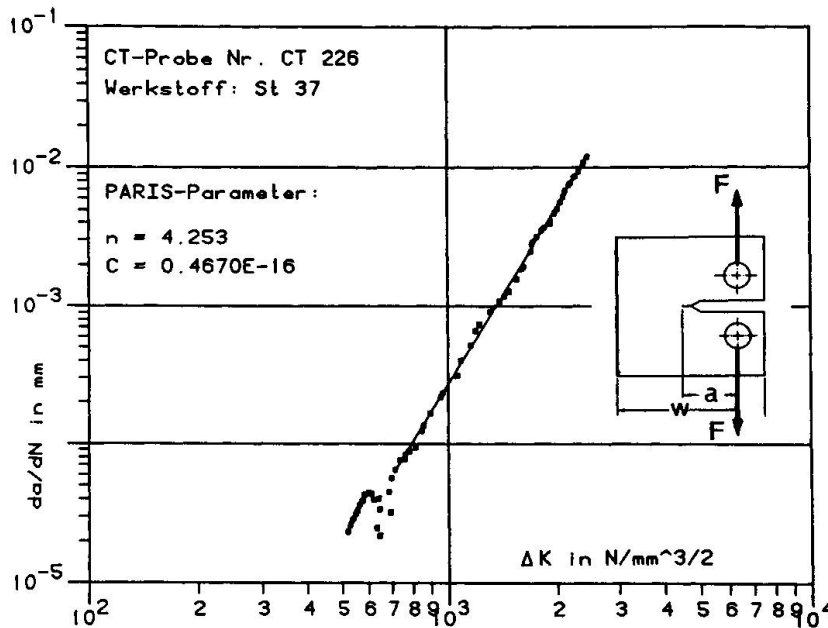
Figure 3.  
Result of  
one of the  
crack  
growth  
tests (ASTM  
E 647-83)  
with re-  
gression  
line re-  
garding the  
Paris equa-  
tion (1)

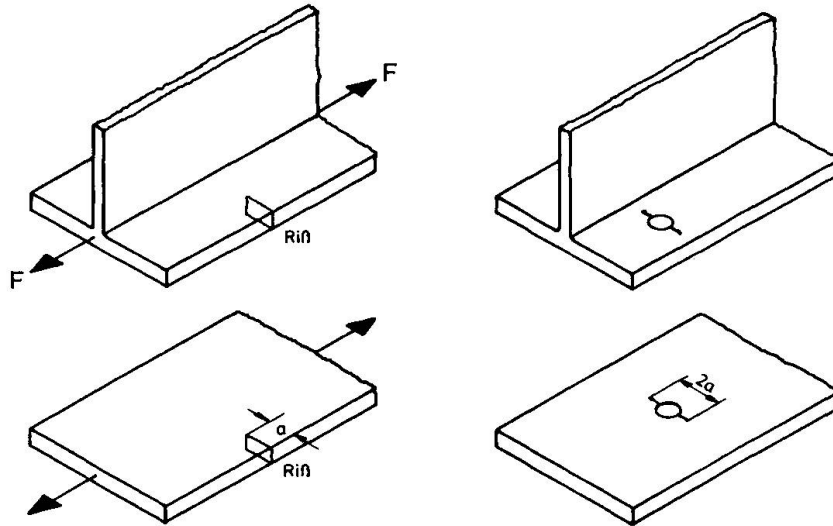
The application of fracture mechanics in the evaluation of remaining fatigue life implies the modelling of cracks in structural members, which can presumably appear, fig 4. The propagation of cracks then is only governed by the stress intensity at the crack's tip as expressed by the Paris equation. On this basis, it is possible to predict how far a certain crack can grow within the period of time between two inspections.

Figure 4.  
Crack pat-  
terns in  
riveted mem-  
bers for  
evaluating  
stress inten-  
sity factors  
and crack  
growth

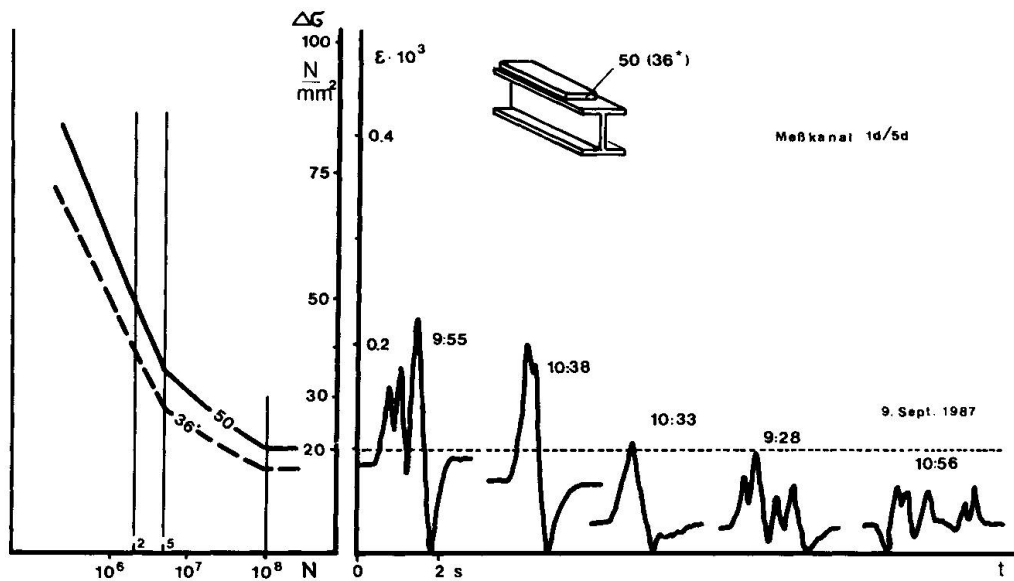
Figure 5. Measured strains/stresses during about 3 hours of observation at one measuring point.

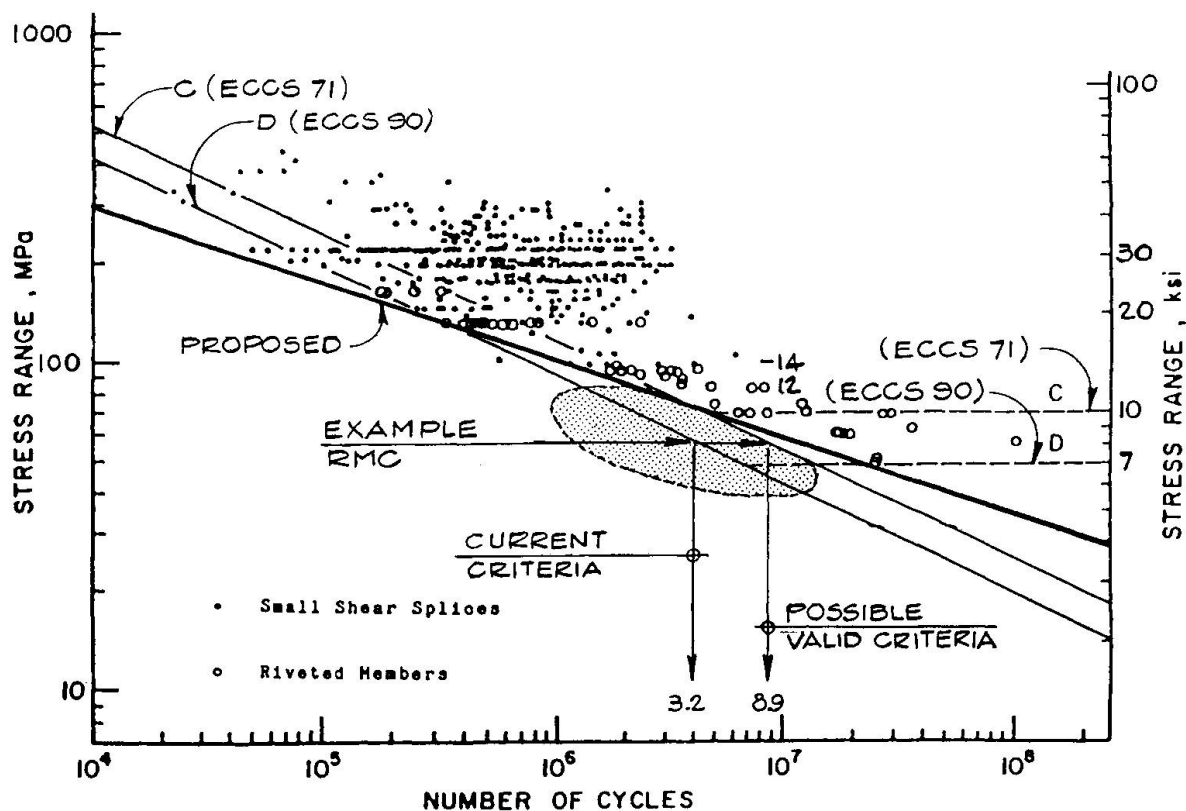
Fig. 2

Comparison of fatigue resistance of full-size members with small shear splices. (3, Fig. 32)
