**Artikel:** Experimental and theoretical investigations of existing railway bridges  
**Autor:** Mang, Friedrich / Bucak, Oemer  
**DOI:** <https://doi.org/10.5169/seals-45703>

## Experimental and Theoretical Investigations of Existing Railway Bridges

This paper describes an investigation of a complete bridge structure of the «museum railway» in the community of Blumberg as well as two bridge structures of the «Deutsche Bundesbahn». Results of component tests are compared with data taken from the literature as well as other results of similar investigations.

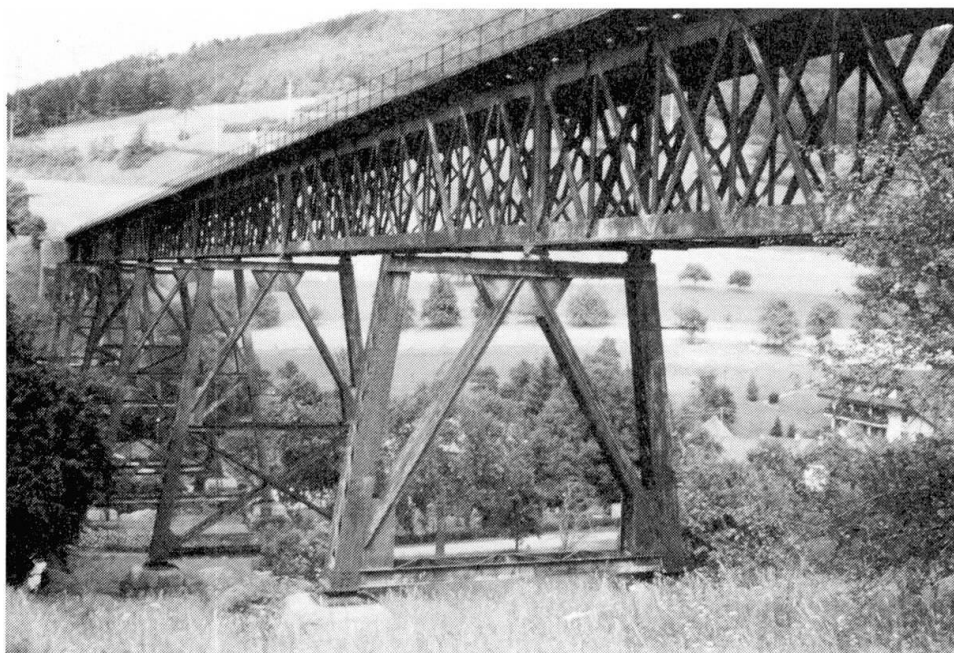
Fig. 2 Bridge of the "Museumsbahn"

At the "Versuchsanstalt für Stahl, Holz und Steine" tests were carried out on a whole bridge built in 1887 which had been chosen from different bridge systems of the "Museumsbahn" (Fig. 2).
