Artikel: Experimental and theoretical investigations of existing railway bridges
Autor: Mang, Friedrich / Bucak, Oemer
DOI: <https://doi.org/10.5169/seals-45703>

Experimental and Theoretical Investigations of Existing Railway Bridges

This paper describes an investigation of a complete bridge structure of the «museum railway» in the community of Blumberg as well as two bridge structures of the «Deutsche Bundesbahn». Results of component tests are compared with data taken from the literature as well as other results of similar investigations.

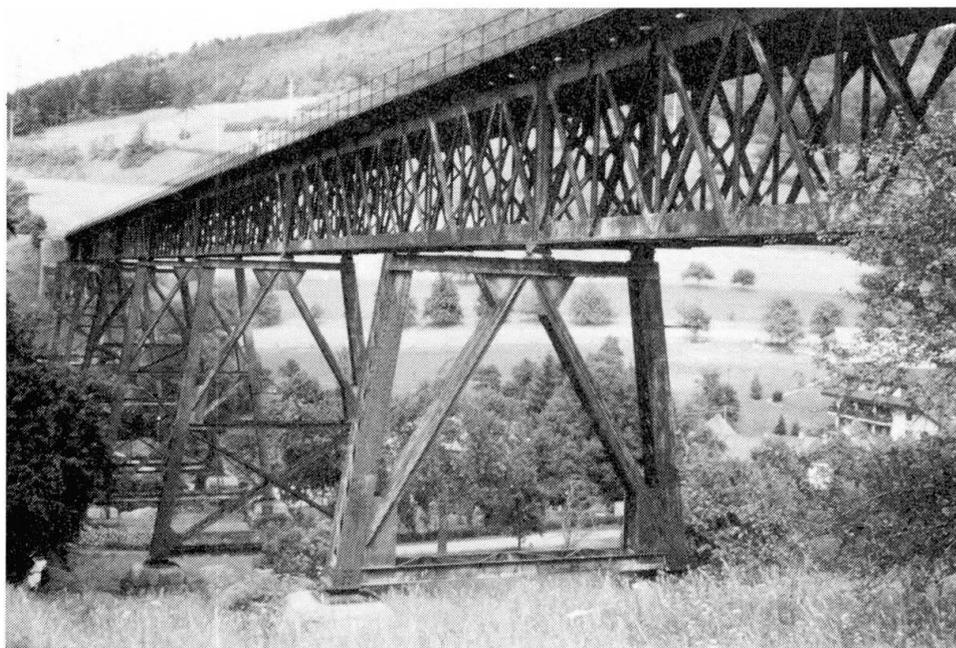
Fig. 2 Bridge of the "Museumsbahn"

At the "Versuchsanstalt für Stahl, Holz und Steine" tests were carried out on a whole bridge built in 1887 which had been chosen from different bridge systems of the "Museumsbahn" (Fig. 2).
