Artikel: Experimental and theoretical investigations of existing railway bridges
Autor: Mang, Friedrich / Bucak, Oemer
DOI: <https://doi.org/10.5169/seals-45703>

Experimental and Theoretical Investigations of Existing Railway Bridges

This paper describes an investigation of a complete bridge structure of the «museum railway» in the community of Blumberg as well as two bridge structures of the «Deutsche Bundesbahn». Results of component tests are compared with data taken from the literature as well as other results of similar investigations.

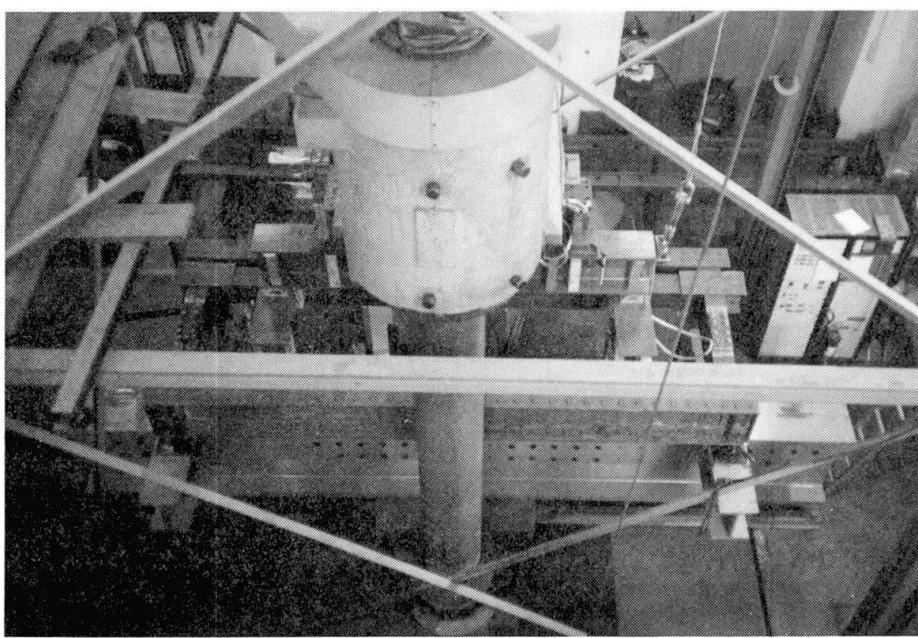
The whole bridge was built in the 50 MN power press of the institute. Fig. 3 shows the bridge built in according to load configuration LF 1.

Fig. 3 Bridge of the "Museumsbahn" in the 50 MN power press

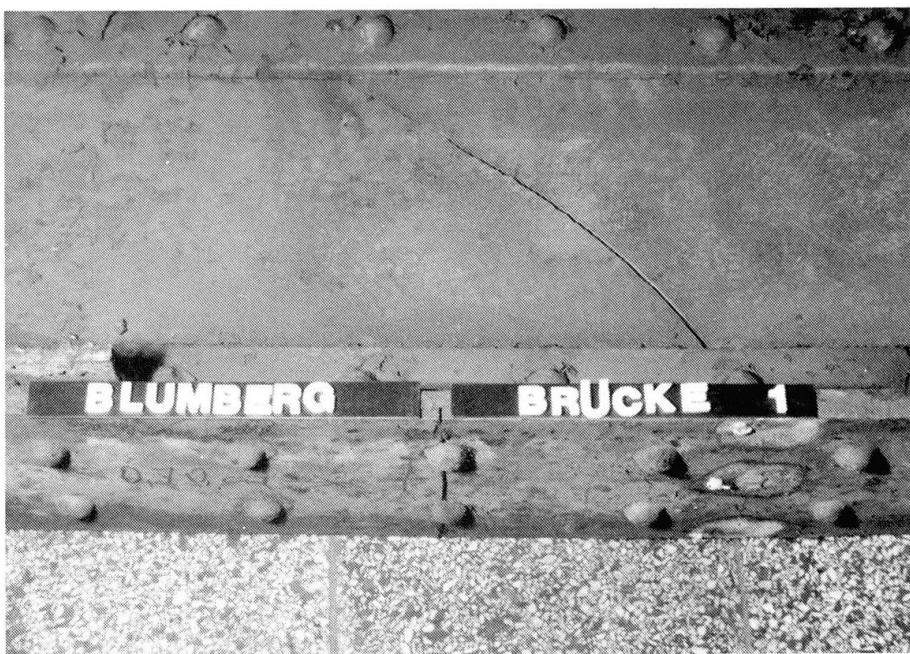
Under a maximum stress of 165 N/mm^2 and at 1 534 000 stress cycles the crack occurred in the web of main girder I of the Blumberg bridge. Despite the crack, the main girder carried the full load and the test was continued until the two angles and the cover plate of the main girder tensile chord failed at a total number of stress cycles of 1 572 600. This means that the minimum number of stress cycles between crack appearance and total failure of the main girder was 38 600 (see Fig. 7).

Fracture first occurred in the web, then in the angle section and finally in the cover plate. The cracks were not situated on one level.

Fig. 7 Points of fracture of main girder I

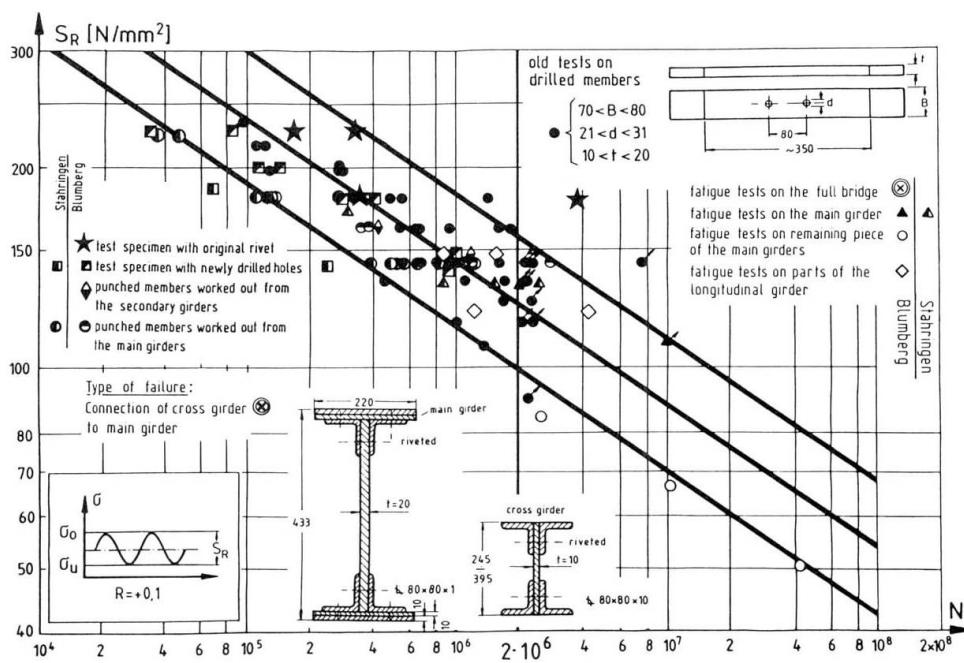
Fig. 8 shows the test results in comparison with earlier data obtained by tests on punched specimens of puddled iron. The diagram shows that the results of the main girder and transverse girder tests are within the range of scattering of results for small-scale specimens.

Fig. 8 Results of tests on components of the Blumberg bridge compared to earlier test results of punched specimens

The results of the specimens taken from the remaining parts of the main girder are slightly beyond the $P_{\bar{u}} = 97.5\%$ line which is due to previous fatigue loads endured during service and during the girder tests (1.6 to $2.0 \cdot 10^6$ stress cycles).

Four specimens were taken from the longitudinal girders of the Museumsbahn bridge and subjected to three-point-bending tests with a span of 1500 mm. For two specimens the maximum stress was 165 N/mm², for the other ones 135 N/mm². The ultimate stress ratio was $R = + 0.1$. The test results are shown in Fig. 8 in comparison with earlier data for flat plate specimens of similar age. The cracks usually started at a distance of about 600 mm from the point of support and proceeded diagonally through the web. In some specimens further cracks occurred in the angle sections. Fig. 9 gives an example of the failure mode.

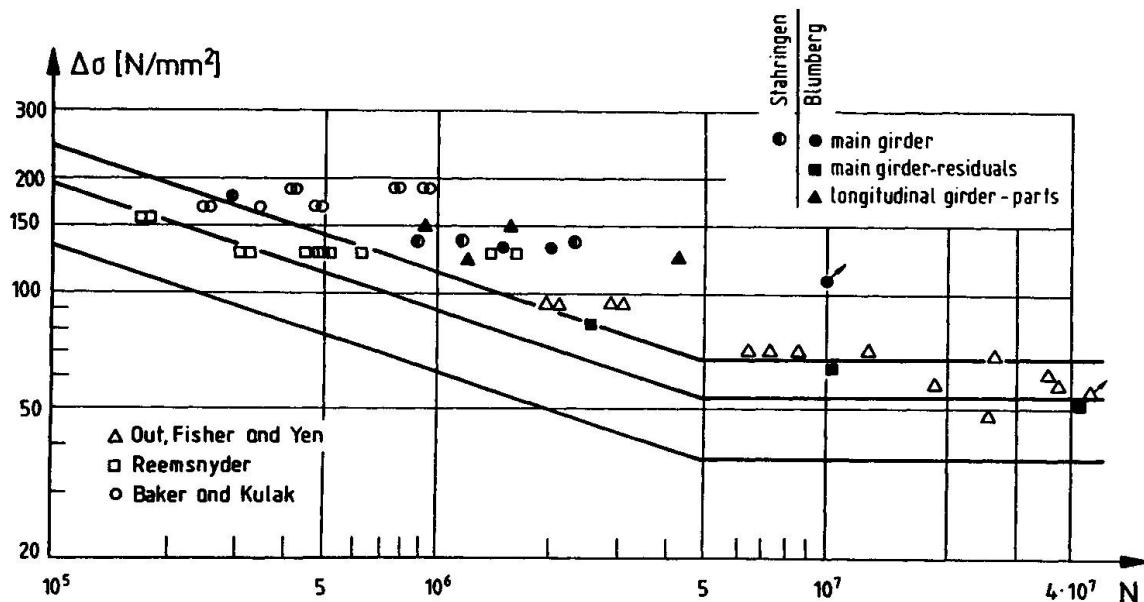
As mentioned before, information on the fatigue behaviour of old steels, particularly from the 19th century is very scarce. Hirt and Brühwiler [3] were the first researchers to carry out a methodical evaluation for two old bridge components. They compared their results to those of three other reports. For comparison the test results of the Blumberg bridge and the Stahringen bridge were entered into the diagrams of Figs. 12 and 13.

Fig. 12 Test results and data from [3]

Fig. 13 Test results and data from [3]
