Artikel: Crack growth tests to assess the remaining fatigue life of old steel bridges
Autor: Brandes, Klaus
DOI: <https://doi.org/10.5169/seals-45707>

Crack Growth Tests to Assess the Remaining Fatigue Life of Old Steel Bridges

Klaus BRANDES

Dr.-Ing.
BAM
West-Berlin

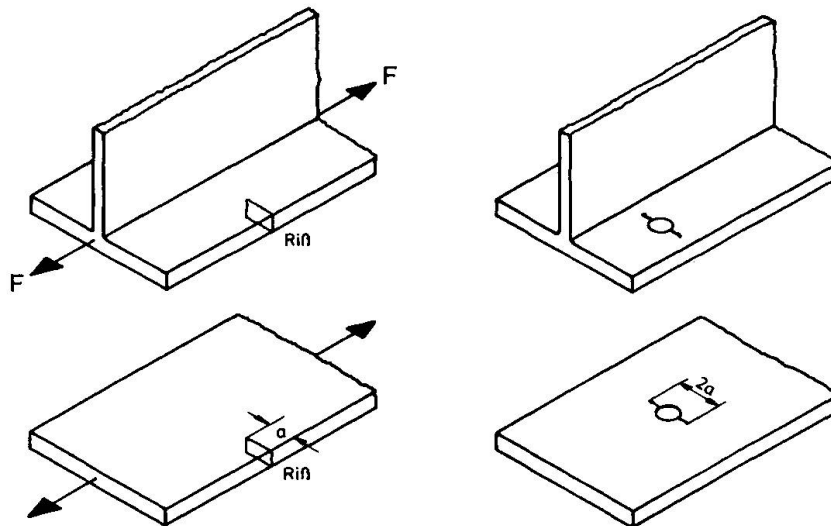
Figure 4.
Crack pat-
terns in
riveted mem-
bers for
evaluating
stress inten-
sity factors
and crack
growth

The application of fracture mechanics in the evaluation of remaining fatigue life implies the modelling of cracks in structural members, which can presumably appear, fig 4. The propagation of cracks then is only governed by the stress intensity at the crack's tip as expressed by the Paris equation. On this basis, it is possible to predict how far a certain crack can grow within the period of time between two inspections.
