Crack Growth Tests to Assess the Remaining Fatigue Life of Old Steel Bridges

Klaus BRANDES

Dr.-Ing.
BAM
West-Berlin

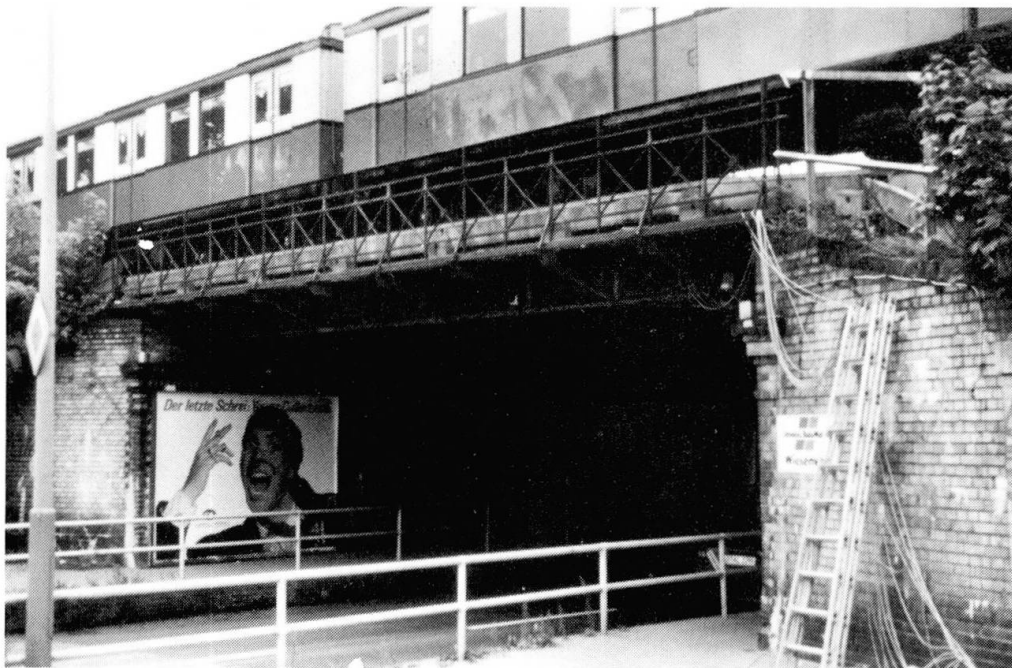
Figure 1.
Steel bridge
of the
Berlin
Metropoli-
tan, built
in 1898,
replaced
1988

Up to now, crack growth tests have been included in the investigation of three bridges in our institute [5] [8]. The first one, a road bridge, was built in 1952 with unidentified material from the thirties. The other ones, two parallel bridges of the Berlin Metropolitan, fig. 1, were erected in 1898. The latter ones are now replaced because of widening of the streets they crossed. In all cases, we measured strains under traffic. The two bridges of the Berlin Metropolitan will be used as models of natural size to evaluate their fatigue life after hundred years of loading, maintenance and corrosion.

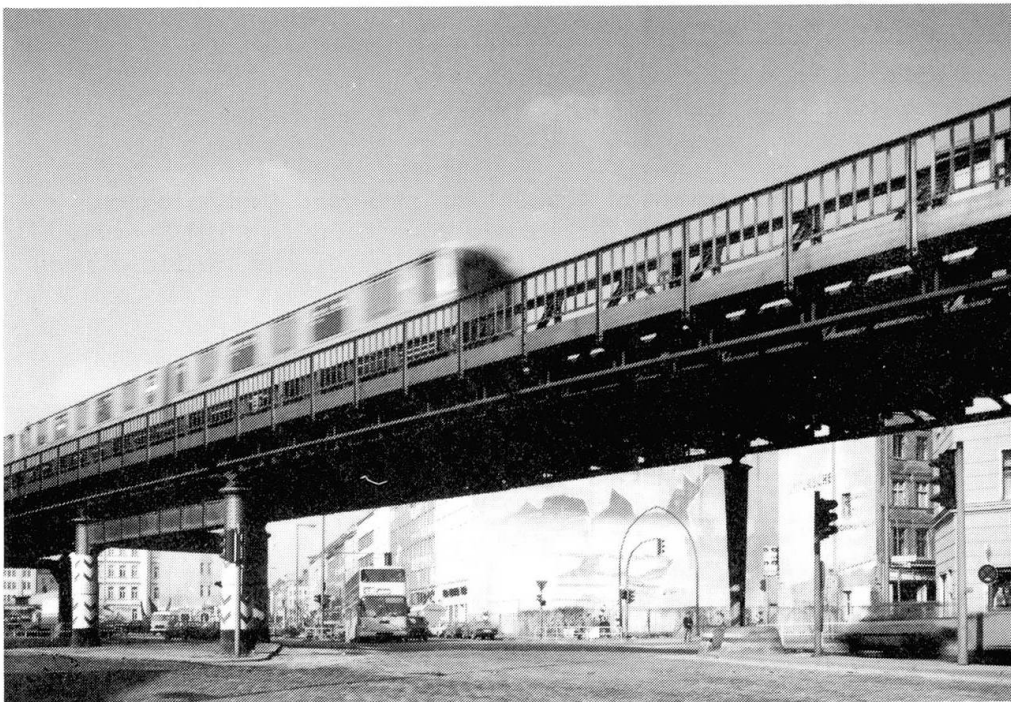
Figure 2.
Truss gir-
der bridge
of the
Berlin
Underground,
built in
1902, re-
placed in
1989

Today, we perform cyclic loading tests on parts of the Berlin Underground Bridge shown in fig. 2, which was built in 1902.

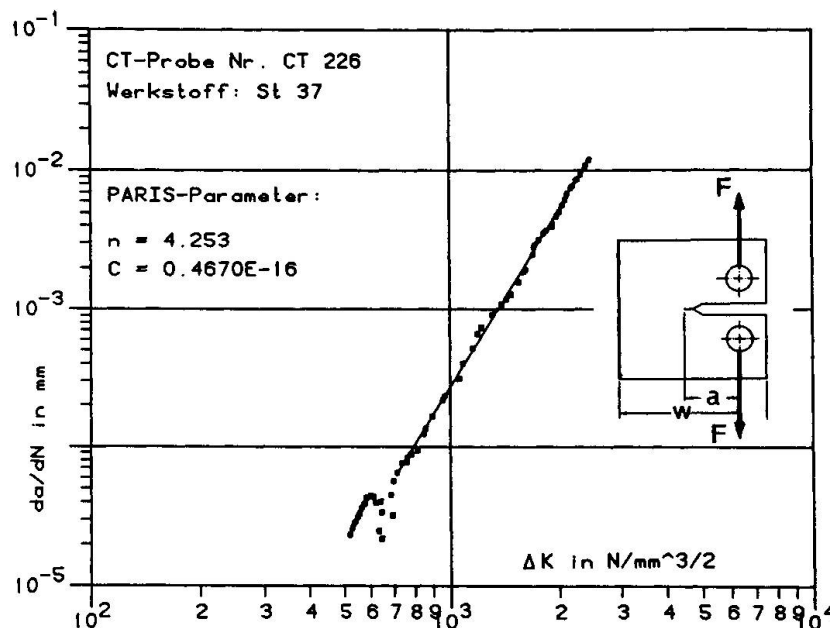
Figure 3.
Result of
one of the
crack
growth
tests (ASTM
E 647-83)
with re-
gression
line re-
garding the
Paris equa-
tion (1)

The crack growth tests which supplemented the set of standard technological tests (strength, chemical analysis) were performed according to ASTM E 647-83 [10]. The specimens were 12.5 mm thick. The initial value of the cyclic stress intensity factor ΔK reached 300 N/mm^{3/2} to 500 N/mm^{3/2}.

The results of the tests, given in terms of the Paris-equation, fig. 3,

$$\frac{da}{dN} = C \Delta K^n \quad (1)$$

have proven that there is no significant difference between mild steel produced at the turn of the centuries and today.

The value of n tends to a little bit higher values than presented in textbooks for present-day steel

$$n = 2.83 \dots 4.75.$$

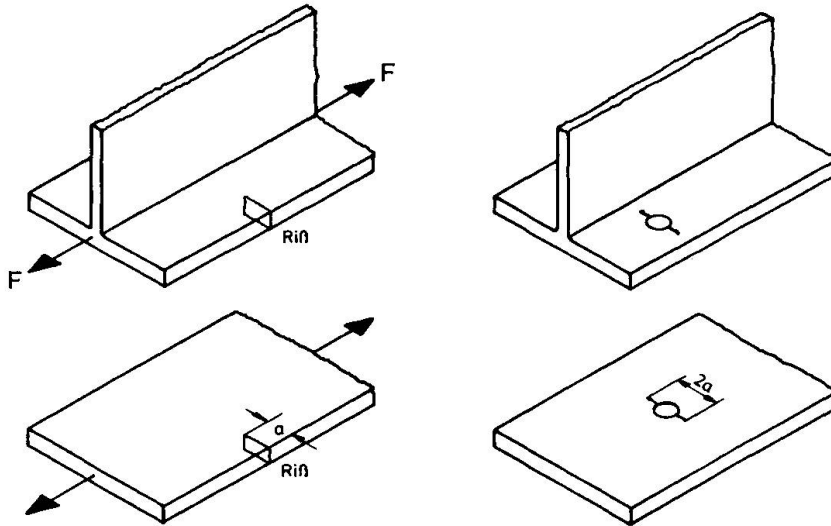
Figure 4.
Crack pat-
terns in
riveted mem-
bers for
evaluating
stress inten-
sity factors
and crack
growth

The application of fracture mechanics in the evaluation of remaining fatigue life implies the modelling of cracks in structural members, which can presumably appear, fig 4. The propagation of cracks then is only governed by the stress intensity at the crack's tip as expressed by the Paris equation. On this basis, it is possible to predict how far a certain crack can grow within the period of time between two inspections.

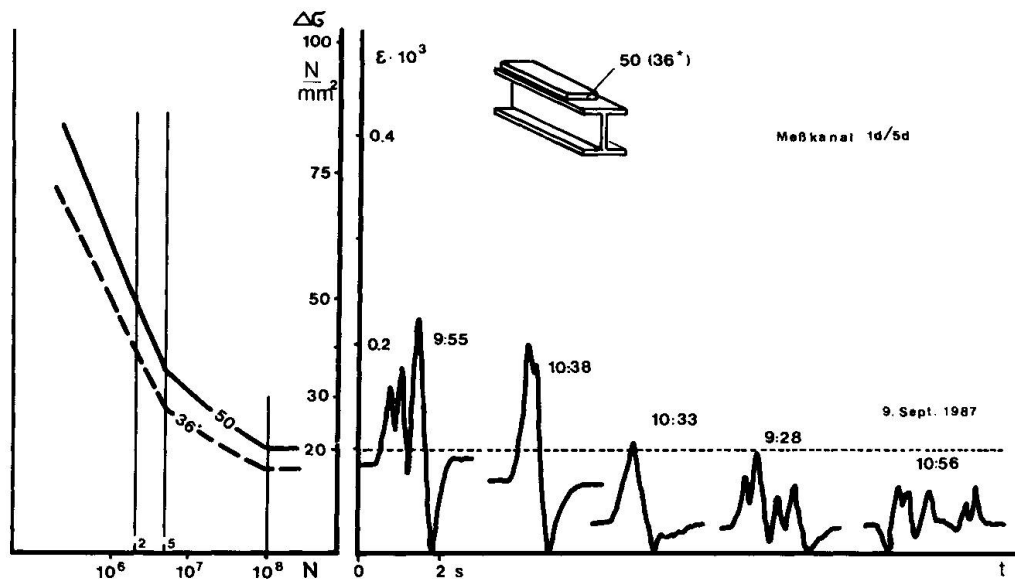
Figure 5. Measured strains/stresses during about 3 hours of observation at one measuring point.

The curves on the right hand side represent the largest measured cycles (indicated: time of vehicle passing) [5] which are compared with the cut-off limits of the ECCS-fatigue strength curve 50 (36*) [11]

The long-life fatigue behaviour of welded structures has been subject of discussion and research quite recently [9]. However, the same problems occur for old riveted structures, too. Looking at the results of measurements at some bridges, we found that only very few of the stress cycles exceed the cut-off limits as given e. g. in the ECCS Recommendations [11], fig. 5.
