Measurement of Service Stress and Fatigue Life Evaluation of Bridges

Kentaro YAMADA

Professor
Nagoya University
Nagoya, Japan

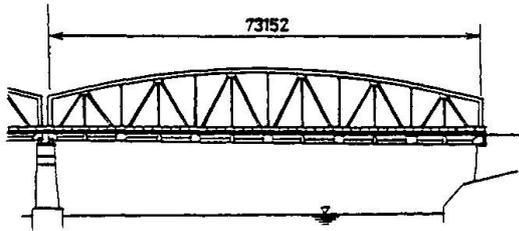
Fig.1 Bridge A: Riveted truss bridge

1) Bridge A: It is a 60-year old riveted Warren truss bridge, as shown in Fig. 1, with a span of 73 m and a 16 m wide roadway. The bridge is daily subjected to about 250 trains at a speed of about 10 km/h and about 10,000 vehicles, in which 11 percent are trucks. The traffic is considered rather light in Japan.

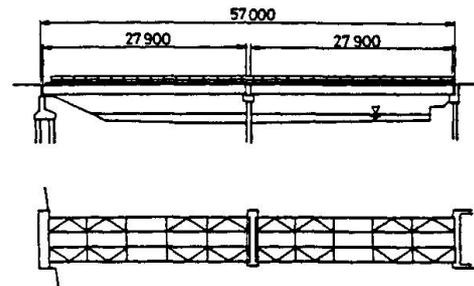
Fig.2 Bridge B: Composite plate girder bridge

2) Bridge B: It is a welded plate girder bridge built in 1967, with a span of 27.9 m and a 7.0 m wide roadway for two lanes, as shown in Fig.2. The spacings of main girders are 2.0 m and the sway bracings are placed at 5.58 m intervals. The reinforced concrete deck was originally 23 cm thick, and was later added by a 12 cm thick steel-fiber reinforced concrete in 1979. It is a private bridge in a steel works. Although about twenty special trucks of more than 785 kN (80 tons) pass on it daily, the number of daily truck traffic is very small.

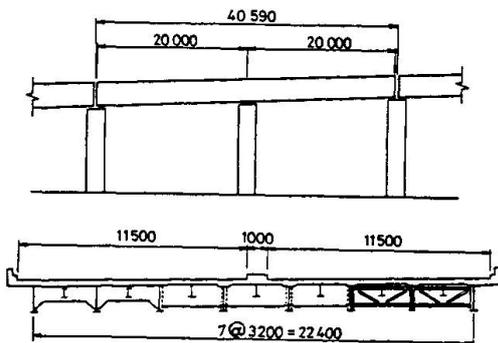
Fig.3 Bridge C: Non-composite plate girder bridge

3) Bridge C: It is a two-span continuous plate girder bridge built in 1964, with eight main girders spaced at 3.2 m intervals, as shown in Fig.3. The total length is 40 m with two spans of 20 m each. The roadway is for six lanes, three lanes for each direction. The deck is made of 19 cm thick reinforced concrete slab. The bridge situates in an industrial area and carries about 100,000 vehicles daily. About half of the passing vehicles are trucks and it is considered to be under severe traffic condition. The bridge was repaired and retrofitted in 1982, when cracks were found in the fillet weld at the upper end of vertical stiffener. The stress measurement was carried out in 1984 [4].

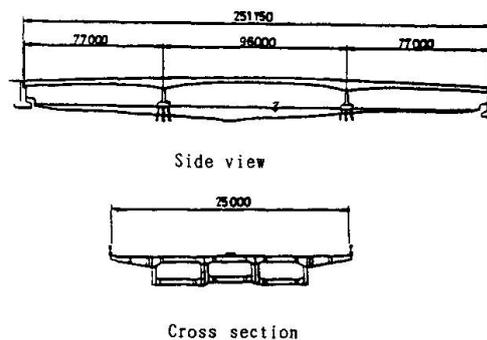
Fig.4 Bridge D: Three span continuous box girder bridge

4) Bridge D: It is a three-span box girder bridge with orthotropic steel decks, built in 1964. It has a 96 m center span and two 77 m side spans, as shown in Fig.4. It is situated on the same route as Bridge C, and is also subjected to severe traffic condition. Several fatigue cracks were found in the corner of diaphragms, and rehabilitation works were carried out in 1989.

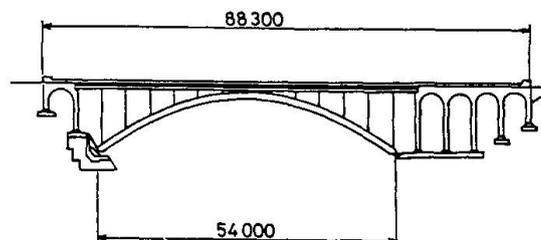
Fig.5 Bridge E: Deck type arch bridge

5) Bridge E: It is a two-hinge deck type arch bridge built in 1964. The arch has 54 m span and the width of roadway is 9.9 m, as shown in Fig.5. The bridge is subjected to about 80,000 vehicles every day, and 26 percent of them are trucks. The bridge is also subjected to severe traffic condition. Fatigue cracks were found in stringers of floor system and vertical members of arch. The cracks of the stringers were repaired and the cracked parts were stiffened. Further repair and strengthening of the arch and replacement of concrete slab into orthotropic steel deck are underway.

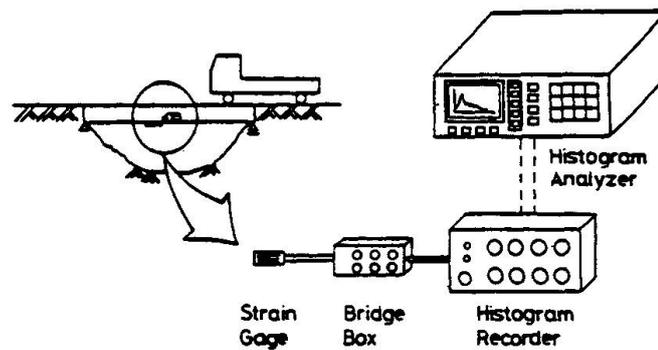
Fig.6 Measurement of stress histogram

Stresses under service condition are important to evaluate the durability of structures. Service stresses can be measured by using a Histogram Recorder, as

shown in Fig.6 [9]. It analyzes the strain waves in real time and records the stress ranges and the number of their occurrence. The analysis may be based on rainflow counting method, peak counting method, level crossing counting method, and so on. The rainflow counting method was used in this study to obtain stress range histogram. The Histogram Recorder has some advantages as that it requires no traffic control, and the disadvantage is that it distinguishes neither the type of trucks nor their axle weight. Therefore, stresses under model vehicle with controlled weight are often measured and used as reference values.

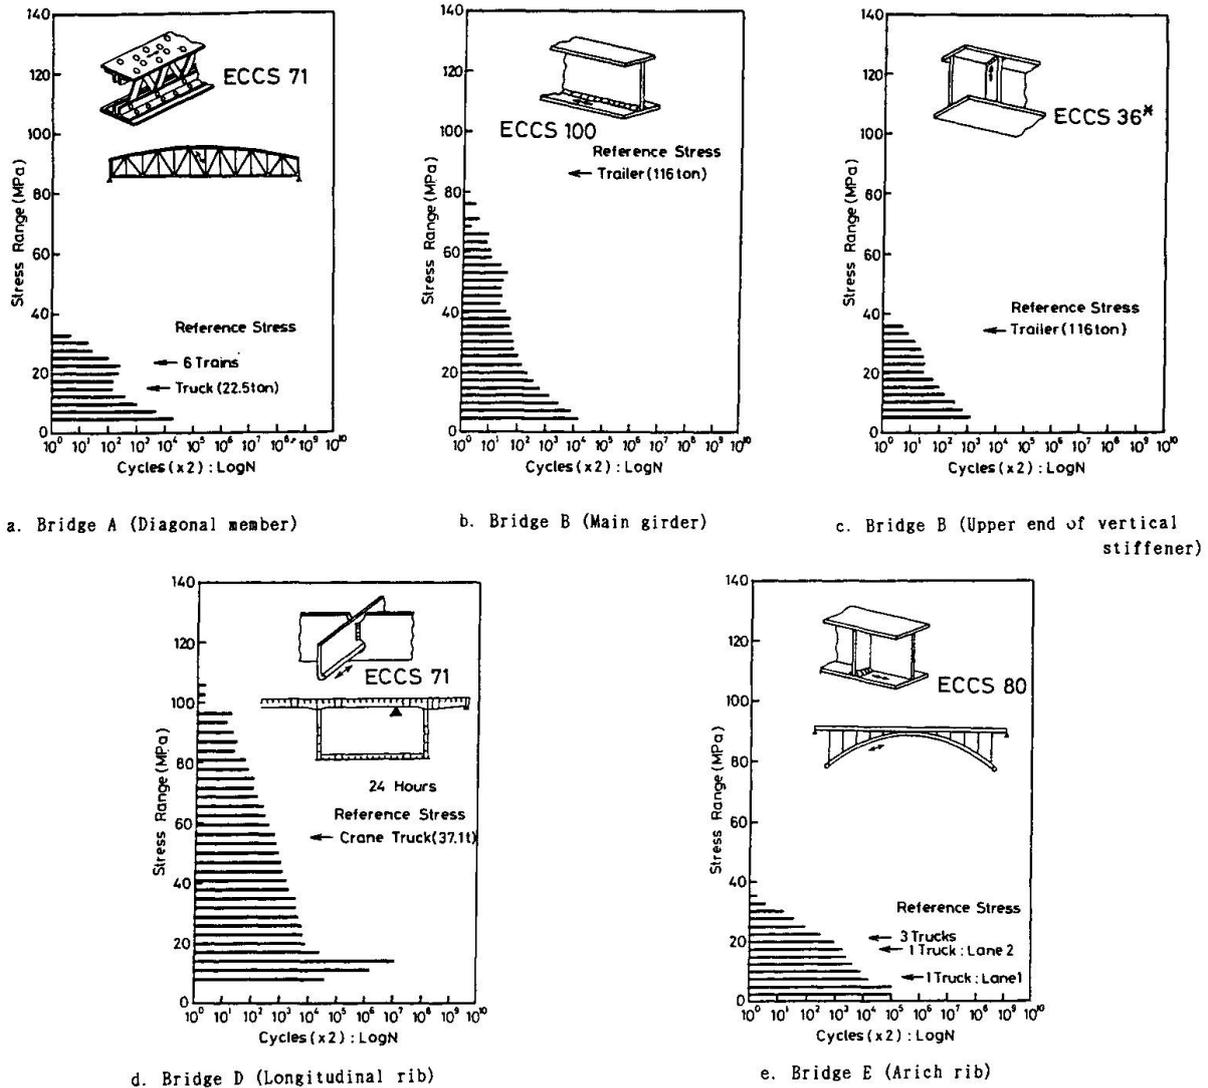
Fig.7 Example of stress range histogram records

Examples of the stress range histogram measured for 24 hours are shown in Fig. 7, where the ordinate indicates stress range and the abscissa shows the number of half stress cycles in logarithmic scale. The stress ranges corresponding to the model vehicles are also shown as reference values.

The stress histogram of a diagonal member of the Bridge A is shown in Fig.7a. The model vehicles are a 22.5-ton dump truck with 3 axles and a train with 6 cars. It seems that the upper peak of stress cycles is caused by the trains. The stress cycles below the reference value by the model truck may be caused by lighter trucks and the other vehicles and that above the reference value by the train is considered to be caused when the trucks and the train passed on the bridge simultaneously.

Figs.7b and 7c show stress range histograms measured at a lower flange and the upper end of a vertical stiffener of Bridge B, respectively. The measured maximum stress range in the lower flange is close to reference stress range by the 1140 kN (116 tons) trailer truck. And that in the lower flange of Bridge B is about 80 MPa, about twice of that in the diagonal members of Bridge A.

Fig.7d shows stress range histogram measured at bottom of longitudinal rib in the orthotropic steel deck of Bridge D. The model vehicle was a crane truck of 364 kN (37.1 tons). The maximum stress range was about 105 MPa, about twice of stresses due to the model vehicle. It is either because the trucks weigh more than the model vehicle, or because heavy trucks crossed the bridge simultaneously. There was extremely large number of low stress ranges. This may be explained by the frequent passage of small trucks or vibration in the orthotropic steel deck due to the passing traffics.

Fig.7e shows stress range histogram measured at the arch rib of passing lane side of Bridge E. The reference stress ranges due to a truck of 206 kN (21 tons) passing on the slow lane or on the passing lane, or three same trucks are also shown in the figure. The measured stress range were larger than the stresses by the three trucks. It implies that vehicles weighed more than the model trucks frequently passed on the bridge.

The stress range histograms of Bridges D and E were different from that of Bridges A and B. This is because the volume of traffics is much greater in Bridges D and E than in Bridges A and B. For example, about 250 trains and 10,000 vehicles passed on Bridge A, while over 100,000 vehicles passed on Bridge D and about 80,000 vehicles passed on Bridge E for 24 hours.

In this study the design S-N diagrams specified in the ECCS Recommendation for the Fatigue Design of Steel Structures [8] were used to evaluate the fatigue strength of weld details. Since the design S-N diagrams correspond to the mean-2xs (s:standard deviation) S-N diagrams, the computed fatigue life is the lower bound fatigue life. The design S-N diagrams are given for classified structural detail. The detail categories evaluated for fatigue life in this study are also shown in Fig.7.

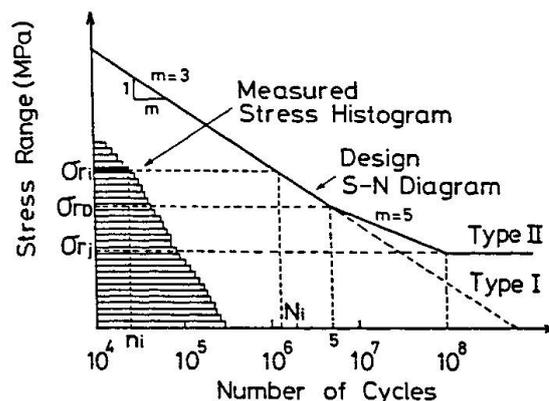
Fig.8 ECCS design S-N diagram

Two types of design S-N diagrams specified in the ECCS Recommendation are used to evaluate the fatigue damage based on the stress range histogram, as shown in Fig.8.

- 1) Type I (Modified miner's rule): The S-N diagram of slope of $m=3$ is extended linearly.
- 2) Type II (Three line method): The slope of the S-N diagram m is equal to 3 for N less than 5 million cycles, and 5 for N between 5 million and 100 million cycles. Stress ranges below the cut-off limit are neglected.

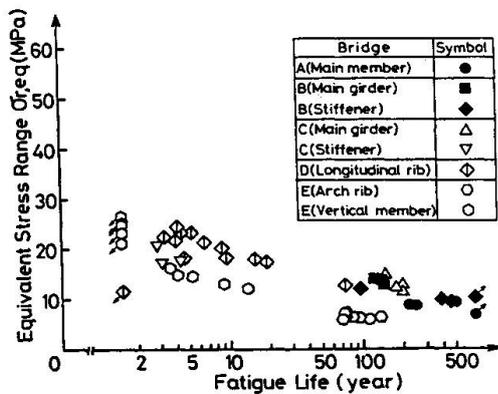
Fig.9 Equivalent stress range and fatigue life for Bridges A and B

Fatigue lives of the above-mentioned structural details in the Bridges A and B computed from the measured stress histograms are plotted in Fig.9. The two bridges were subjected to relatively light traffics, and their fatigue life are shown by the solid symbols in Fig.9. The fatigue life of the main members of Bridge A yields to more than 220 years, and that of the tension flanges of Bridge B are between 120 and 140 years. Even the upper end of vertical stiffeners of Bridge B showed the life longer than 90 years. Considering that the evaluated fatigue life is the lower bound because of the use of the lower bound S-N diagrams, it may be safe to concluded that fatigue cracks would hardly occur in these details, provided that traffic condition will remain unchanged and structural deterioration such as corrosion will not take place.

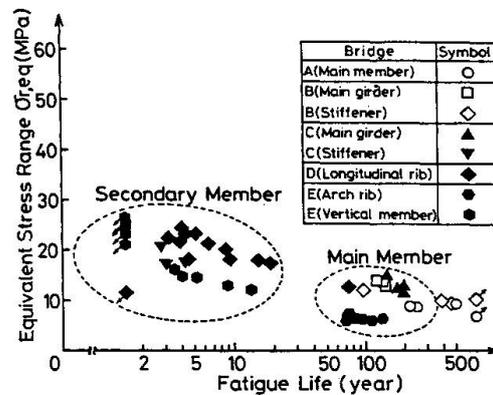
Fig.10 Equivalent stress range and fatigue life for Bridges C, D and E

Bridges C, D and E were subjected to severe traffic condition, and their fatigue lives are plotted by the solid symbols in Fig.10. If the structural details are grouped into main members and secondary members, the computed fatigue lives can be also grouped accordingly. For example, the fatigue lives of the tension flange of Bridge C are more than 100 years, and that of the arch ribs of Bridge E is between 70 and 130 years. On the contrary, the fatigue lives of the vertical members of the arch are less than 4 years, that of the longitudinal ribs in Bridge D are less than 20 years, and that of the upper and lower ends of the vertical members of Bridge E are below 15 years. Actually, the welded details in these secondary members were found susceptible to fatigue cracking previously [2,3,4]. Therefore, the fatigue lives obtained from the measured stress range histogram are a good

indicator of the severeness of structural detail against fatigue, even though the fatigue lives computed here are still inaccurate due to many uncertainties involved in the analysis.

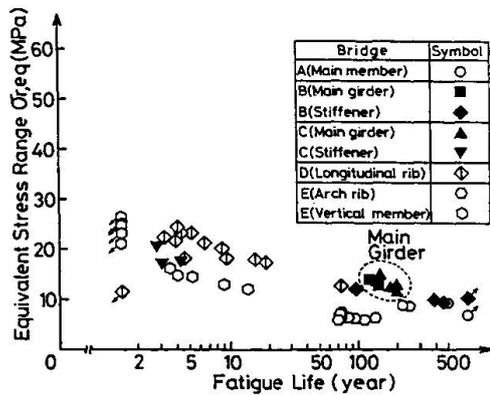
Fig.11 Equivalent stress range and fatigue life for Bridges B and C

Bridges B and C are both plate girder bridges with similar structural details, and their fatigue lives are plotted by the solid symbols in Fig. 11. It is noted that the main girder of Bridge B showed shorter fatigue life than Bridge C, although Bridge C are subjected to about 100,000 vehicles daily. This may be because Bridge B carries special vehicles of over 785 kN (80 tons). However, the upper ends of the vertical stiffeners in Bridge B showed long fatigue lives. This may be due to the 35 cm thick concrete slab and the 2.0 m girder spacing in Bridge B. They reduced the stresses and hence increased the fatigue life. On the contrary the Bridge C has a 19 cm thick concrete slab and 3.2 m girder spacings.

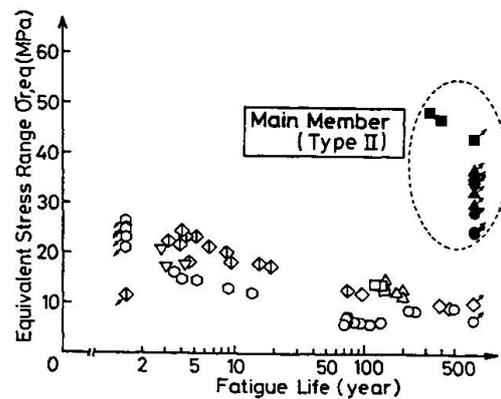
Fig.12 Equivalent stress range and fatigue damage for main members

The type II S-N diagram (Three line method) was also used to evaluate the fatigue life of each detail, and the results are plotted in Figs. 12 and 13. In Fig. 12, computed fatigue life of the main members (the tension flanges and the arch ribs) using the type II S-N diagram are shown by the solid symbols. They are over 300 years, longer than that evaluated by using the type I S-N diagram. This is because most of the stress ranges in the histograms are below the cut-off limit and they are neglected in the type II S-N diagram. In the case of the arch ribs of the

bridge E, the fatigue life becomes infinite because all stress ranges are below the cut-off limit.

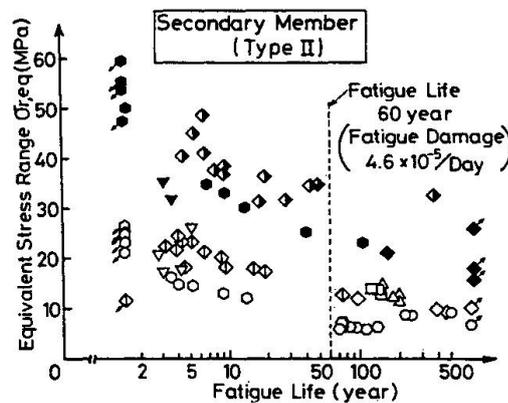
Fig.13 Equivalent stress range and fatigue damage for secondary members

The fatigue lives of the secondary members are shown by the solid symbols in Fig.13. Although the equivalent stress ranges increase, the computed fatigue lives are similar to the lives computed based on the type I S-N diagram. A good part of the stress ranges in the histogram were above cut-off limit and contributed to the fatigue damages of the secondary members. Some secondary members actually experienced fatigue crackings, and therefore this trend can also be used to evaluate the severeness of stresses against fatigue.
