Zeitschrift: IABSE reports = Rapports AIPC = IVBH Berichte
Band: 59 (1990)

Artikel: Measurement of service stress and fatigue life evaluation of bridges
Autor: Yamada, Kentaro / [s.n.]
DOI: <https://doi.org/10.5169/seals-45709>

Measurement of Service Stress and Fatigue Life Evaluation of Bridges

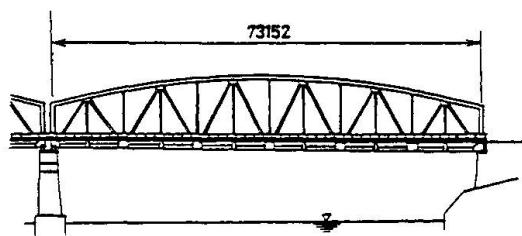
- 1) Bridge A: It is a 60-year old riveted Warren truss bridge, as shown in Fig. 1, with a span of 73 m and a 16 m wide roadway. The bridge is daily subjected to about 250 trains at a speed of about 10 km/h and about 10,000 vehicles, in which 11 percent are trucks. The traffic is considered rather light in Japan.

Fig.1 Bridge A: Riveted truss bridge

The stress histogram of a diagonal member of the Bridge A is shown in Fig.7a. The model vehicles are a 22.5-ton dump truck with 3 axles and a train with 6 cars. It seems that the upper peak of stress cycles is caused by the trains. The stress cycles below the reference value by the model truck may be caused by lighter trucks and the other vehicles and that above the reference value by the train is considered to be caused when the trucks and the train passed on the bridge simultaneously.

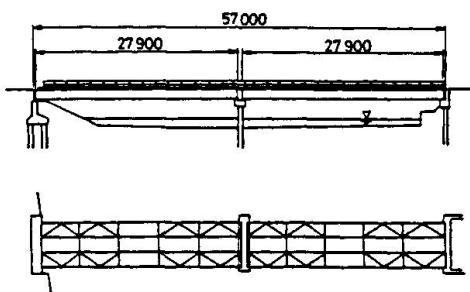
- 2) Bridge B: It is a welded plate girder bridge built in 1967, with a span of 27.9 m and a 7.0 m wide roadway for two lanes, as shown in Fig.2. The spacings of main girders are 2.0 m and the sway bracings are placed at 5.58 m intervals. The reinforced concrete deck was originally 23 cm thick, and was later added by a 12 cm thick steel-fiber reinforced concrete in 1979. It is a private bridge in a steel works. Although about twenty special trucks of more than 785 kN (80 tons) pass on it daily, the number of daily truck traffic is very small.

Fig.2 Bridge B: Composite plate girder bridge

Figs.7b and 7c show stress range histograms measured at a lower flange and the upper end of a vertical stiffener of Bridge B, respectively. The measured maximum stress range in the lower flange is close to reference stress range by the 1140 kN (116 tons) trailer truck. And that in the lower flange of Bridge B is about 80 MPa, about twice of that in the diagonal members of Bridge A.

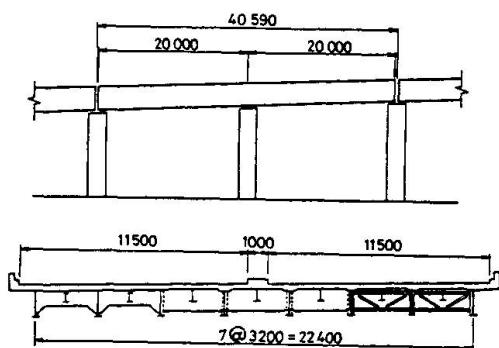
- 3) Bridge C: It is a two-span continuous plate girder bridge built in 1964, with eight main girders spaced at 3.2 m intervals, as shown in Fig.3. The total length is 40 m with two spans of 20 m each. The roadway is for six lanes, three lanes for each direction. The deck is made of 19 cm thick reinforced concrete slab. The bridge situates in an industrial area and carries about 100,000 vehicles daily. About half of the passing vehicles are trucks and it is considered to be under severe traffic condition. The bridge was repaired and retrofitted in 1982, when cracks were found in the fillet weld at the upper end of vertical stiffener. The stress measurement was carried out in 1984 [4].

Fig.3 Bridge C: Non-composite plate girder bridge

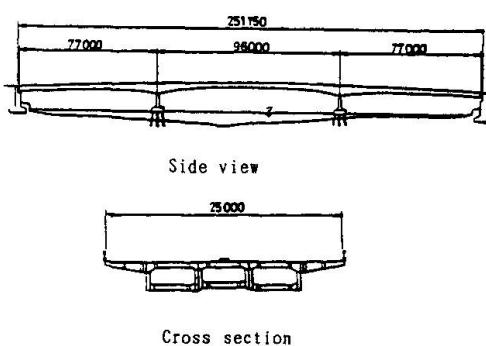
- 4) Bridge D: It is a three-span box girder bridge with orthotropic steel decks, built in 1964. It has a 96 m center span and two 77 m side spans, as shown in Fig.4. It is situated on the same route as Bridge C, and is also subjected to severe traffic condition. Several fatigue cracks were found in the corner of diaphragms, and rehabilitation works were carried out in 1989.

Fig.4 Bridge D: Three span continuous box girder bridge

Fig.7d shows stress range histogram measured at bottom of longitudinal rib in the orthotropic steel deck of Bridge D. The model vehicle was a crane truck of 364 kN (37.1 tons). The maximum stress range was about 105 MPa, about twice of stresses due to the model vehicle. It is either because the trucks weigh more than the model vehicle, or because heavy trucks crossed the bridge simultaneously. There was extremely large number of low stress ranges. This may be explained by the frequent passage of small trucks or vibration in the orthotropic steel deck due to the passing traffics.

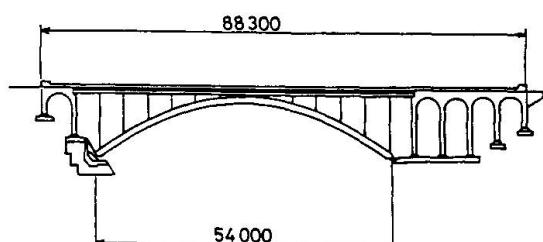
- 5) Bridge E: It is a two-hinge deck type arch bridge built in 1964. The arch has 54 m span and the width of roadway is 9.9 m, as shown in Fig.5. The bridge is subjected to about 80,000 vehicles every day, and 26 percent of them are trucks. The bridge is also subjected to severe traffic condition. Fatigue cracks were found in stringers of floor system and vertical members of arch. The cracks of the stringers were repaired and the cracked parts were stiffened. Further repair and strengthening of the arch and replacement of concrete slab into orthotropic steel deck are underway.

Fig.5 Bridge E: Deck type arch bridge

Fig.7e shows stress range histogram measured at the arch rib of passing lane side of Bridge E. The reference stress ranges due to a truck of 206 kN (21 tons) passing on the slow lane or on the passing lane, or three same trucks are also shown in the figure. The measured stress range were larger than the stresses by the three trucks. It implies that vehicles weighed more than the model trucks frequently passed on the bridge.

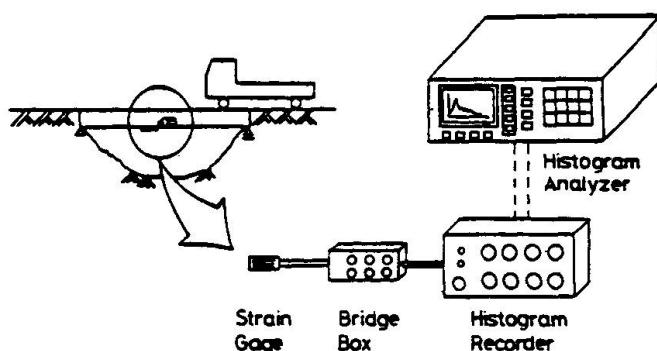
shown in Fig.6 [9]. It analyzes the strain waves in real time and records the stress ranges and the number of their occurrence. The analysis may be based on rainflow counting method, peak counting method, level crossing counting method, and so on. The rainflow counting method was used in this study to obtain stress range histogram. The Histogram Recorder has some advantages as that it requires no traffic control, and the disadvantage is that it distinguishes neither the type of trucks nor their axle weight. Therefore, stresses under model vehicle with controlled weight are often measured and used as reference values.

Fig.6 Measurement of stress histogram

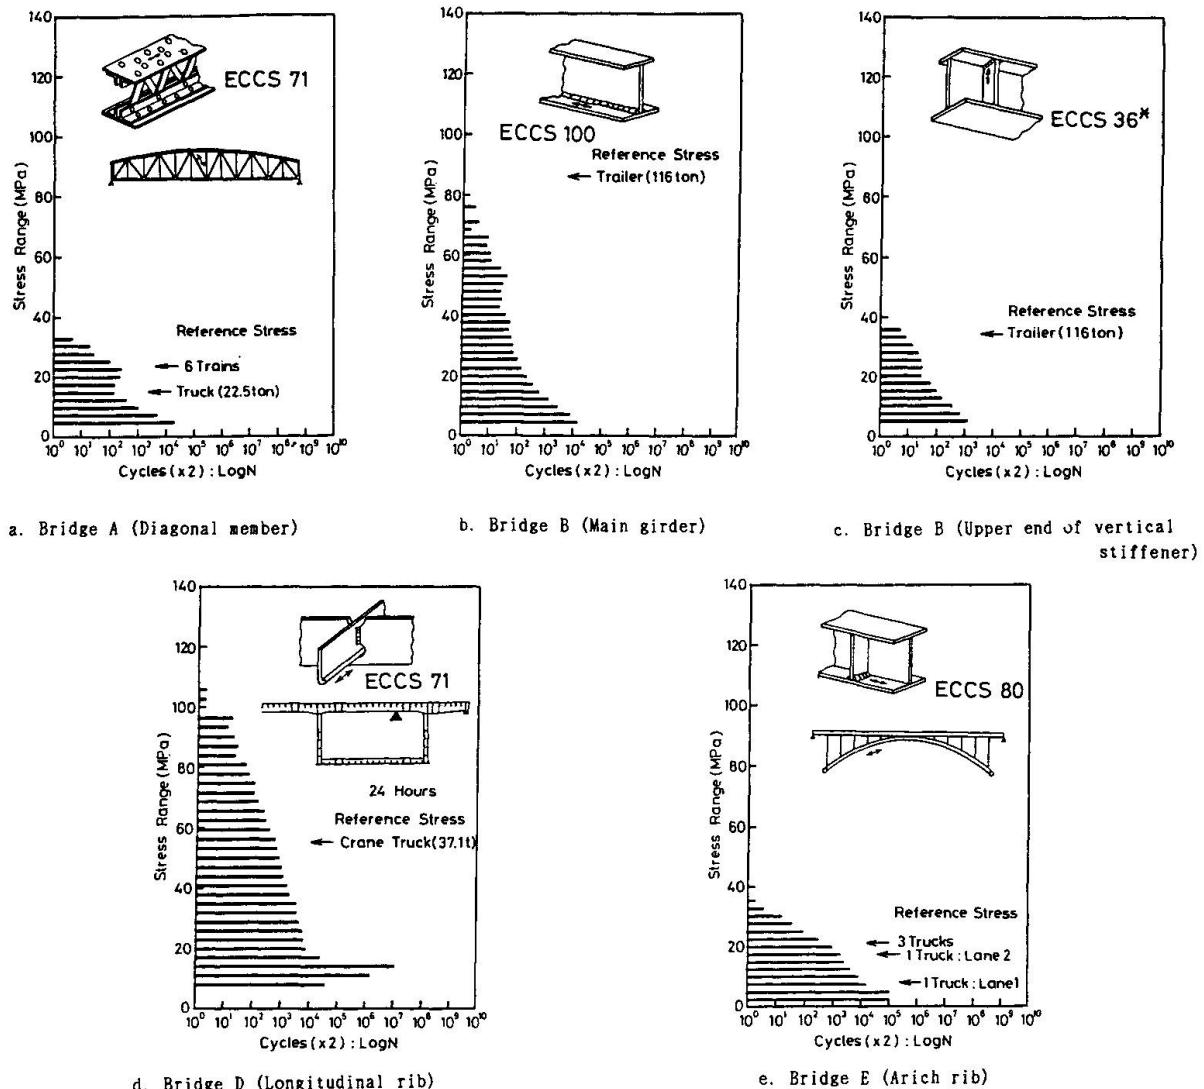
Examples of the stress range histogram measured for 24 hours are shown in Fig. 7, where the ordinate indicates stress range and the abscissa shows the number of half stress cycles in logarithmic scale. The stress ranges corresponding to the model vehicles are also shown as reference values.

Fig.7 Example of stress range histogram records

The stress range histograms of Bridges D and E were different from that of Bridges A and B. This is because the volume of traffics is much greater in Bridges D and E than in Bridges A and B. For example, about 250 trains and 10,000 vehicles passed on Bridge A, while over 100,000 vehicles passed on Bridge D and about 80,000 vehicles passed on Bridge E for 24 hours.

- 1) Bridge A: Riveted joints are classified as ECCS 71.
- 2) Bridge B and C: The lower flange of the plate girder is fillet-welded to the web, and this detail is classified as ECCS 100. The upper end of the vertical stiffener (connection plate) with a cross beam or a lateral bracing can be considered as load-carrying fillet weld, and it is ECCS 36 if root-cracking is assumed.

- 3) Bridge D: The stress range of longitudinal ribs welded to lateral ribs in the orthotropic steel deck is used from that measured at the bottom of the longitudinal rib. The welds are assumed as load-carrying fillet weld and it is classified as ECCS 71 for toe crack.

- 4) Bridge E: The upper and the lower ends of the vertical members are fillet-welded to splice plates, which are then riveted to the arch rib and the floor system. The weld detail is classified as ECCS 71. The arch rib has stiffeners that are fillet-welded to the arch rib web. The detail is non-load-carrying fillet weld, and is classified as ECCS 80.

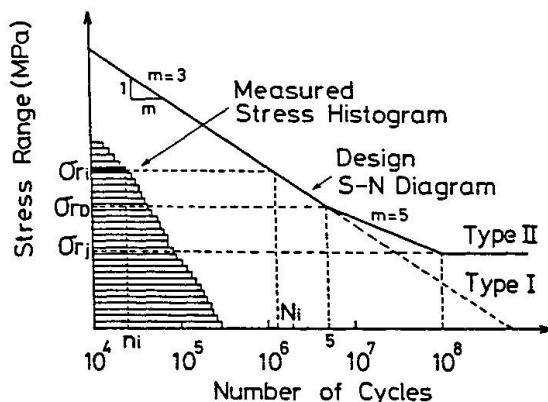
Two types of design S-N diagrams specified in the ECCS Recommendation are used to evaluate the fatigue damage based on the stress range histogram, as shown in Fig.8.

Fig.8 ECCS design S-N diagram

- 1) Type I (Modified Miner's rule): The S-N diagram of slope of $m=3$ is extended linearly.
- 2) Type II (Three line method): The slope of the S-N diagram m is equal to 3 for N less than 5 million cycles, and 5 for N between 5 million and 100 million cycles. Stress ranges below the cut-off limit are neglected.

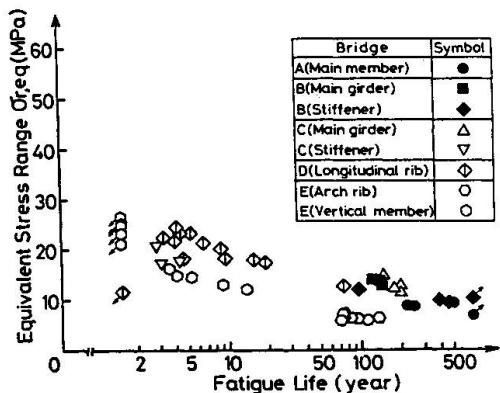
Fatigue lives of the above-mentioned structural details in the Bridges A and B computed from the measured stress histograms are plotted in Fig.9. The two bridges were subjected to relatively light traffics, and their fatigue life are shown by the solid symbols in Fig.9. The fatigue life of the main members of Bridge A yields to more than 220 years, and that of the tension flanges of Bridge B are between 120 and 140 years. Even the upper end of vertical stiffeners of Bridge B showed the life longer than 90 years. Considering that the evaluated fatigue life is the lower bound because of the use of the lower bound S-N diagrams, it may be safe to concluded that fatigue cracks would hardly occur in these details, provided that traffic condition will remain unchanged and structural deterioration such as corrosion will not take place.

Fig.9 Equivalent stress range and fatigue life for Bridges A and B

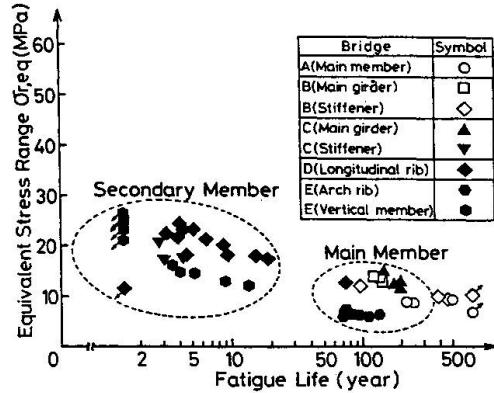
Fig.10 Equivalent stress range and fatigue life for Bridges C, D and E

Bridges C, D and E were subjected to severe traffic condition, and their fatigue lives are plotted by the solid symbols in Fig.10. If the structural details are grouped into main members and secondary members, the computed fatigue lives can be also grouped accordingly. For example, the fatigue lives of the tension flange of Bridge C are more than 100 years, and that of the arch ribs of Bridge E is between 70 and 130 years. On the contrary, the fatigue lives of the vertical members of the arch are less than 4 years, that of the longitudinal ribs in Bridge D are less than 20 years, and that of the upper and lower ends of the vertical members of Bridge E are below 15 years. Actually, the welded details in these secondary members were found susceptible to fatigue cracking previously [2,3,4]. Therefore, the fatigue lives obtained from the measured stress range histogram are a good

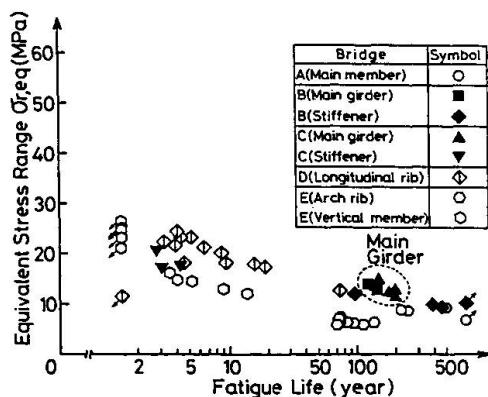
Bridges B and C are both plate girder bridges with similar structural details, and their fatigue lives are plotted by the solid symbols in Fig. 11. It is noted that the main girder of Bridge B showed shorter fatigue life than Bridge C, although Bridge C are subjected to about 100,000 vehicles daily. This may be because Bridge B carries special vehicles of over 785 kN (80 tons). However, the upper ends of the vertical stiffeners in Bridge B showed long fatigue lives. This may be due to the 35 cm thick concrete slab and the 2.0 m girder spacing in Bridge B. They reduced the stresses and hence increased the fatigue life. On the contrary the Bridge C has a 19 cm thick concrete slab and 3.2 m girder spacings.

Fig.11 Equivalent stress range and fatigue life for Bridges B and C

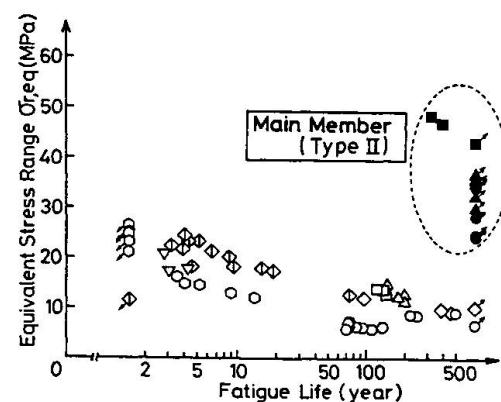
Fig.12 Equivalent stress range and fatigue damage for main members

The type II S-N diagram (Three line method) was also used to evaluate the fatigue life of each detail, and the results are plotted in Figs. 12 and 13. In Fig. 12, computed fatigue life of the main members (the tension flanges and the arch ribs) using the type II S-N diagram are shown by the solid symbols. They are over 300 years, longer than that evaluated by using the type I S-N diagram. This is because most of the stress ranges in the histograms are below the cut-off limit and they are neglected in the type II S-N diagram. In the case of the arch ribs of the

bridge E, the fatigue life becomes infinite because all stress ranges are below the cut-off limit.

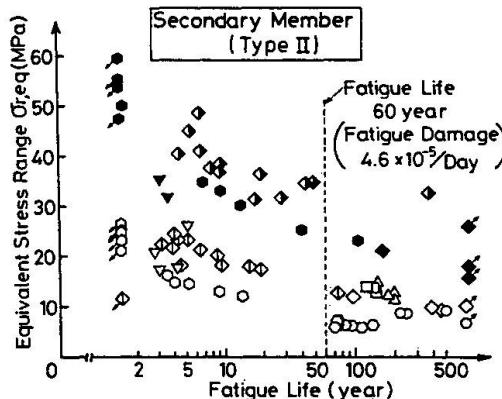
Fig.13 Equivalent stress range and fatigue damage for secondary members

The fatigue lives of the secondary members are shown by the solid symbols in Fig.13. Although the equivalent stress ranges increase, the computed fatigue lives are similar to the lives computed based on the type I S-N diagram. A good part of the stress ranges in the histogram were above cut-off limit and contributed to the fatigue damages of the secondary members. Some secondary members actually experienced fatigue crackings, and therefore this trend can also be used to evaluate the severeness of stresses against fatigue.
