Zeitschrift: IABSE reports = Rapports AIPC = IVBH Berichte
Band: 59 (1990)

Measurement of Service Stress and Fatigue Life Evaluation of Bridges

Kentaro YAMADA

Professor
Nagoya University
Nagoya, Japan

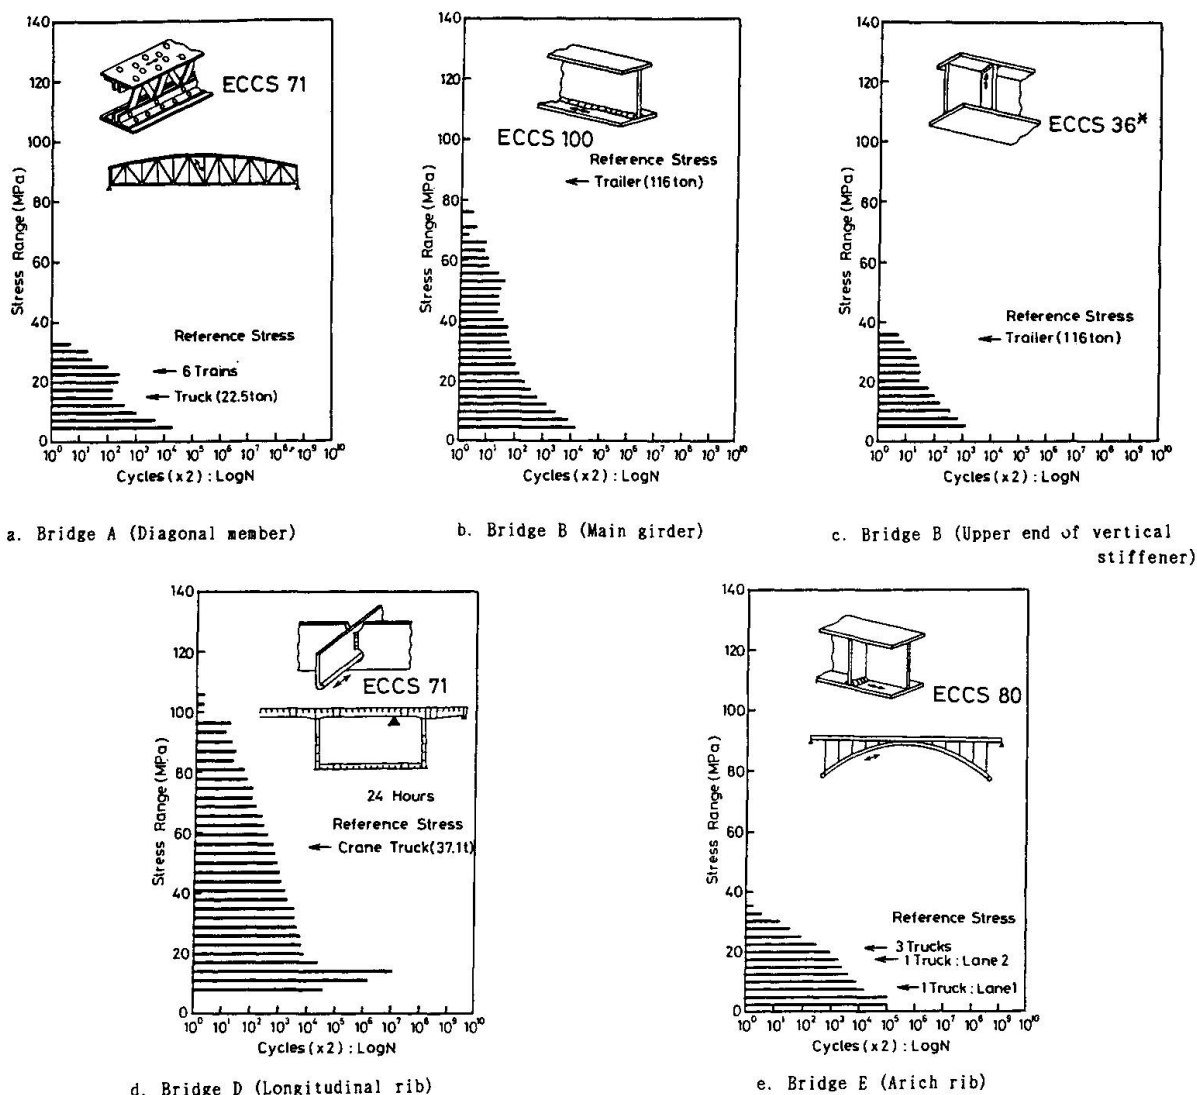
Fig.7 Example of stress range histogram records

Examples of the stress range histogram measured for 24 hours are shown in Fig. 7, where the ordinate indicates stress range and the abscissa shows the number of half stress cycles in logarithmic scale. The stress ranges corresponding to the model vehicles are also shown as reference values.

The stress histogram of a diagonal member of the Bridge A is shown in Fig.7a. The model vehicles are a 22.5-ton dump truck with 3 axles and a train with 6 cars. It seems that the upper peak of stress cycles is caused by the trains. The stress cycles below the reference value by the model truck may be caused by lighter trucks and the other vehicles and that above the reference value by the train is considered to be caused when the trucks and the train passed on the bridge simultaneously.

Figs.7b and 7c show stress range histograms measured at a lower flange and the upper end of a vertical stiffener of Bridge B, respectively. The measured maximum stress range in the lower flange is close to reference stress range by the 1140 kN (116 tons) trailer truck. And that in the lower flange of Bridge B is about 80 MPa, about twice of that in the diagonal members of Bridge A.

Fig.7d shows stress range histogram measured at bottom of longitudinal rib in the orthotropic steel deck of Bridge D. The model vehicle was a crane truck of 364 kN (37.1 tons). The maximum stress range was about 105 MPa, about twice of stresses due to the model vehicle. It is either because the trucks weigh more than the model vehicle, or because heavy trucks crossed the bridge simultaneously. There was extremely large number of low stress ranges. This may be explained by the frequent passage of small trucks or vibration in the orthotropic steel deck due to the passing traffics.

Fig.7e shows stress range histogram measured at the arch rib of passing lane side of Bridge E. The reference stress ranges due to a truck of 206 kN (21 tons) passing on the slow lane or on the passing lane, or three same trucks are also shown in the figure. The measured stress range were larger than the stresses by the three trucks. It implies that vehicles weighed more than the model trucks frequently passed on the bridge.

The stress range histograms of Bridges D and E were different from that of Bridges A and B. This is because the volume of traffics is much greater in Bridges D and E than in Bridges A and B. For example, about 250 trains and 10,000 vehicles passed on Bridge A, while over 100,000 vehicles passed on Bridge D and about 80,000 vehicles passed on Bridge E for 24 hours.

In this study the design S-N diagrams specified in the ECCS Recommendation for the Fatigue Design of Steel Structures [8] were used to evaluate the fatigue strength of weld details. Since the design S-N diagrams correspond to the mean-2xs (s:standard deviation) S-N diagrams, the computed fatigue life is the lower bound fatigue life. The design S-N diagrams are given for classified structural detail. The detail categories evaluated for fatigue life in this study are also shown in Fig.7.

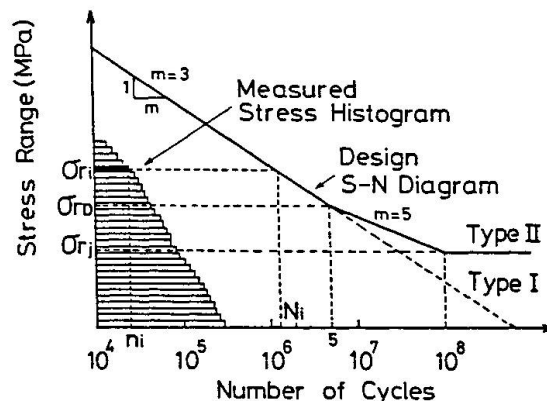
Fig.8 ECCS design S-N diagram

Two types of design S-N diagrams specified in the ECCS Recommendation are used to evaluate the fatigue damage based on the stress range histogram, as shown in Fig.8.

- 1) Type I (Modified miner's rule): The S-N diagram of slope of $m=3$ is extended linearly.
- 2) Type II (Three line method): The slope of the S-N diagram m is equal to 3 for N less than 5 million cycles, and 5 for N between 5 million and 100 million cycles. Stress ranges below the cut-off limit are neglected.

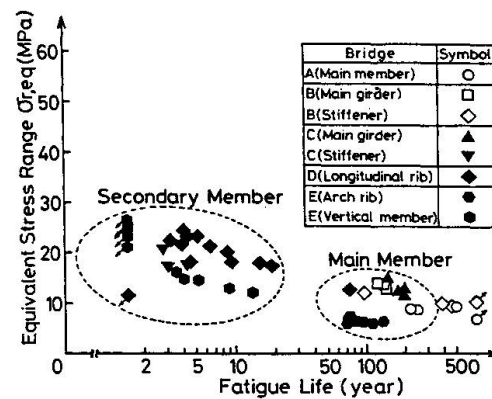
Fig.10 Equivalent stress range and fatigue life for Bridges C, D and E

Bridges C, D and E were subjected to severe traffic condition, and their fatigue lives are plotted by the solid symbols in Fig.10. If the structural details are grouped into main members and secondary members, the computed fatigue lives can be also grouped accordingly. For example, the fatigue lives of the tension flange of Bridge C are more than 100 years, and that of the arch ribs of Bridge E is between 70 and 130 years. On the contrary, the fatigue lives of the vertical members of the arch are less than 4 years, that of the longitudinal ribs in Bridge D are less than 20 years, and that of the upper and lower ends of the vertical members of Bridge E are below 15 years. Actually, the welded details in these secondary members were found susceptible to fatigue cracking previously [2,3,4]. Therefore, the fatigue lives obtained from the measured stress range histogram are a good

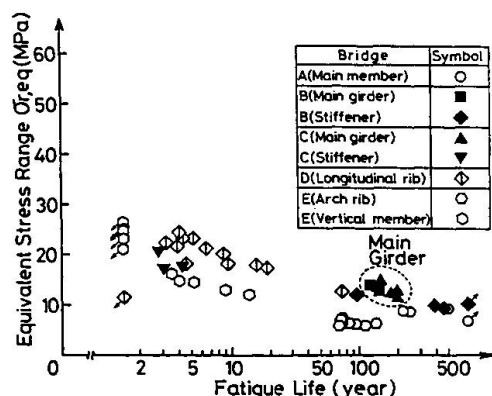
Fig.11 Equivalent stress range and fatigue life for Bridges B and C

Bridges B and C are both plate girder bridges with similar structural details, and their fatigue lives are plotted by the solid symbols in Fig. 11. It is noted that the main girder of Bridge B showed shorter fatigue life than Bridge C, although Bridge C are subjected to about 100,000 vehicles daily. This may be because Bridge B carries special vehicles of over 785 kN (80 tons). However, the upper ends of the vertical stiffeners in Bridge B showed long fatigue lives. This may be due to the 35 cm thick concrete slab and the 2.0 m girder spacing in Bridge B. They reduced the stresses and hence increased the fatigue life. On the contrary the Bridge C has a 19 cm thick concrete slab and 3.2 m girder spacings.

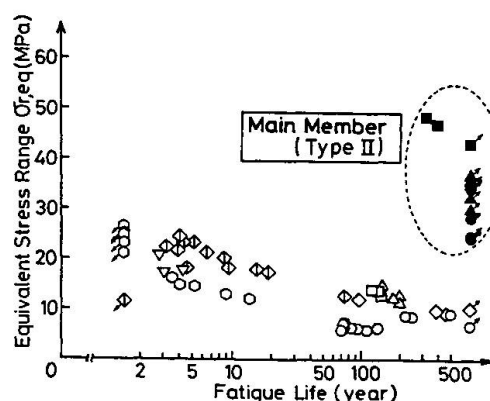
Fig.12 Equivalent stress range and fatigue damage for main members

The type II S-N diagram (Three line method) was also used to evaluate the fatigue life of each detail, and the results are plotted in Figs. 12 and 13. In Fig. 12, computed fatigue life of the main members (the tension flanges and the arch ribs) using the type II S-N diagram are shown by the solid symbols. They are over 300 years, longer than that evaluated by using the type I S-N diagram. This is because most of the stress ranges in the histograms are below the cut-off limit and they are neglected in the type II S-N diagram. In the case of the arch ribs of the

bridge E, the fatigue life becomes infinite because all stress ranges are below the cut-off limit.

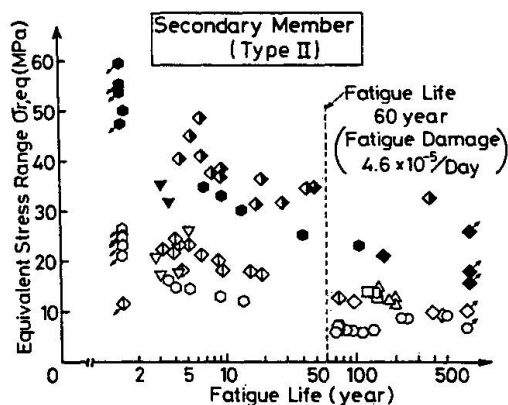
Fig.13 Equivalent stress range and fatigue damage for secondary members

The fatigue lives of the secondary members are shown by the solid symbols in Fig.13. Although the equivalent stress ranges increase, the computed fatigue lives are similar to the lives computed based on the type I S-N diagram. A good part of the stress ranges in the histogram were above cut-off limit and contributed to the fatigue damages of the secondary members. Some secondary members actually experienced fatigue crackings, and therefore this trend can also be used to evaluate the severeness of stresses against fatigue.
