**Zeitschrift:** IABSE reports = Rapports AIPC = IVBH Berichte  
**Band:** 59 (1990)

**Artikel:** Fatigue of cross-beam connections in plate-girder highway bridges  
**Autor:** Okura, Ichiro / Fukumoto, Yuhshi  
**DOI:** <https://doi.org/10.5169/seals-45714>

## Fatigue of Cross-Beam Connections in Plate-Girder Highway Bridges

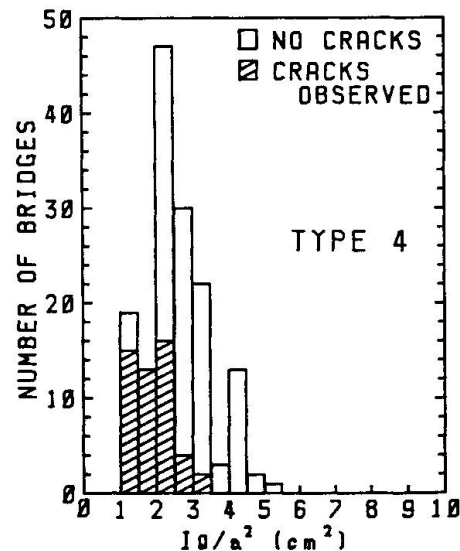
Fig.8 Relationship between  $I_0/a^2$  and the number of bridges in which Type 4 cracks were observed

Figure 8 shows the relationship between  $I_Q/a^2$  and the number of bridges in which Type 4 cracks were observed. With the increase in  $I_Q/a^2$ , the number of bridges suffering from cracking gradually decreases, since the influence of  $\theta_g$  on the local stress  $\sigma_{by}$  which causes Type 4 cracks becomes small. No cracks occur in the bridges for  $I_Q/a^2 > 3.5 \text{ cm}^2$ .
