Artikel: Epoxy bonded steel plate method for repairing deteriorated slabs

Epoxy Bonded Steel Plate Method for Repairing Deteriorated Slabs

Keiichiro SONODA

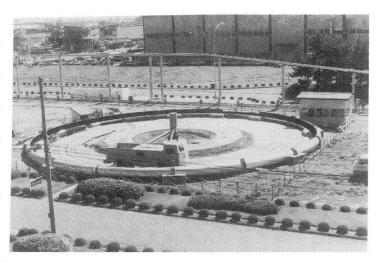
Photo. 1 Test View

tests slabs supported by a twin girder bridge spanning over 3.6m have 8cm thick, main re-bars in 10cm pitch and distribution re-bars in 15cm pitch, which were modeled to an existing RC deck slab on a typical highway road bridge in Japan. A full size truck cyclically running on six composite girder bridges arranged on a circular test road was used, as shown in Photo. 1. Three steps of tests were carried out. The first was static tests by a central patch load on the slabs. The second was fatigue loading tests before repairing, in order to give some degrees of deterioration to the slabs. The third was fatigue loading tests after repairing. Through those steps, the mechanical behavior of repaired and non-repaired slabs was examined, in particular on cracking pattern, debonding of steel plate, degradation of stiffness and so on. The six test slabs named No.1 to No.6 have the same sizes and reinforcements. The load intensity truck rear wheel in running was set to 51kN for slabs Nos.1, 3 and 5 and to 42kN for slabs Nos.2, 4 and 6. Slabs Nos.1,2,3 and 4 were repaired after finite number of loading cycles. Slabs Nos. 5 and 6 remained non-repaired for monitoring. The higher load intensity of rear wheel applied were corresponding to about 1.5 times as large as an equivalent design load specified by the Japanese code [1].

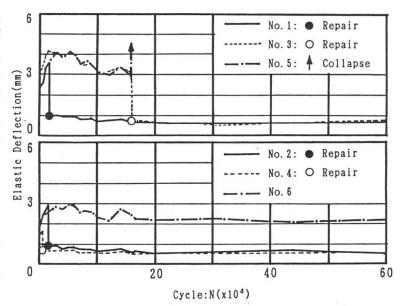
Fig. 1 Relationship between Loading Cycle and Elastic Deflection at Center

Figure 1 shows variations of elastic deflection under the central rear wheel load, which mean the degradation of stiffness of slab. Non-repaired slab No.5 collapsed at about 160000 cycles, and slabs Nos. 1 and 3 with the same loading condition as No.5 were repaired at 17000 and 160000 cycles, respecti-While, slabs Nos.2 and 4 subjected to a lighter loading condition were repaired at earlier stages of 5000 and 17000 cycles, respectively. All test slabs except No.5 did not collapse until 600000 cycles when the tests ceas-

The collapse mode occurred in slab No.5 was like a punching shear mode without fracture of re-bars. By taking a view of the cross section sawn out after the tests were over, it was known that diagonal shear cracks in concrete might appear at earlier stage, but so severe debonding of steel plate to lead a shear bond failure soon was not seen yet, though only some ofsmall parts of debonding of steel plate occurred from small cavities within epoxy resin layer, which seemed to be already made at the repair stage.
