Artikel: Full-scale shear tests on two bridges

Autor: Plos, Mario / Gylltoft, Kent / Cederwall, Krister

Full-Scale Shear Tests on two Bridges

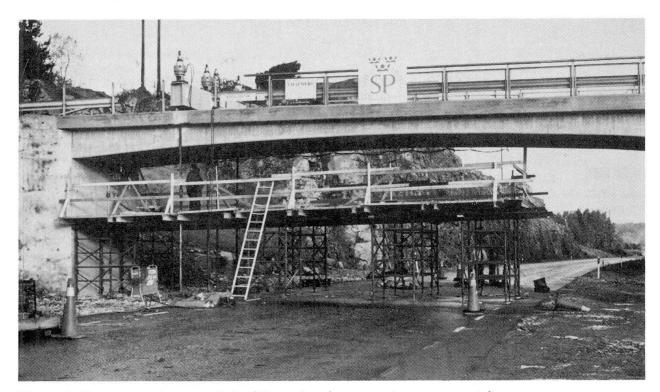
Fig. 1 Non-prestressed bridge during test preparation.

Full scale shear tests were performed on two concrete portal frame bridges. One of the bridges was a non-prestressed slab frame bridge with a free span of 21 m (fig 1 and 2).

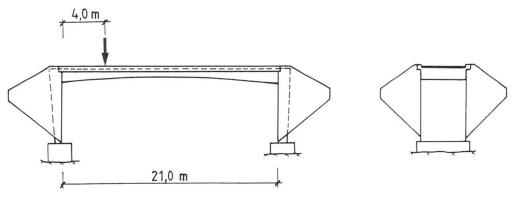
Fig. 2 Non-prestressed bridge

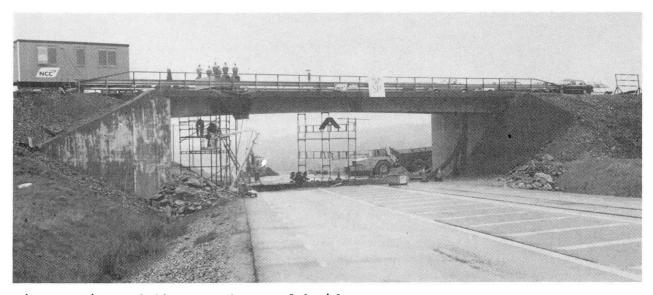
Fig. 4 View of the prestressed bridge

The other bridge was prestressed and had a free span of 31 m (fig 3 and 4). The span consisted of two post-tensioned beams connected by a bridge deck slab. The beams and the slab were connected with the front walls at the supports, forming a frame.

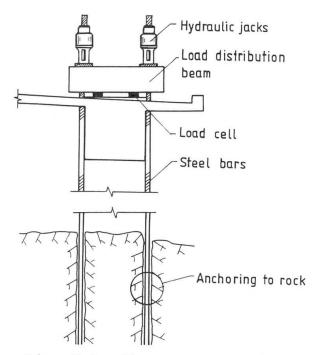
Fig. 5 Loading arrangement

The loads were applied through steel bars anchored to the rock under the bridges and transferred to the bridges by hydraulic jacks (fig 5). Loads, deflections and strains were measured during the tests, and crack growth was registered. The concrete strength was tested on cylinders drilled out of the bridges.

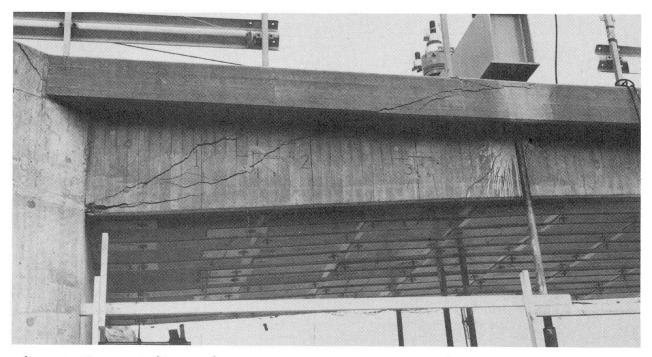
Fig. 6 Shear failure in the non-prestressed bridge

The non-prestressed bridge was loaded 4,00 m from one of the supports and failed at a load of 4,5 MN due to a sudden diagonal shear crack (fig 6). The bridge was substantially cracked due to bending, and some shear-bending cracks were observed close to the loading section before the failure occurred.

In the non-prestressed bridge a typical shear failure occurred. The moment and shear distribution of this bridge are under evaluation, but preliminary results indicate good agreement between the capacity according to the model in the code and test results.

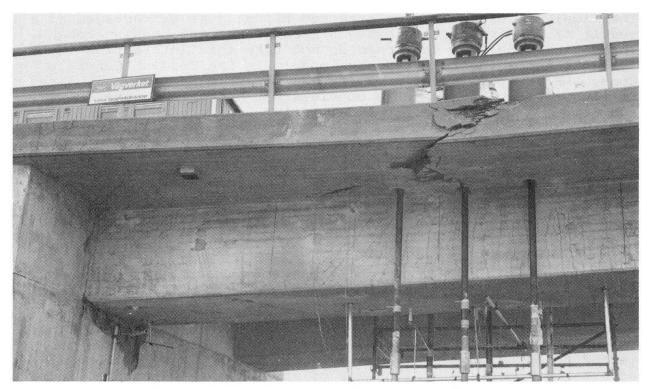
Fig. 7 Failure in the prestressed bridge. Cracking, support failure and concrete compression failure at the top of the loading section can be seen.

When the support failed, the load decreased to 6,0 MN. Further loading with the jacks lead to large deformations and several inclined cracks in the shear span. The final failure occurred at a load of 6,3 MN, when the concrete at the upper edge of the loading section crushed due to compression (fig 7).

The final failure in the prestressed bridge must be regarded as a result of the interaction between shear force and bending moment. The design models in the codes do not take this interaction into account. According to the design models in the Swedish Concrete Code, BBK 79, both shear capacity and moment capacity, calculated as separate capacities, were considerably higher than the shear and moment in the bridge at final failure.

It should however be observed that the final failure was achieved at a load level lower than the maximal. The difference between calculated shear capacity and shear force in the bridge was much smaller at maximum load level than at the final failure. The moment in the loading section, however, increased considerably from maximum load level until final failure occurred. The effect of moment must therefore have a decisive influence on the failure.
