Artikel: Full-scale shear tests on two bridges
Autor: Plos, Mario / Gylltoft, Kent / Cederwall, Krister
DOI: <https://doi.org/10.5169/seals-47696>

Full-Scale Shear Tests on two Bridges

Full-scale shear tests were performed on two concrete highway bridges constructed in 1980. The test results reveal short-comings in the design models when a combination of shear and moment actions leads to failure. The results show the need for better design models based on a clear physical understanding of failure. Fracture mechanics can be used together with the finite element method to obtain a better understanding of the failure process.

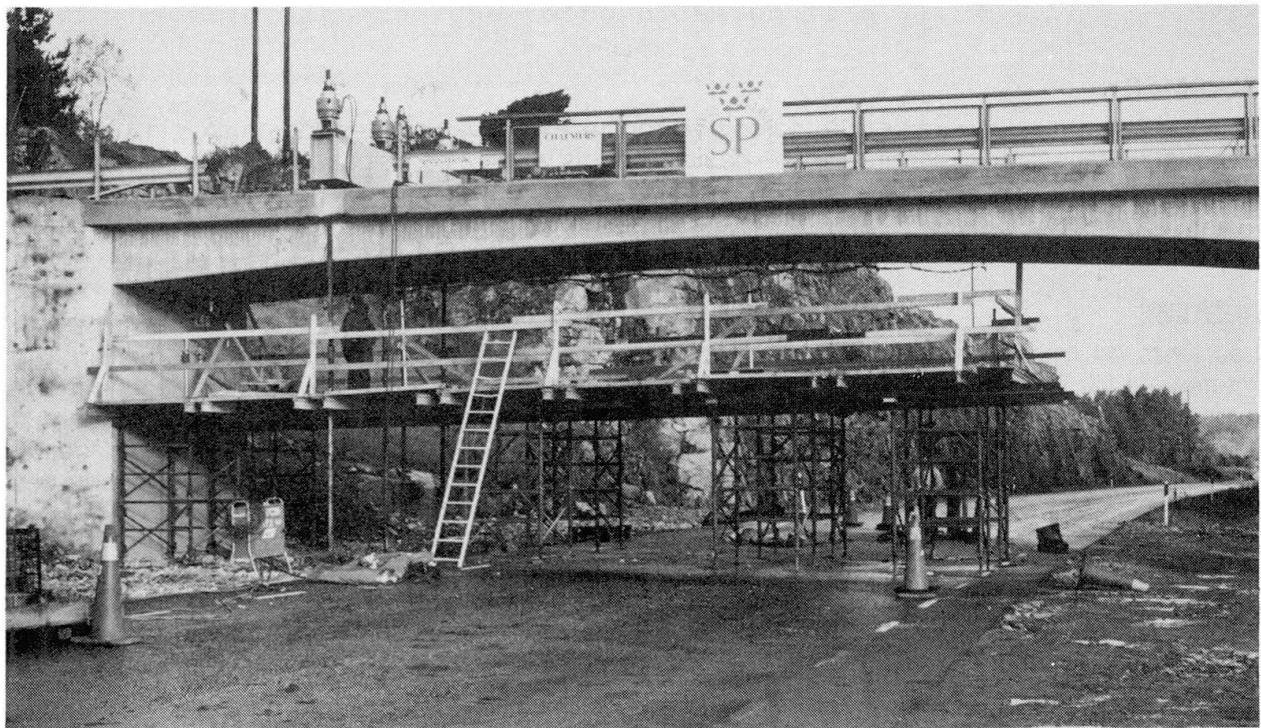
Fig. 1 Non-prestressed bridge during test preparation.

Full scale shear tests were performed on two concrete portal frame bridges. One of the bridges was a non-prestressed slab frame bridge with a free span of 21 m (fig 1 and 2).

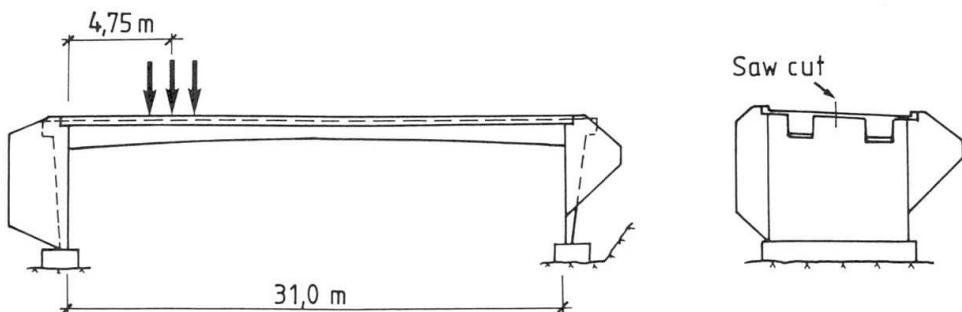
Fig. 3 Prestressed bridge

The other bridge was prestressed and had a free span of 31 m (fig 3 and 4). The span consisted of two post-tensioned beams connected by a bridge deck slab. The beams and the slab were connected with the front walls at the supports, forming a frame.

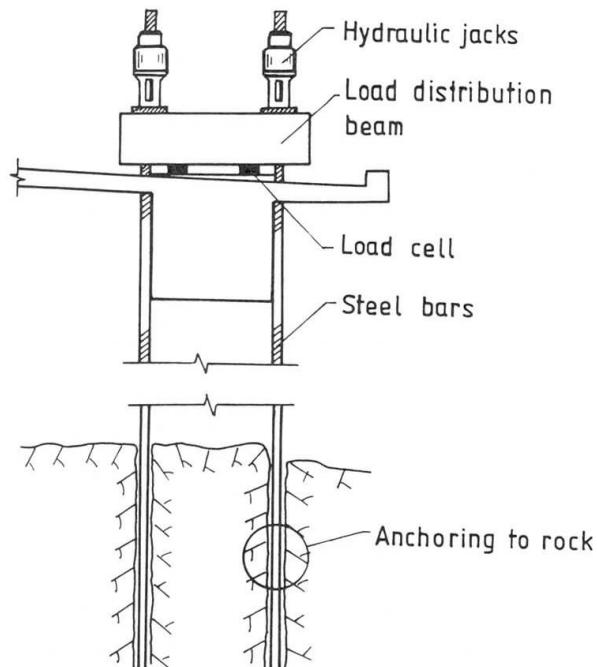
Fig. 5 Loading arrangement

The loads were applied through steel bars anchored to the rock under the bridges and transferred to the bridges by hydraulic jacks (fig 5). Loads, deflections and strains were measured during the tests, and crack growth was registered. The concrete strength was tested on cylinders drilled out of the bridges.

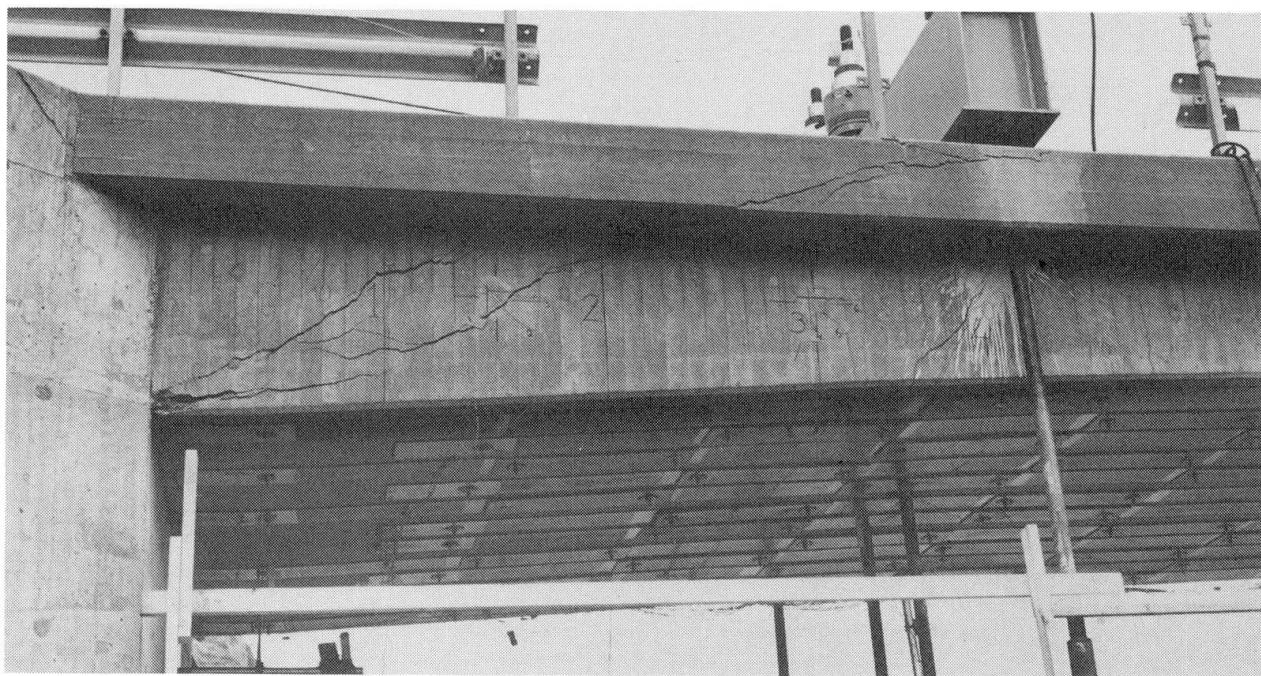
Fig. 6 Shear failure in the non-prestressed bridge

The non-prestressed bridge was loaded 4,00 m from one of the supports and failed at a load of 4,5 MN due to a sudden diagonal shear crack (fig 6). The bridge was substantially cracked due to bending, and some shear-bending cracks were observed close to the loading section before the failure occurred.

In the non-prestressed bridge a typical shear failure occurred. The moment and shear distribution of this bridge are under evaluation, but preliminary results indicate good agreement between the capacity according to the model in the code and test results.

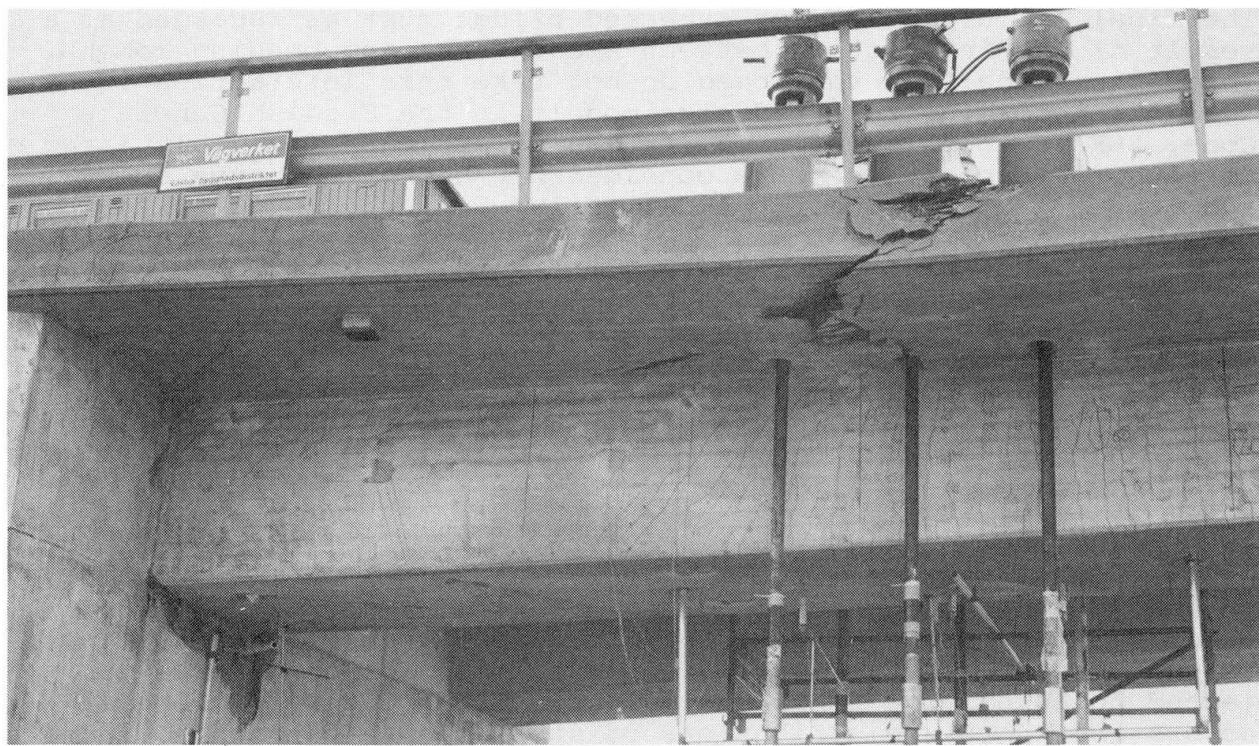
Fig. 7 Failure in the prestressed bridge. Cracking, support failure and concrete compression failure at the top of the loading section can be seen.

The failure of the pre-stressed bridge was more complicated. Before the test this bridge was cut longitudinally between the two main beams and one of the beams was loaded about 4,75 m from one of the supports. After extensive cracking due to bending, together with a few shear-bending cracks, the support closest to the load unexpectedly failed at a load of 8,5 MN. The support failure lead to a redistribution of the moment, with increasing moment in the loading section.

When the support failed, the load decreased to 6,0 MN. Further loading with the jacks lead to large deformations and several inclined cracks in the shear span. The final failure occurred at a load of 6,3 MN, when the concrete at the upper edge of the loading section crushed due to compression (fig 7).

The final failure in the prestressed bridge must be regarded as a result of the interaction between shear force and bending moment. The design models in the codes do not take this interaction into account. According to the design models in the Swedish Concrete Code, BBK 79, both shear capacity and moment capacity, calculated as separate capacities, were considerably higher than the shear and moment in the bridge at final failure.

It should however be observed that the final failure was achieved at a load level lower than the maximal. The difference between calculated shear capacity and shear force in the bridge was much smaller at maximum load level than at the final failure. The moment in the loading section, however, increased considerably from maximum load level until final failure occurred. The effect of moment must therefore have a decisive influence on the failure.
