Zeitschrift: IABSE reports = Rapports AIPC = IVBH Berichte
Band: 62 (1991)

Artikel: Full-scale shear tests on two bridges
Autor: Plos, Mario / Gylltoft, Kent / Cederwall, Krister
DOI: <https://doi.org/10.5169/seals-47696>

Full-Scale Shear Tests on two Bridges

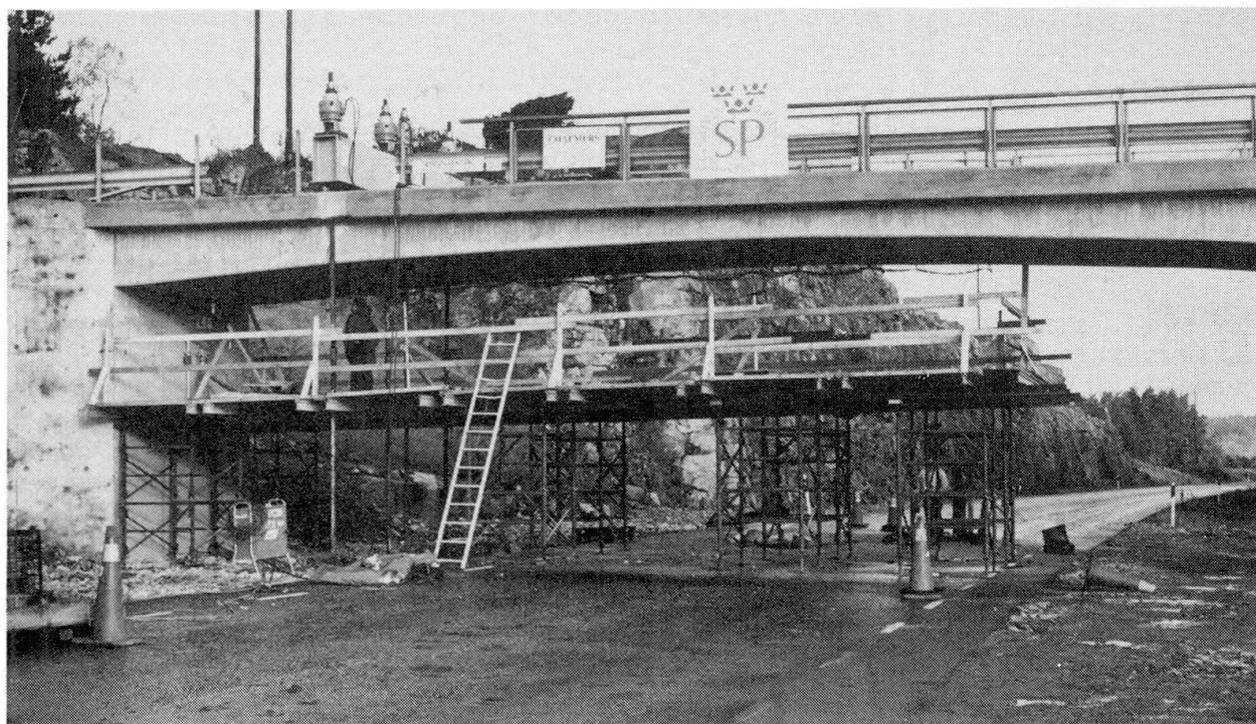
Fig. 1 Non-prestressed bridge during test preparation.

Full scale shear tests were performed on two concrete portal frame bridges. One of the bridges was a non-prestressed slab frame bridge with a free span of 21 m (fig 1 and 2).

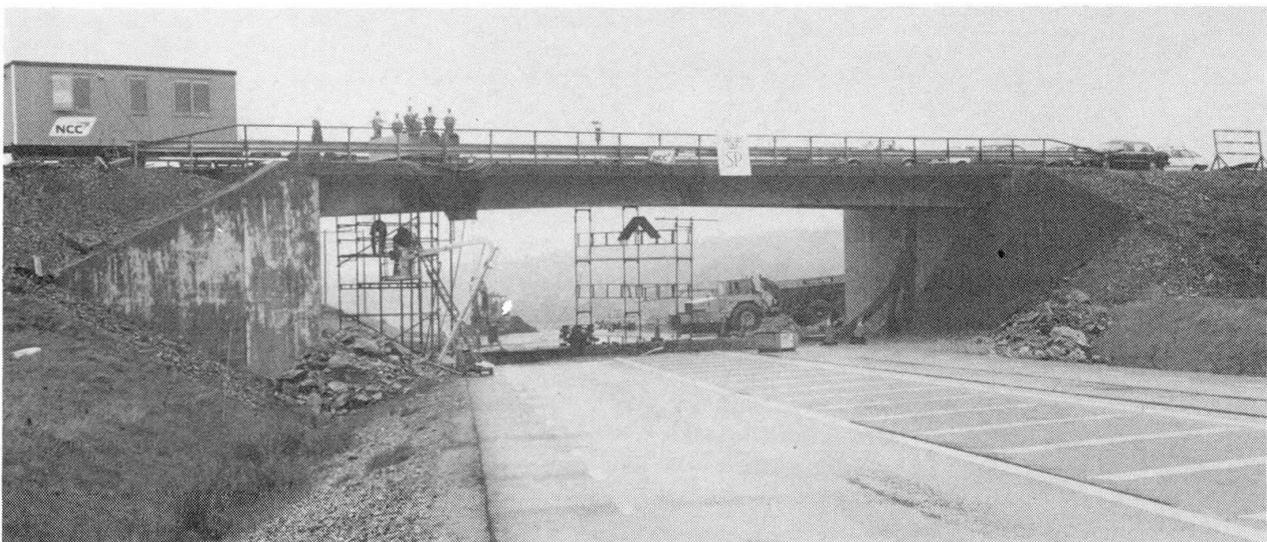
Fig. 4 View of the prestressed bridge

The other bridge was prestressed and had a free span of 31 m (fig 3 and 4). The span consisted of two post-tensioned beams connected by a bridge deck slab. The beams and the slab were connected with the front walls at the supports, forming a frame.

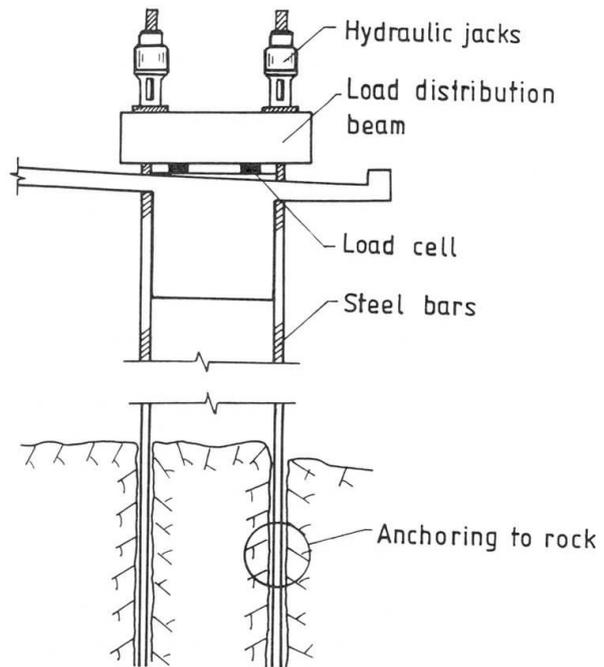
Fig. 5 Loading arrangement

The loads were applied through steel bars anchored to the rock under the bridges and transferred to the bridges by hydraulic jacks (fig 5). Loads, deflections and strains were measured during the tests, and crack growth was registered. The concrete strength was tested on cylinders drilled out of the bridges.
