Artikel: Performance assessment of cap-column joints under seismic loading

Performance Assessment of Cap-Column Joints Under Seismic Loading

An overview of joint damage in beam-column joints of multi-level bridge bents during the 1989 Loma Prieta earthquake, is presented. Assessment criteria for evaluating seismic performance characteristics and retrofitting schemes for existing concrete bridge structures, are developed. The application of analytical concrete models of various complexities in support of structural concrete design is demonstrated.

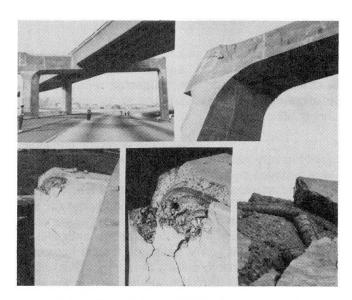
Fig. 1 Outrigger bent joint damage

A single-deck outrigger bent (bent #38) with only a 0.92 m (3 ft) outrigger cap beam extension past the superstructure on I-980 featured heavy joint damage as shown in Fig. 1c,d,e. Built in 1985, the column was well confined with an interlocking spiral, see Fig. 3, however, this spiral did not continue into the joint region

A capacity check on the cap beam and column capacities showed that the cap beam capacity is critical for positive moment due to the insufficient anchorage length of 1.8 m (72 in.) for the D = 57 mm (#18) bars which, based on ACI 318-89, require a basic development length of 3.0 m (117 in.) which is likely to be on the conservative side. In the other loading direction (negative moment in the joint), the column capacity is critical. Joint shear force levels derived from simple stress models, Fig. 4, show joint shear stress levels of $0.37\sqrt{t_C}$ MPa $(4.3\sqrt{t_C}$ psi) and $0.5\sqrt{t_C}$ MPa $(6.0\sqrt{t_C}$ psi), under positive and negative moment loading, respectively, which are both above an assumed level of $0.33\sqrt{t_C}$ MPa $(4.0\sqrt{t_C}$ psi), where diagonal tension cracking in the joint can be expected. Since the shear capacity of the 5 gauge wire spirals does not add significant joint shear capacity, the formation of any flexural hinge mechanism in adjacent members was inhibited. This explains the encountered diagonal joint crack patterns during the Loma Prieta earthquake, see Fig. 1c,d,e.

In addition to the diagonal crack patterns, large areas of cover concrete spalling along the outer cap comer as well as a ruptured D = 57 mm (#18) reinforcement bar which was bent on a 45 cm (1'-6") radius were observed, see Fig. 1d,e.

The first phenomenon of cover concrete spalling can be explained with the fully reversed cyclic loading. Under negative moment, flexural cracks open on the cap surface as shown in Fig. 3 and under subsequent positive moment loading, the entire compression force has to be transferred through the negative moment reinforcement until the cracks can close. These high compression forces in the negative moment reinforcement transferred to the concrete by bond, have a tendency to spall off the concrete cover between flexural cracks developed in the previous tensile excursions. The second phenomenon, the ruptured reinforcing bar, see Fig. 1d, points to a potentially critical problem which needs further investigation. Common ultimate strain levels in D = 57 mm (#18) f_y = 414 MPa (Grade 60) bars are in a range from 7 to 15%. Introducing a R = 45 cm (18 in.) radius bent into a D = 57 mm (#18 or ϕ = 2.25 in.) bar causes strain levels of D/(2R) = 225/(2 × 18) = 6.25%, which is close to the ultimate strain range. The very low strain reserves and possible strain aging effects which raise the notch ductile temperature at which steel will fail in a brittle mode can cause sudden failure in these bent bars at very low additional strain levels.

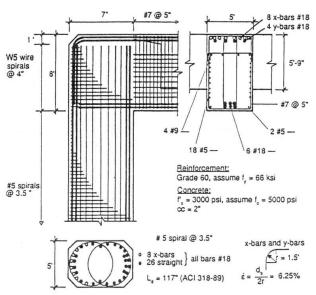
Fig. 3 I-980, #38, Reinforcement details

where it was replaced by a 5 gauge wire spiral with D = 5 mm at 10 cm (ϕ 0.2 in. @ 4 in.). Also, the cap beam reinforcement, aside from the top and bottom bars, see Fig. 3, did not extend into the joint region.

Detailing for repair or retrofit of the damaged knee joint on I-980, bent #38, can be derived using either strut and tie models as outlined in Fig. 3 with additional considerations as outlined in [2] for transverse splitting under negative moment and tie back for fully reversed cyclic loading, or directly from the force states derived from the compression field analysis, see Fig. 5. A possible repair measure consists of providing an additional 23 cm (9 in.) concrete jacket around the existing joint with horizontal and vertical distributed joint reinforcement and a diagonal corner tie back based on force and reinforcement quantities derived in Fig. 4. The damaged joint concrete can either be removed and the joint rebuilt completely or the damaged joint can be epoxy injected subsequent to removal of loose concrete, roughening of the interface, and adequate doweling bonding of the added structural concrete jacket.
