**Artikel:** Performance assessment of cap-column joints under seismic loading  
**Autor:** Seible, Frieder / Priestley, M.J. Nigel  
**DOI:** <https://doi.org/10.5169/seals-47650>

## Performance Assessment of Cap-Column Joints Under Seismic Loading

### 2.2 The Oakland Southbound Connector, I-980, Bent 38

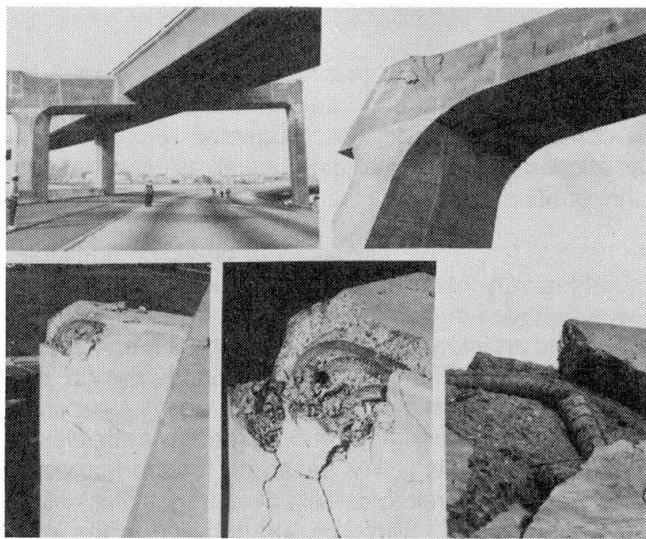
Fig. 1 Outrigger bent joint damage

A single-deck outrigger bent (bent #38) with only a 0.92 m (3 ft) outrigger cap beam extension past the superstructure on I-980 featured heavy joint damage as shown in Fig. 1c,d,e. Built in 1985, the column was well confined with an interlocking spiral, see Fig. 3, however, this spiral did not continue into the joint region

A capacity check on the cap beam and column capacities showed that the cap beam capacity is critical for positive moment due to the insufficient anchorage length of 1.8 m (72 in.) for the  $D = 57$  mm (#18) bars which, based on ACI 318-89, require a basic development length of 3.0 m (117 in.) which is likely to be on the conservative side. In the other loading direction (negative moment in the joint), the column capacity is critical. Joint shear force levels derived from simple stress models, Fig. 4, show joint shear stress levels of  $0.37\sqrt{f'_c}$  MPa (4.3 $\sqrt{f'_c}$  psi) and  $0.5\sqrt{f'_c}$  MPa (6.0 $\sqrt{f'_c}$  psi), under positive and negative moment loading, respectively, which are both above an assumed level of  $0.33\sqrt{f'_c}$  MPa (4.0 $\sqrt{f'_c}$  psi), where diagonal tension cracking in the joint can be expected. Since the shear capacity of the 5 gauge wire spirals does not add significant joint shear capacity, the formation of any flexural hinge mechanism in adjacent members was inhibited.. This explains the encountered diagonal joint crack patterns during the Loma Prieta earthquake, see Fig. 1c,d,e.

In addition to the diagonal crack patterns, large areas of cover concrete spalling along the outer cap corner as well as a ruptured  $D = 57$  mm (#18) reinforcement bar which was bent on a 45 cm (1'-6") radius were observed, see Fig. 1d,e.

The first phenomenon of cover concrete spalling can be explained with the fully reversed cyclic loading. Under negative moment, flexural cracks open on the cap surface as shown in Fig. 3 and under subsequent positive moment loading, the entire compression force has to be transferred through the negative moment reinforcement until the cracks can close. These high compression forces in the negative moment reinforcement transferred to the concrete by bond, have a tendency to spall off the concrete cover between flexural cracks developed in the previous tensile excursions. The second phenomenon, the ruptured reinforcing bar, see Fig. 1d, points to a potentially critical problem which needs further investigation. Common ultimate strain levels in  $D = 57$  mm (#18)  $f_y = 414$  MPa (Grade 60) bars are in a range from 7 to 15%. Introducing a  $R = 45$  cm (18 in.) radius bent into a  $D = 57$  mm (#18 or  $\phi = 2.25$  in.) bar causes strain levels of  $D/(2R) = 225/(2 \times 18) = 6.25\%$ , which is close to the ultimate strain range. The very low strain reserves and possible strain aging effects which raise the notch ductile temperature at which steel will fail in a brittle mode can cause sudden failure in these bent bars at very low additional strain levels.

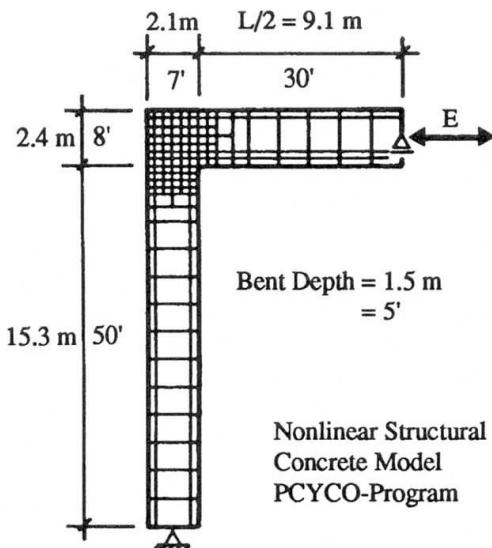
Fig. 2 Analytical bent model

In addition to the simple stress models of the knee bent joint, detailed nonlinear finite element simulations, see Fig. 2, based on extended compression field principles were performed to determine analytically failure modes and joint deformation contributions to the overall bent deformations. Reinforcement development of straight bars was modeled by assuming a reduced yield level in the anchor zone decreasing linearly from the full yield at the ACI 318-89 basic development location to zero at the bar end. Subsequently derived yield patterns in bar anchorage regions therefore are indicative of bond failure or slip. Superimposed to the dead load case, the half bent, Fig. 2, was subjected to lateral force, and force-deformation envelopes with major event indicators, depicted for positive moment loading in Fig. 5, were obtained. Associated crack, slip/yield and first crushing patterns, see Fig. 5, indicate the failure mechanisms in the joint region. The heavy yield in the joint center, both horizontally and vertically, indicates the deficiency of both vertical and horizontal joint shear reinforcement, particularly under negative moment on the joint. Also, the crushing of the concrete in the outer joint region under the bent negative moment reinforcement under loading to the left or negative moment indicates the high compressive stress state and associated transverse prying forces in this region and the need for sufficient transverse confinement reinforcement, as outlined by Schlaich et al. [2], for strut and tie models for negative moment knee joints.

Since joints should be detailed based on capacity considerations such that the major inelastic action occurs in the cap or column, and since they should remain effectively elastic for small seismic disturbances (Paulay et al. [4]), the nonlinear finite element analysis was repeated with a linear elastic joint for a direct comparison of deformation limit states. As can be seen from Fig. 5, while joint deformations did not contribute significantly to the initial overall structural deformations, the failure mode in the positive moment direction shows improved ductile behavior when the failure mechanism is shifted from joint distress to flexural cap beam hinging. It should be noted that the cap beam capacity still may be artificially low due to the reduced yield strength in the bottom  $D = 57$  mm (#18) reinforcing bars based on a reduced development length according to ACI 318-89. Negative moment loading behavior is also improved by forcing the yield mechanism clearly into the column (not shown). Since the bent joint failure is the critical link in the overall behavior, repair/retrofit of these joints is a logical next step.

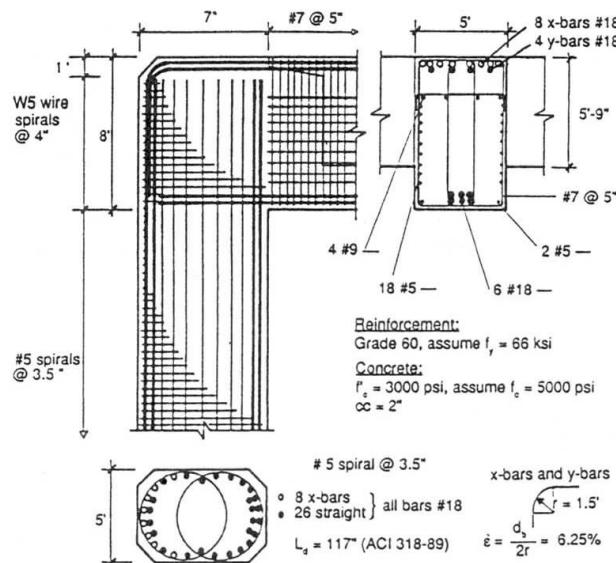
Fig. 3 I-980, #38, Reinforcement details

where it was replaced by a 5 gauge wire spiral with  $D = 5$  mm at 10 cm ( $\phi 0.2$  in. @ 4 in.). Also, the cap beam reinforcement, aside from the top and bottom bars, see Fig. 3, did not extend into the joint region.

Detailing for repair or retrofit of the damaged knee joint on I-980, bent #38, can be derived using either strut and tie models as outlined in Fig. 3 with additional considerations as outlined in [2] for transverse splitting under negative moment and tie back for fully reversed cyclic loading, or directly from the force states derived from the compression field analysis, see Fig. 5. A possible repair measure consists of providing an additional 23 cm (9 in.) concrete jacket around the existing joint with horizontal and vertical distributed joint reinforcement and a diagonal corner tie back based on force and reinforcement quantities derived in Fig. 4. The damaged joint concrete can either be removed and the joint rebuilt completely or the damaged joint can be epoxy injected subsequent to removal of loose concrete, roughening of the interface, and adequate doweling bonding of the added structural concrete jacket.
