Artikel: East River bridge rehabilitation in New York
Autor: Kotlyarsky, Edward / Trachtenberg, Eugene
DOI: <https://doi.org/10.5169/seals-49346>

East River Bridge Rehabilitation in New York

The unique design and construction aspects of the rehabilitation of two major East River Bridges in New York City is the subject of this paper.

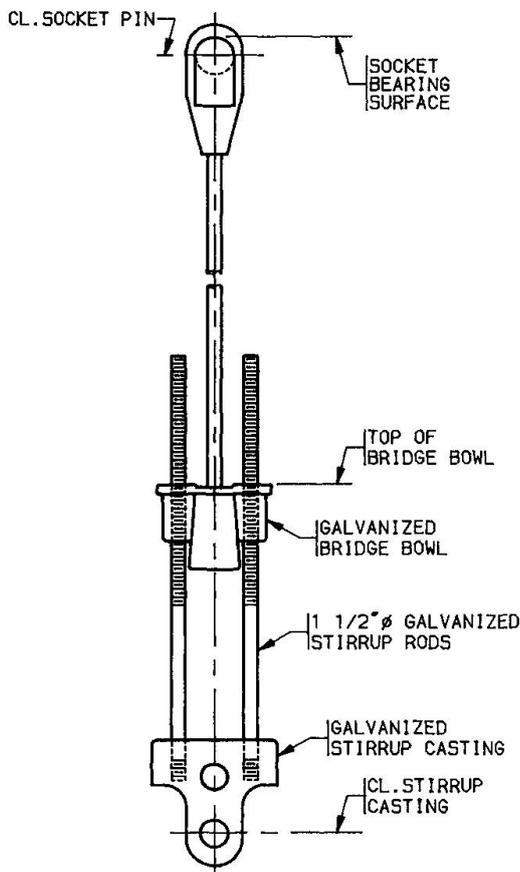
Fig. 1 New wire rope suspender

Existing suspenders were replaced with new 35 mm (1 3/8 in) diameter galvanized wire ropes attached to the cable with new cable bands. Suspender attachment to the truss bottom chord consists of two stirrup rods, galvanized stirrup casting and bridge bowl (Fig. 1), provided for required adjustment of suspender length. The socket baskets were filled with zinc. Solid rods were used in areas requiring very short suspenders.

Upon completion of the suspender replacement, existing stays were replaced with 41.4 mm (1 5/8 in) galvanized structural wire ropes. The stay assembly and its attachment to the truss is similar to that of the suspender.

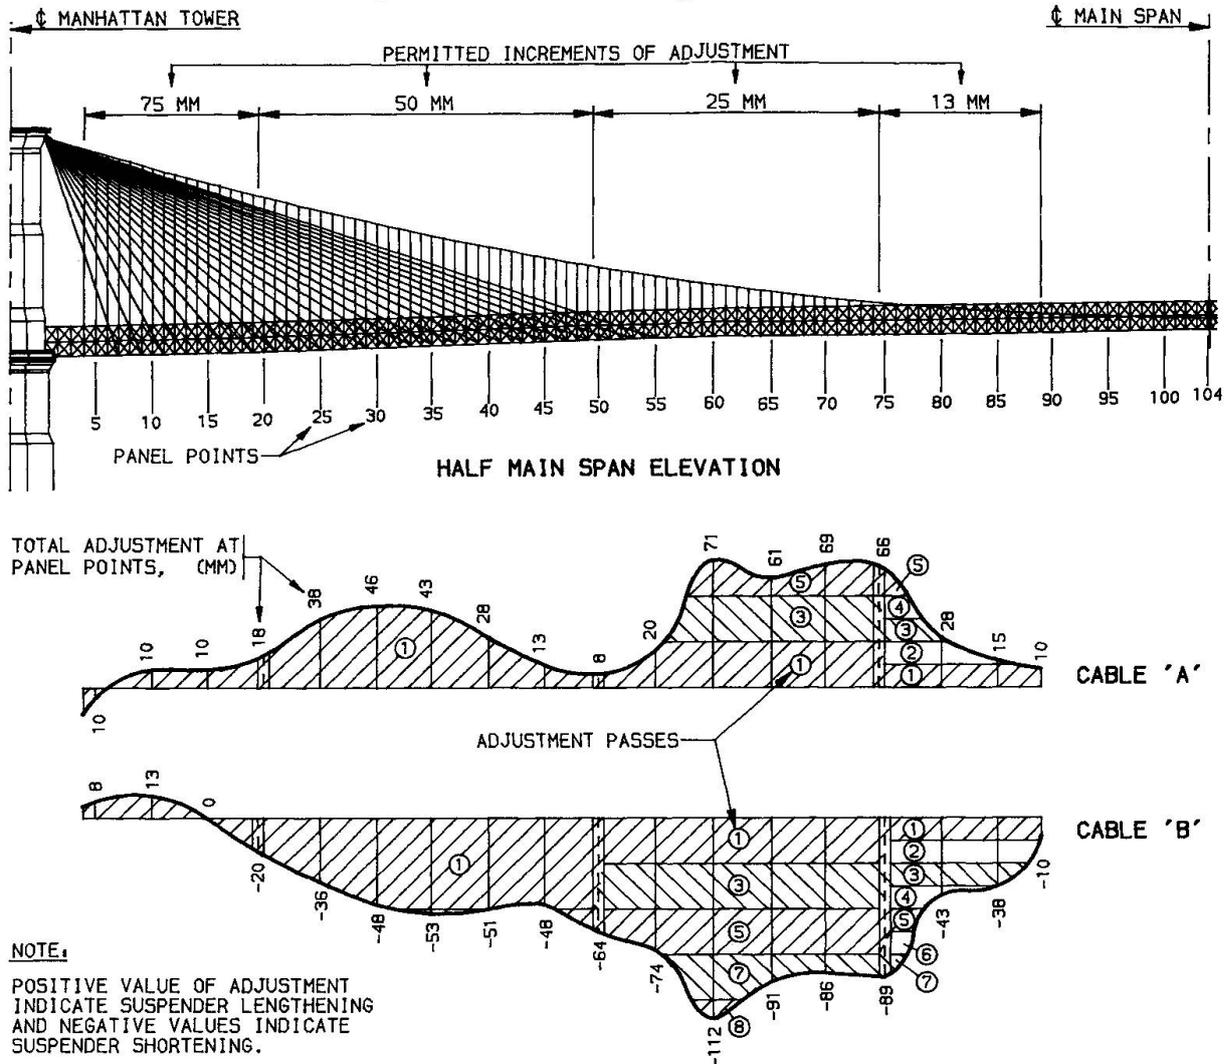
Fig. 2 Adjustment passes. Brooklyn half of Main Span

The values of adjustments and the number of passes for outer cable "A" and inner cable "B" for half main span are shown on Fig. 2.

The adjustments are mainly positive for cables A and D and negative for cables B and C. When done, these adjustments increase tension in the inner and reduce it in the outer cables thus achieving the desirable dead load distribution.

The adjustments were done by passes based on computed "bite" values. All passes progressed in each span from the shortest solid rod suspenders toward the towers.

During each pass adjustments were made on all four suspenders at each panel point before proceeding to the next panel point. Subsequent passes were performed in predetermined sequence until all adjustments were completed.

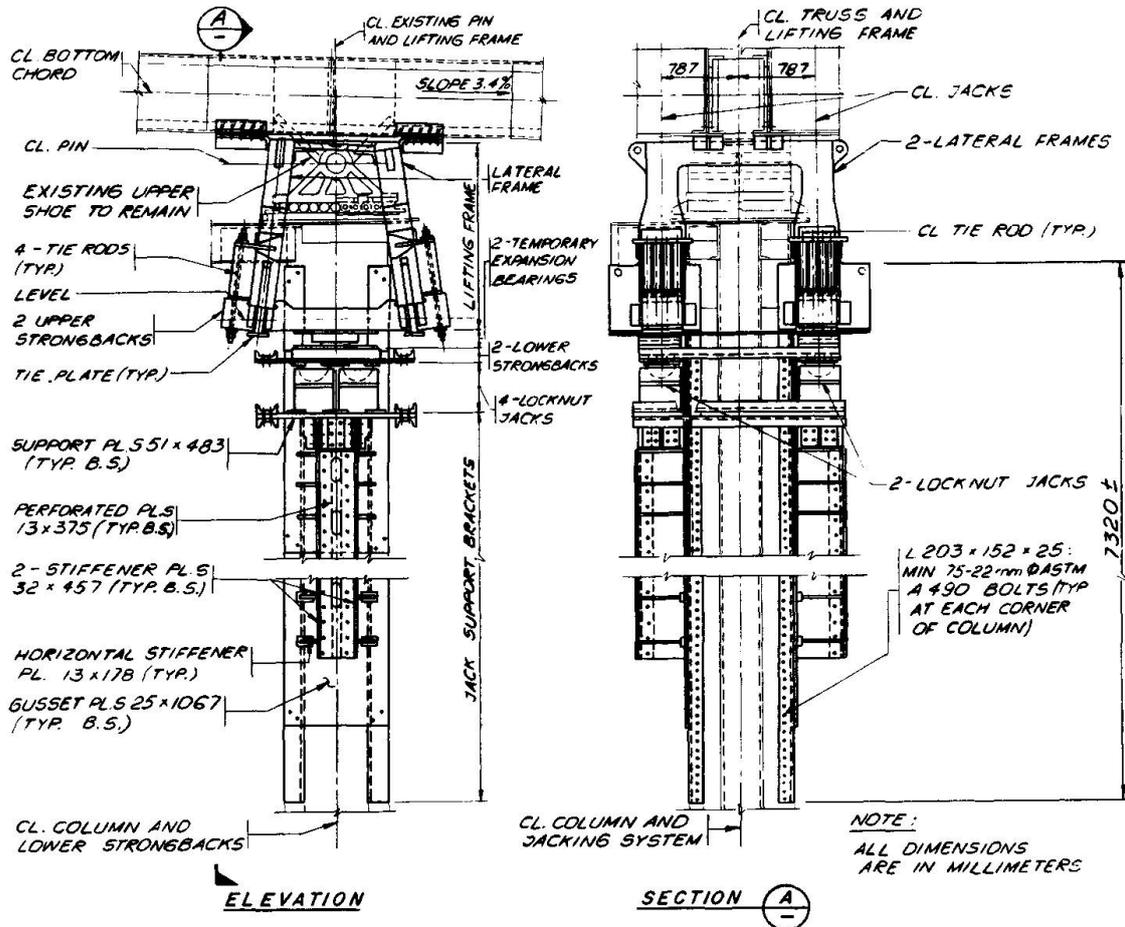
Fig. 4 Bearing replacement jacking system.

The entire system for the lifting and lowering of the existing trusses (Fig. 4) consisted of a high strength steel space frame, two temporary expansion bearings each seated on a strongback, four 4448 kN (500 ton) capacity locknut jacks and the lower support system. The temporary expansion bearings allowed the truss and jacking frame to translate and rock during the entire jacking operation. There were two different types of lower support system used: jack support brackets bolted to the existing columns at pp Nos. 20, 40, and 58; and jack support columns seated on the existing footings at pp Nos. 78, 82 and 86. Another procedure was used to replace expansion bearings at pp 0.

Lifting frame geometry was complicated by the need to fit in a very congested area and to provide clearances required to dismantle and remove the existing bearing elements and to erect new bearing components. Structural analysis of the space frame revealed that after lifting the existing truss, the maximum combined unit stress in the frame legs due to axial force and biaxial bending was 371 MPa (53.8 KSI). Because of the high design stresses in the frame elements they were fabricated of high strength quenched and tempered low alloy steel ASTM A-514 plates with minimum tensile yield point 689.5 MPa (100 ksi). Because this material is not available in thickness greater than 63.5 mm (2 1/2 in) each frame was built up of five plates laminated to provide the total leg thickness of 254 mm (10 in), and bolted together with 25.4 mm (1 in) diameter ASTM A-490 high strength bolts, tightened to a minimum tension of 285 kN (64 kips). The two upper strongbacks were built up of seven 50.8 mm (2 in) plates and two 25.4 mm (1 in) plates. The 50.8 mm (2 in) plate thickness provided openings for four 44.45 mm (1 3/4 in) diameter tie rods at both ends of each

upper strongback, where moment connections to the lateral frames were required. All tie rods were pretensioned to 44.5 kN (10 kips) each prior to the lifting operation. Each lower strongback was supported by two hydraulic jacks seated on two support brackets. Each bracket was connected to the existing column by seventy five 22.23 mm (7/8 in) diameter ASTM A-490 bolts through existing and new holes. The length of each of these connections was about 7.3 m (24 ft). Based on ASHTO requirements, the allowable shear stress on high-strength bolts in these connections was reduced by 20%.

The height of columns at three panel point locations was not sufficient to provide such long connections. This circumstance required the design of temporary four column steel towers installed on the existing 203.2 mm (8 in) thick cast steel base and braced around and to the existing column. Two lower strongbacks were longer than that used at high existing columns to accommodate location of jacks directly above the temporary columns.

All four jacks were controlled by a synchronous lifting and lowering console that maintained simultaneous, equal vertical movement of jacks despite the different reactions on each pair of jacks along the bridge.
